SITE ANALYSIS OVERVIEW

- October 2018 -

LAND NORTH OF SHENFIELDSite R19

LAND NORTH OF SHENFIELD - SITE R19 SURVEY (PLANNING ASSESSMENT)

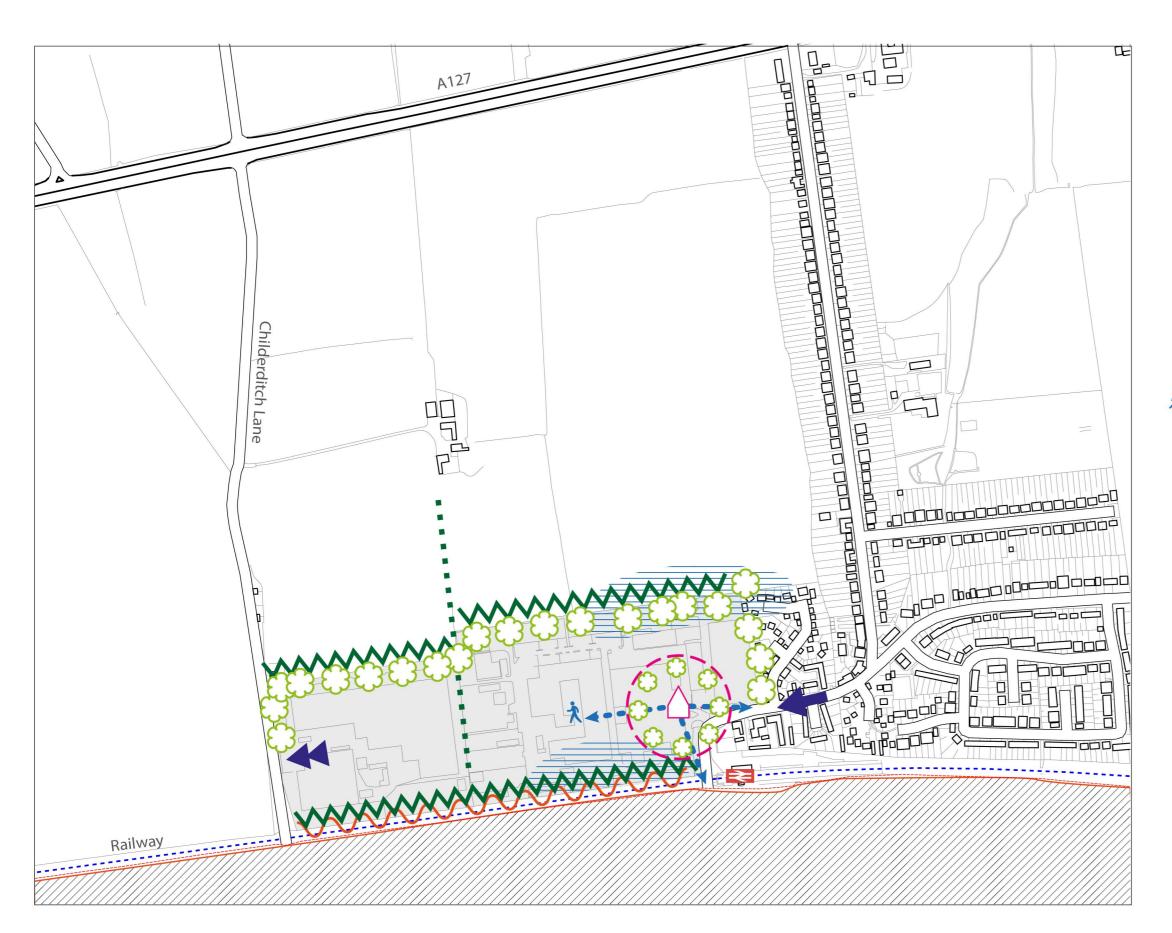
WEST HORNDON INDUSTRIAL ESTATE Site R27

Community focal area

Village centre with mixed use

Improved pedestrian connections

Improved vehicular access

Secondary access/ egress

Opportunities for Green and Blue Infrastructure/ urban ecology

Acoustic buffer measures

SUDS/ Flood risk mitigation

GENERAL DESCRIPTION OF THE SITE		
Existing land uses observed	Majority of the site comprises an industrial estate in active use. Small area of land to the east is a grassed field.	
Greenfield or Brownfield	Majority of site is brownfield with a small area of greenfield to the east.	
Topography	The sites and surrounding area are flat.	
Ground conditions	Existing operational industrial estate with buildings surrounding by tarmac, concrete and a small area of grassed land to the east.	
Significant features	Small water feature surrounded by trees present to the west of the site. A strip of boundary planting is present in the middle of the site running north to south separating the two halves of the site. Culvert runs under the middle of the site from north to south towards the railway line.	
Evidence of contaminated land	Potential risk due to long term presence of industrial activity.	
SITE SURROUNDINGS AND ACCESS

Evidence of current or past flooding?	Flood Zone 1 - low probab ility of flooding - less than 1 in 1000 year (<0.1% AEP) annual probability of river or sea flooding in any year. The Environment Agency's Flooding from Surface Water Map identifies significant areas of potential low, medium and high flood risk through the centre of the site, southern edge and northern boundary. Further analysis including site specific flood risk modelling is likely.

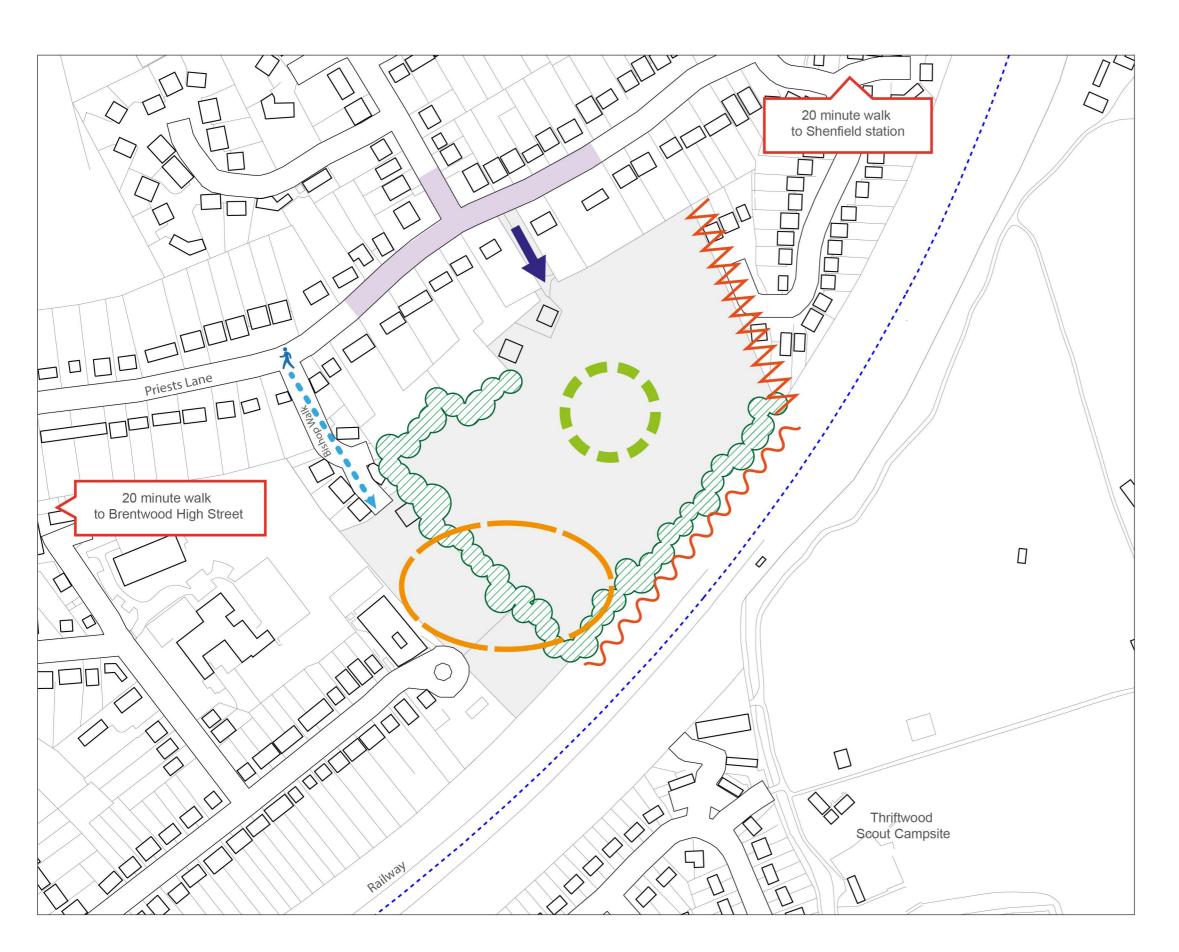
LAND AT PRIESTS LANE, SHENFIELD Site R17

Principal Access

Secondary/ cycling/ walkable access

Potential traffic calming measures

Sensitive edge

Acoustic buffer measures

Opportunity for school expansion Opportunities for central green space

LAND AT PRIESTS LANE - SITE RT/ SURVET (PLANNING ASSESSMENT)		
GENERAL DESCRIPTION OF THE SITE		
Existing land uses observed	Site is an open grassed field with no existing land uses (former use of site 044 understood to be playing field for Usuline School).	
Greenfield or Brownfield	Greenfield (small bungalow and disused sports pavilion situated to north adjoining proposed access to Priests Lane)	
Topography	Gently slopes away to the south.	
Ground conditions	The field was entirely grassed with extensive trees, shrubs and hedges along most boundaries.	
Significant features	A number of mature trees are situated along the boundary.	
Evidence of contaminated land	None was evident.	
SITE SURROUNDINGS AND ACCESS		
Surrounding land uses	Railway line adjoins the south eastern boundary.	
	Residential properties situated along north eastern and north western boundaries.	
	Schools (Hogarth County Primary and The Endeavour) adjoin the south western boundary.

Description and condition of site's boundary features	The north western boundary (rear of properties along Priests Lane) includes a number of well established trees, shrubs and hedges (deciduous and coniferous) which provides a good level of screening.	
	The north eastern boundary comprises a brick wall approximately 2m tall.	
	The south eastern boundary adjoining the railway line comprises well established trees and shrubs providing a good level of screening.	
	An established hedge along with some trees lies along the south western boundary. The screening thins out towards properties along Bishops Walk which back onto the site.	
Potential impacts from surrounding uses	The Railway line to the south east of the site generates some intermittent noise. Due to the line being situated at a lower level than the site and there being substantial screening along the boundary this impact is considered to be low.

Potential impacts to surrounding uses	The site is very well contained and screened with some views into the site from some adjoining properties on St Andrews Place, Bishops Walk and Priests Lane.	
Site's existing access arrangements	The site is accessed via a small gated driveway entrance off Priests Lane which serves existing bungalow on site.	
Barriers to / impacts of providing suitable site access to public highway	The route proposed for access into the site is wide enough to achieve a road with footpaths either side. Visibility splays would need to be created and may involve the loss of some hedgerows and crown lifting of the oak tree on right hand side of entrance. Proximity to Glanthams Road access will need to be considered carefully.	
Description of surrounding access network	Priests Lane is a well-used local road which is narrow in places and has public footpath on one side. This connects to Middleton Hall Lane nearby to the signalised crossroad junction of Ingrave Road and Seven Arches Road. During peak traffic hours this can cause queues along Priests Lane. The speed limit for Priests Lane is 30mph.
