BLACKMORE

CONSERVATION AREA APPRAISAL AND MANAGEMENT PLAN

DRAFT

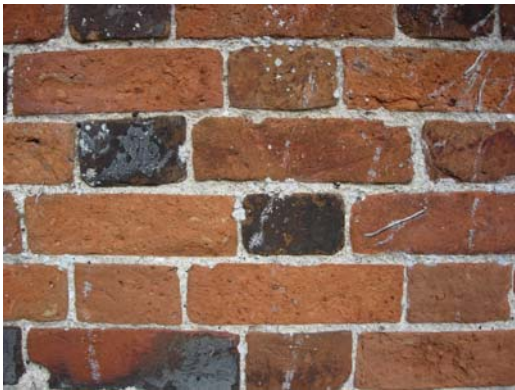
Fig. 6 Traditional brickwork.

Brick and render are the primary wall materials, although the church is in stone. Weatherboard is used on some ancillary and rear buildings. Most of the brickwork is soft red brick in a traditional bond (*Fig. 6*). Exceptions include the gault brick frontage of The Old Manor House, and contextless modern brick usually in monotonous stretcher bond on modern infill buildings. Significant seventeenth century Flemish bond walls in red brick with checkerboard patterns of darker headers are characteristic of Church Street, the Church boundaries and the Priory site to the south.

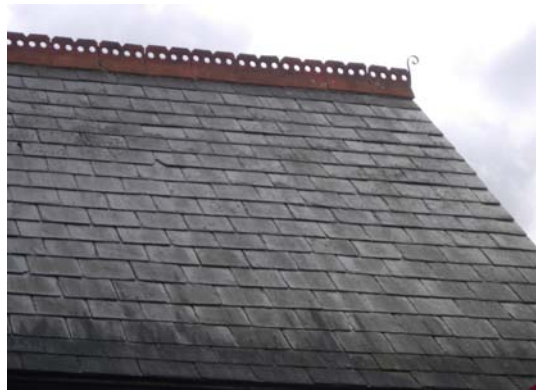
Fig. 7 Slate roof.

Roofs are primarily red clay handmade plain tile on steep roofs, with later welsh slate on shallower pitched nineteenth century buildings, and less attractive modern materials, usually concrete profiled tiles, on modern buildings (*Figs 7 and 9*). Occasionally outbuildings have red clay pantiles.

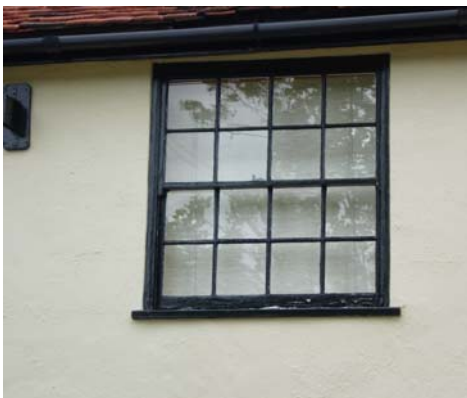
Fig. 8 Original timber window.

Windows are primarily painted timber (*Fig. 8*). Their styles range from seventeenth century to modern. There have been some UPVC replacements but currently these are isolated examples. Doors are also primarily painted timber, although there are occasional new oak boarded doors in a medieval style.

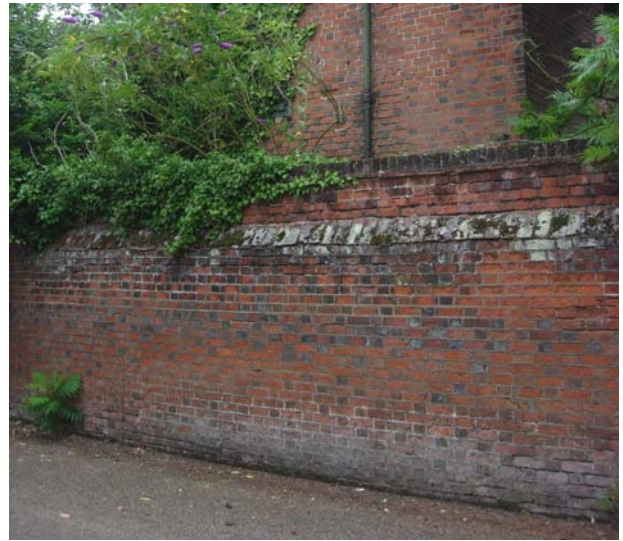
Boundary treatments can make a significant impact on the Conservation Area. The Flemish bond red brick walls of Church Street form a major part of the sense of enclosure and are very important (*Fig. 10*). Less complete sections and remnants of brick boundary walls remain elsewhere such as along the north of The Green and the rear of the Library site in Blacksmiths Alley and should be preserved. Less attractively a mix of short-lived fence panel boundaries can be seen throughout the residential areas, primarily in backlands around the more modern houses.

Fig. 10 Part of brick boundary wall, Jericho Priory, Church Street.

The red brick walls with traditional bond provide distinctive character to the boundaries of gardens to properties particularly along Church Street, the Green and Blacksmiths Lane. These should be valued and preserved and any new development within these areas should incorporate similar walls. The brick boundary walls around the Priory are particularly important and in places (on Church Street and north-east of the churchyard) these require maintenance and repair using traditional methods. The small number of railings within the Conservation Area should be protected and further railings encouraged.

It is recommended that the mature hedging, trees and old brick walls and railings in the Conservation Area be preserved and that any future development respects them or incorporates complementary boundary treatments.

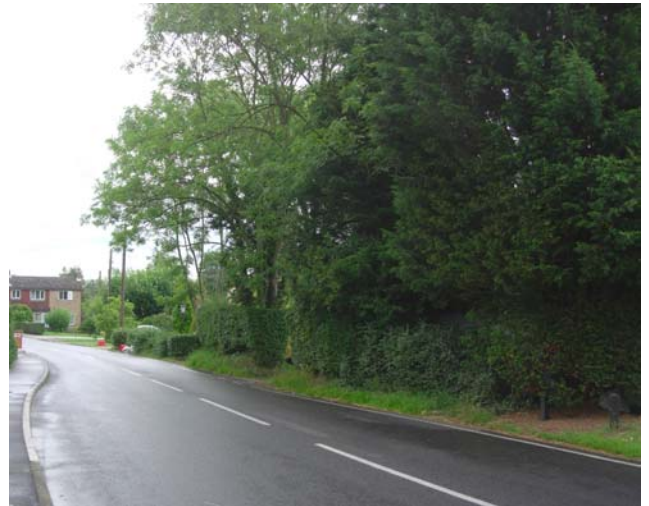
Apart from the walls of Church Street and its environs, hedging and trees are the most extensive boundaries within this Conservation Area and essential to the retention of its rural and enclosed character (*Fig. 11*). Hedging is in traditional species such as hawthorn, beech and blackthorn. Mature oaks are numerous along the hedgerows. Within the churchyard and Priory site to the south are numerous varieties such as mature chestnut, horse chestnut, oak and ash, with willows characteristic of the moat and river edges.

Fig. 11 Hedging and trees, Blackmore Road.

It is recommended that these strong open green areas, the established trees and shrubs within the greens, and the very strong mature tree and hedge boundary to the Conservation Area should be preserved and not eroded by any new development that might take place.

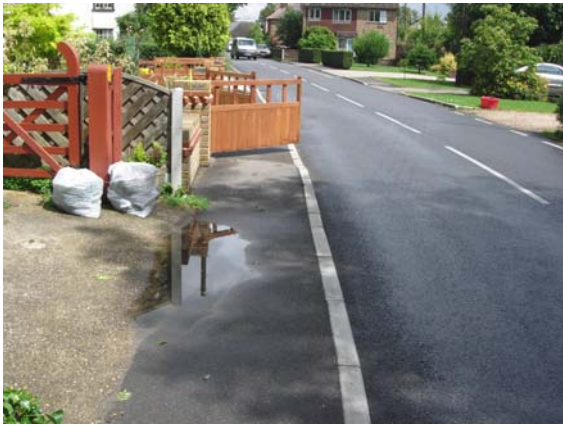
The roads are tarmac. Grit rolled into the surface of Church Street softens its appearance. Church Street, Ingatestone Road and the Alleys have no pavements but along The Green and Blackmore Road there are concrete kerbs (*Fig. 12*).

Fig. 12 Tarmac with concrete kerb stones, Blackmore Road.

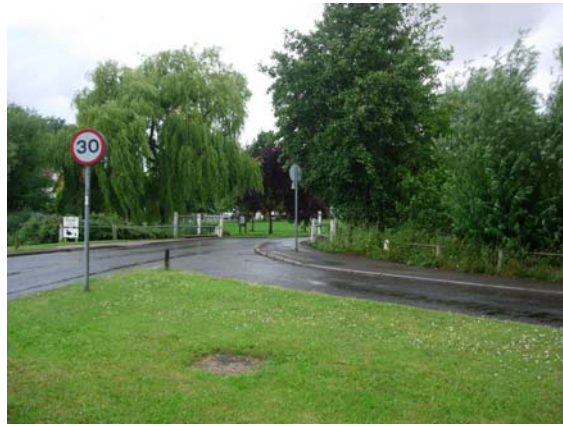
The greens are planted with established trees and shrubs (*Fig. 13*).

Fig. 13 Established planting around The Green.

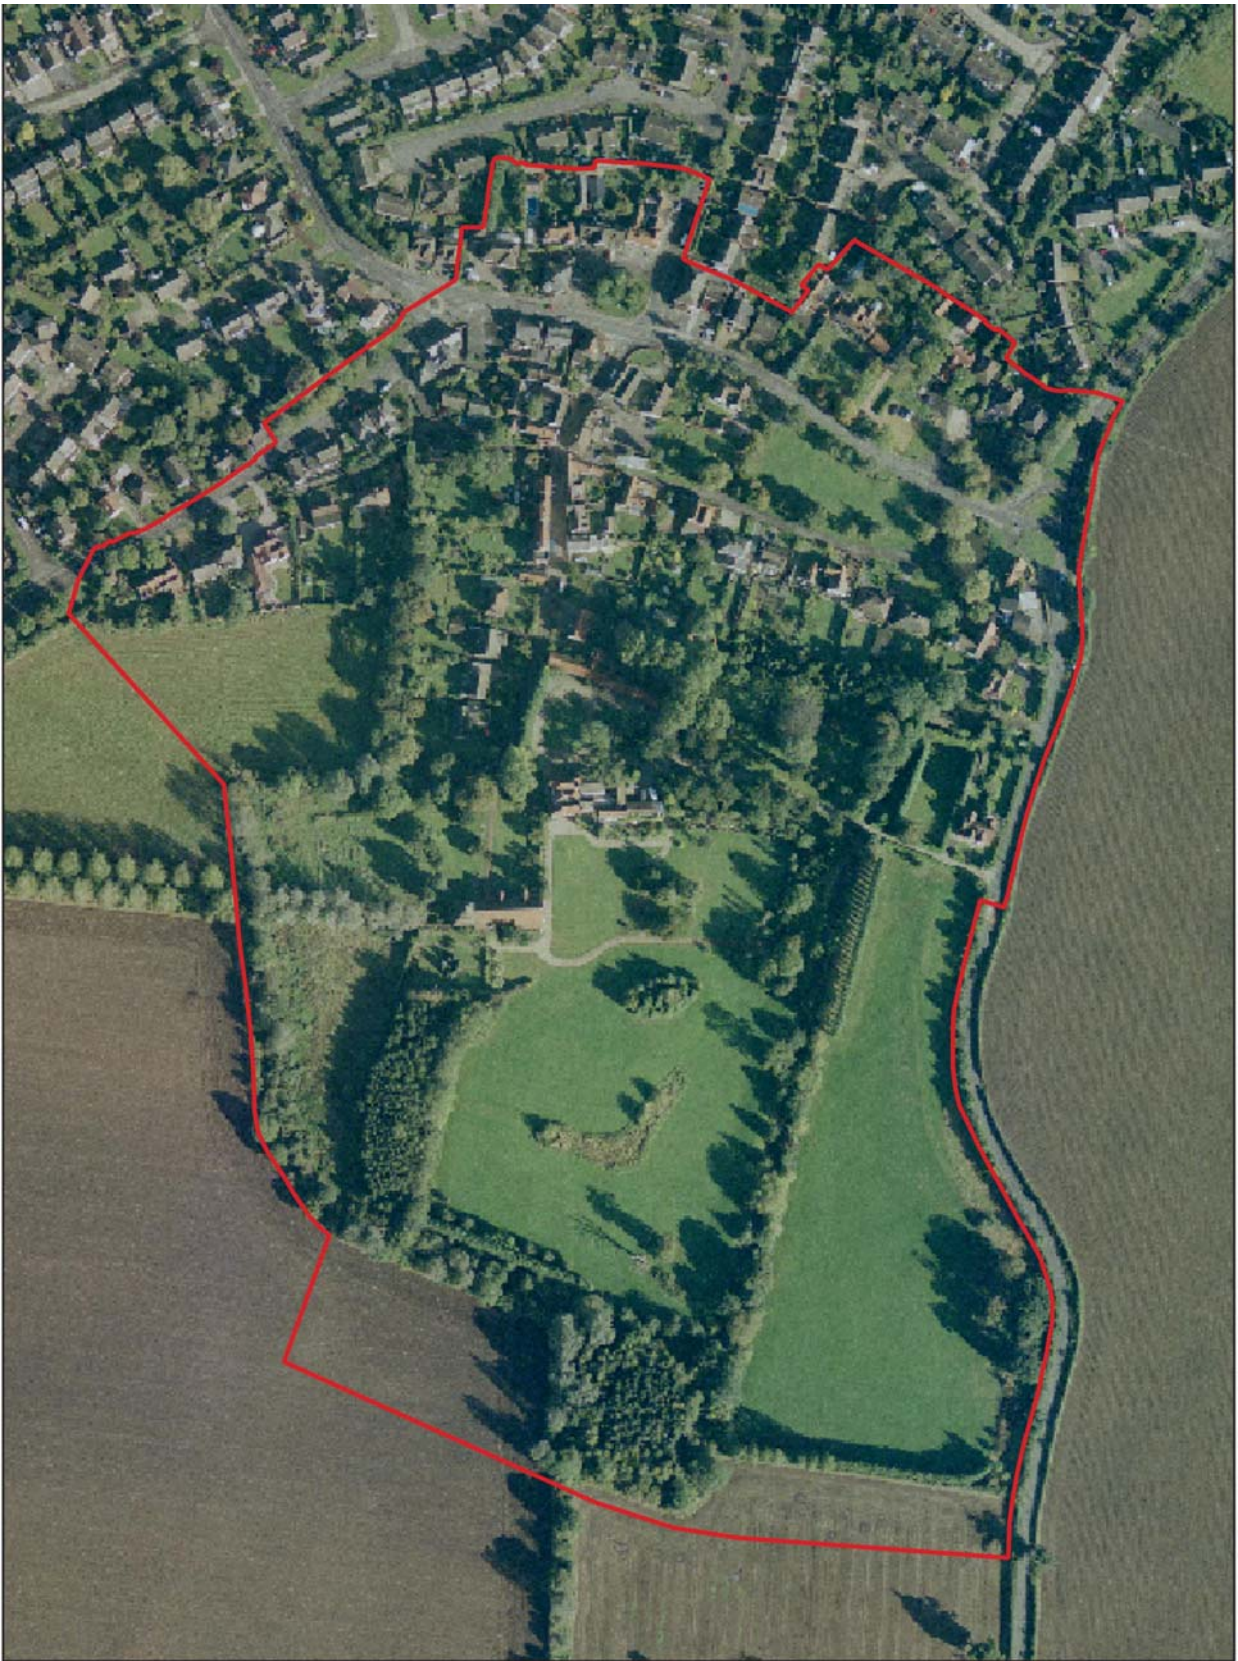
The spatial inter-relationship between streets, buildings, green spaces, trees and hedges can be seen in the aerial photograph of the village (*Fig. 15*). An analysis of the key elements in the townscape character of the conservation area are indicated in *Fig. 16*.

Fig. 15 Aerial photograph with conservation area boundary.

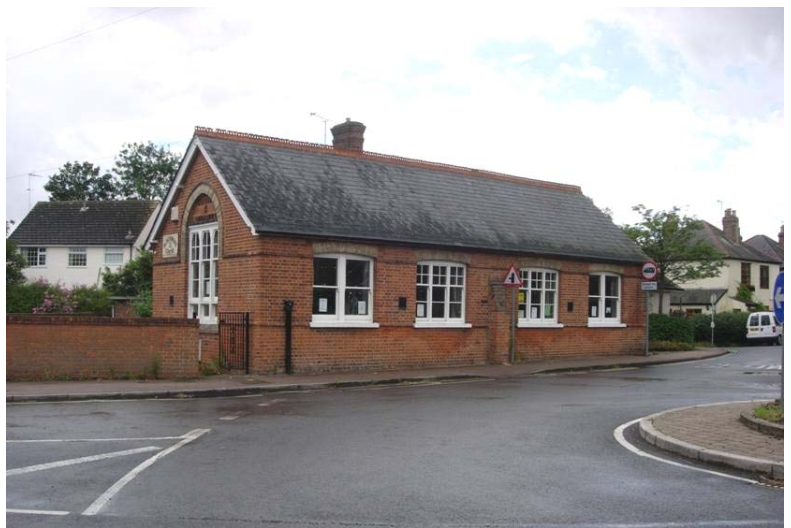
Fig. 19 Blackmore old school.

The nineteenth century **old school** building is the exception to this group (*Fig. 19*). Known as the Blackmore Centre, this is a charming example of a Victorian village school. Its fine brick detailing, original welsh slate roof, well detailed chimney, gables and deeply moulded windows make an irreplaceable contribution to the Conservation Area, and it is located close to the road edge making it a landmark building visible from a distance.

It is recommended that the old school together with its walls and brick outbuildings should be preserved in any new development that might take place.

It is recommended that the old school should be considered for inclusion on a 'local list' if one were to be adopted by the Local Authority.

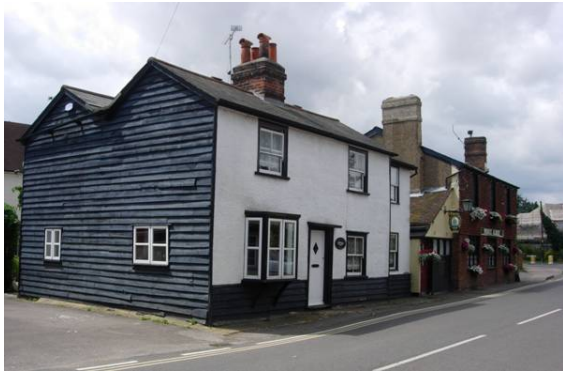
There is a pinch point slightly further to the east where the **Prince Albert Public House and Cottage** and the **Post Office** are all close to the road edge and provide a good framing to the entrance to The Green (*Fig. 20*). These form an attractive grouping of domestic-scale 18th and 19th century buildings. **The Prince Albert** dates from 1757, and has a distinctive frontage with tile hanging. The open car park of the pub would benefit from screening and some enclosure in order to enhance the street scene at this point (*Fig. 21*).

Fig. 20 Prince Albert Cottage and the Prince Albert pub.

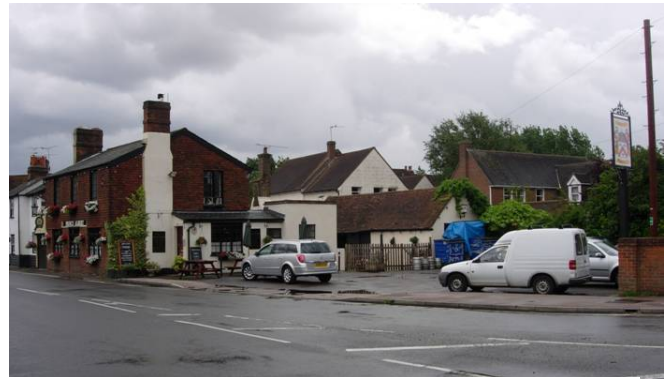
Fig. 21 Open car park for Prince Albert pub.

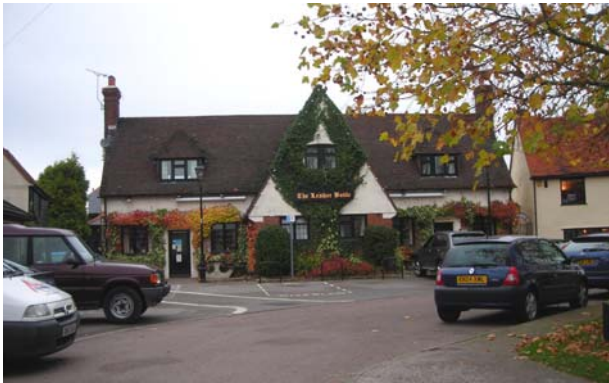
Fig. 24 The Leather Bottle.

The buildings widen out again immediately around Horsefayre Green which has mature trees and an attractive and significant historic group of buildings surrounding it. The posts and chains around the green were erected for Queen Victoria's Diamond Jubilee in 1897 and should be retained (Blackmore Parish Council 2000). This area provides a focus for the village. Commercial premises and community facilities are concentrated here around the green. Prominent historic buildings include the Post Office, Lundishes, The Leather Bottle and Blackmore House as well as the listed telephone box. The nineteenth century shopfront at **The Post Office** is particularly significant as the only easily recognisable historic shopfront (*Fig. 22*). **Lundishes'** early fifteenth century shopfront next door predates this and is very important but not so obvious (*Fig. 23*). **Blackmore House** (previously known as Dadds Village Stores) dates from around 1400, and was probably a high status house originally (*Fig. 25*). The shop front to the right has been sympathetically rebuilt in recent times, and there is a modern rear extension along Fingrith Hall Lane which is reasonably well integrated into the historic setting. **The Leather Bottle** was rebuilt following a fire in 1954, although there had been a pub on the site for generations previously³. It has some unsympathetic modern blinds and a satellite dish on the front elevation (*Fig. 24*).

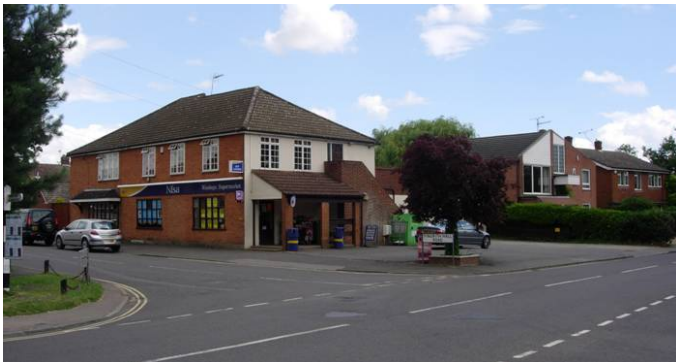
Fig. 26 The shop.

There are numerous signs which detract from the appearance of this area, and these should be rationalised. For example a redundant pole on the green should be removed. The eastern boundary of this part of Horsefayre Green along Fingrith Hall Lane is also less attractive. **The corner shop** is very prominent and basically of good design, but made much less sympathetic by the details of a front lean-to extension, clutter, prominent car parking and the over-use of tarmac. The shop has plastic signage some of which is internally illuminated; this is not appropriate to the sensitive historic setting (*Fig. 26*).

The recommendation is that existing unsatisfactory signage is rationalised, and that in any future development within the Conservation Area, signage should be kept to a minimum to preserve its character. Similarly road markings should be limited to reduce the adverse impact on the appearance of the Conservation Area.

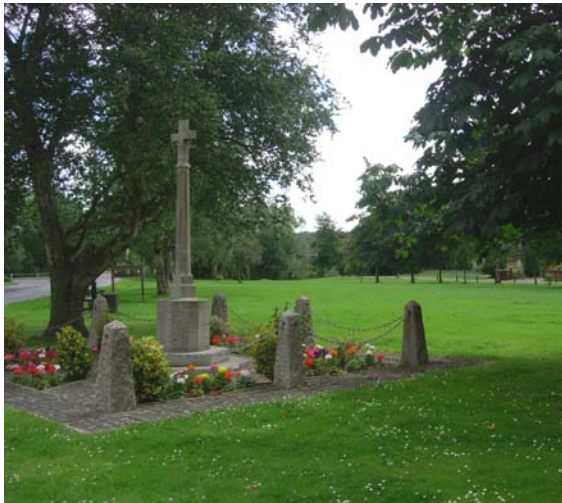
The Green is surrounded and enclosed by houses but is open to Ingatstone Road on the east beyond the ponds. The war memorial, **The Barge** and the ponds are important landmarks within the Green (*Fig. 27*). The mix of historic and modern houses of appropriate

Fig. 27 The war memorial and green.

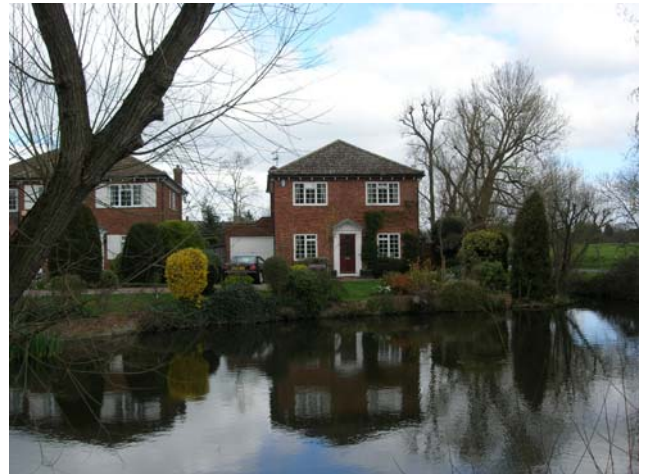
scale forms an important and varied backdrop to The Green. The modern houses on the north-east corner including **Sans Fee** and **Waterfront** are rather cramped and have too-deep plans but do not detract from the attractive views across the pond (Fig. 28). Generally buildings around The Green are comfortably spaced and proportioned. The railings at the eastern end of The Green, which comprise timber and concrete posts with tubular steel rails, are in poor condition, partly due to vandalism, and should be repaired or replaced. The western edge of the Green is less successfully enclosed along the boundary with **The Bull** where clutter is evident and it would benefit from a hedge.

Fig. 28 Waterfront viewed from The Green.

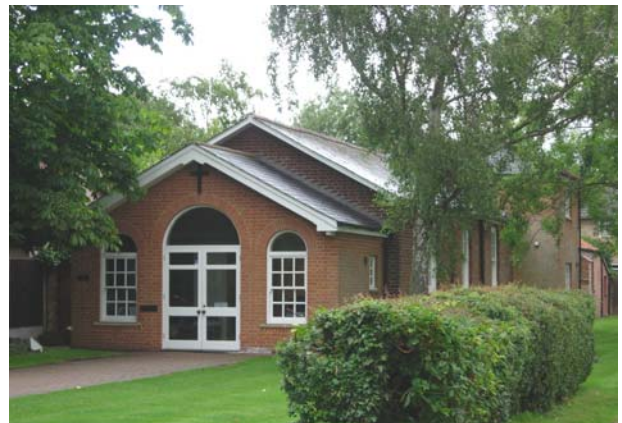
Fig. 29 Baptist Church.

The **Baptist Church** and **Infant School** are landmark buildings halfway along the Green and well set back on the original Green edge (Fig. 29). The original church was built in 1841, by Ashley Barrett (Whites Directory 1848). The Church has been recently extending to the front and although it is a little heavier in character, impressive care has been taken over the materials and details such as Flemish bond brickwork and good sash windows. There is a short length of historic iron railing in front of the Church which is rare in this village and therefore important.

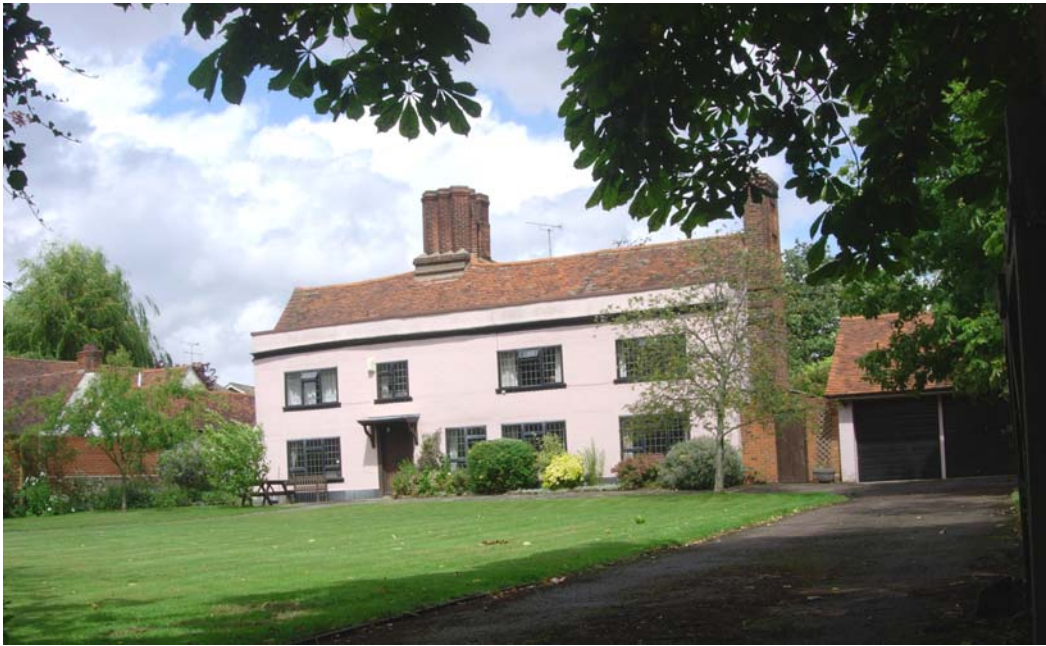
Fig. 30 Laurences.

The red brick wall in front of **Laurences** is significant and allows only limited but attractive views of the building, a substantial early seventeenth century and earlier house with distinctive decorative brick chimneys (Fig. 30).

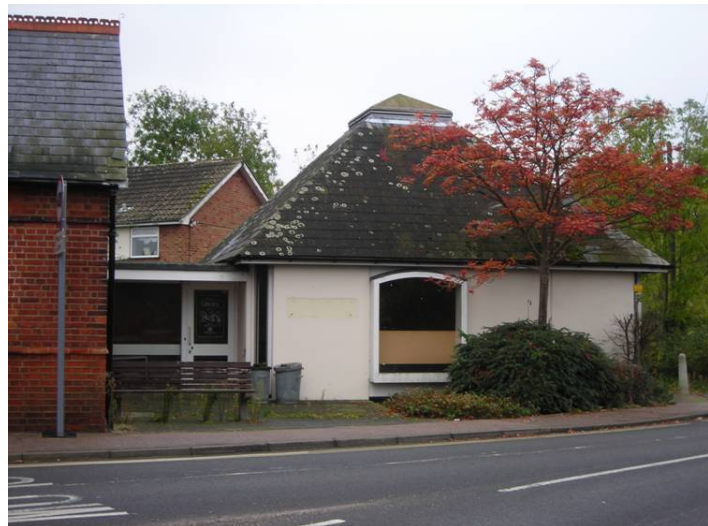
The Green survives on the north-west with mature trees and a rather tatty backdrop of fence panels. The original Green has largely been lost by later development on the east side of the road. Next to the old school is the simple late twentieth century **Library** (Fig. 31). The Library has been closed and the site is being considered for redevelopment. Any new building would need to be subsidiary to the old school but worthy in its own right as a landmark building on this prominent site. The current Library does this well even though it is not derived from the local architecture or materials.

Fig. 31 Redundant library building.

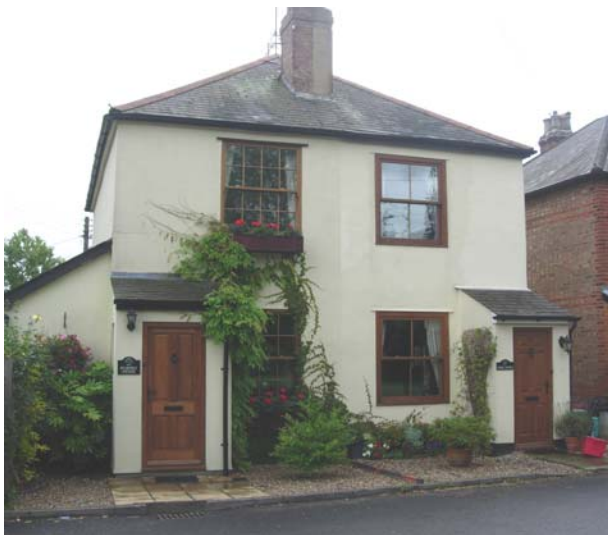
Fig. 32 Nos 1-2 Blackmore Road.

Numbers 1-4 Blackmore Road are significant nineteenth century semi-detached houses (*Fig. 32*). They have all been altered but retain their original welsh slate roofs and brick chimneys. Nos 1-2 have been rendered and nos 1-2 and 3 have had porches added; windows and doors have been changed on all the houses, one with uncharacteristic leaded casements, and only one front garden retains a picket fence or original front boundary. Any further loss of front gardens should be resisted. The replacement windows on the fronts of nos 1 & 2 have been sympathetically done, albeit not matching and not painted as they would originally have been.

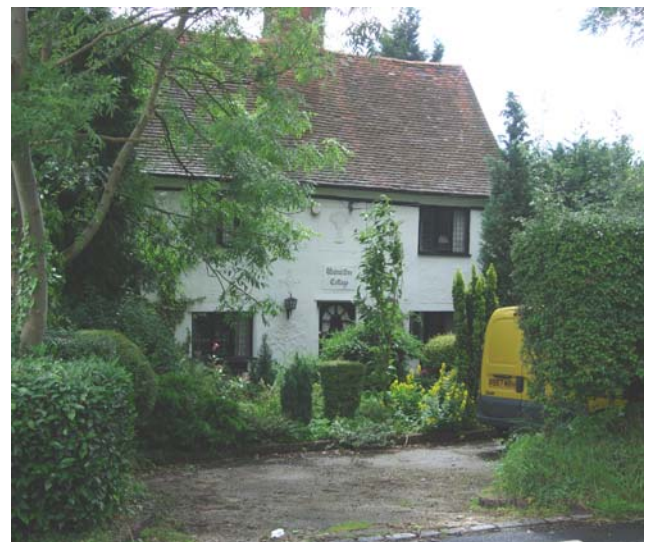
At the entrance to the village along Blackmore Road is a significant group, set back behind hedging, **Walnut Tree Cottage** and **Trees Cottage**, originally a single house from circa 1600 (*Fig. 33*). Trees Cottage has an unattractive front extension, once a shop.

Fig. 33 Walnut Tree Cottage.

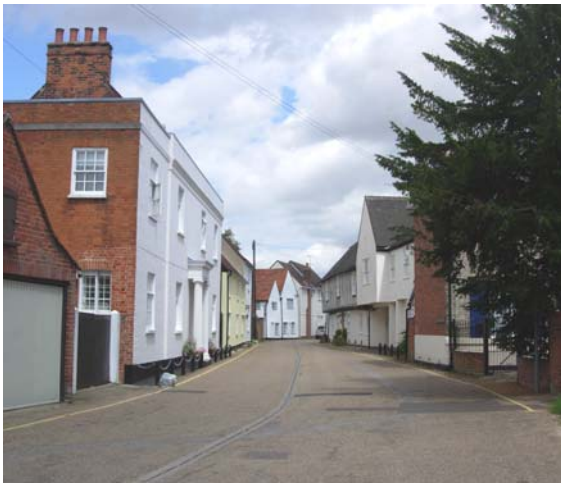
medieval in date (*Fig. 34*). It is closely built up on the northern approach and more rural and tree-lined towards the church on the south. It has strong distinctive red brick walls, softened by trees, which unite the street and provide concentrated views and a strong sense of enclosure. However the tall *Leylandii* conifer trees along the boundary of **Jericho Priory** are overly-dominant in these views having been left to grow unchecked (*Fig. 35*) The church and lychgate provide significant focus on the southern end and jettied and varied houses along the road edge provide visual interest. There is a slight change of direction along the road with distinctive landmarks at this point giving variety to the views. There are no pavements and the simple relatively undisturbed road scene enhances the historic and rural nature of the street.

Fig. 34 Church Street, looking north.

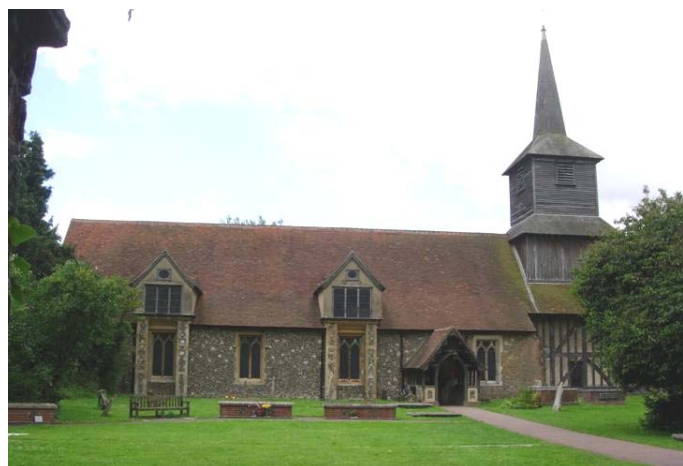
Fig. 36 Church of St Laurence.

The **Church of St Laurence** is Norman, and was originally erected as the church of the Augustinian Priory (*Fig. 36*). The flint rubble west wall of the Norman church still survives. The remarkable timber bell tower has been tree-ring dated to c.1400 (Bridge 2004). Pevsner described the tower as one of the most impressive, if not the most impressive, of all English timber towers (Bettley and Pevsner 2007). The church was restored by Frederick Chancellor 1896-1902. St Laurence is of exceptional importance, and visually picturesque. The attractive

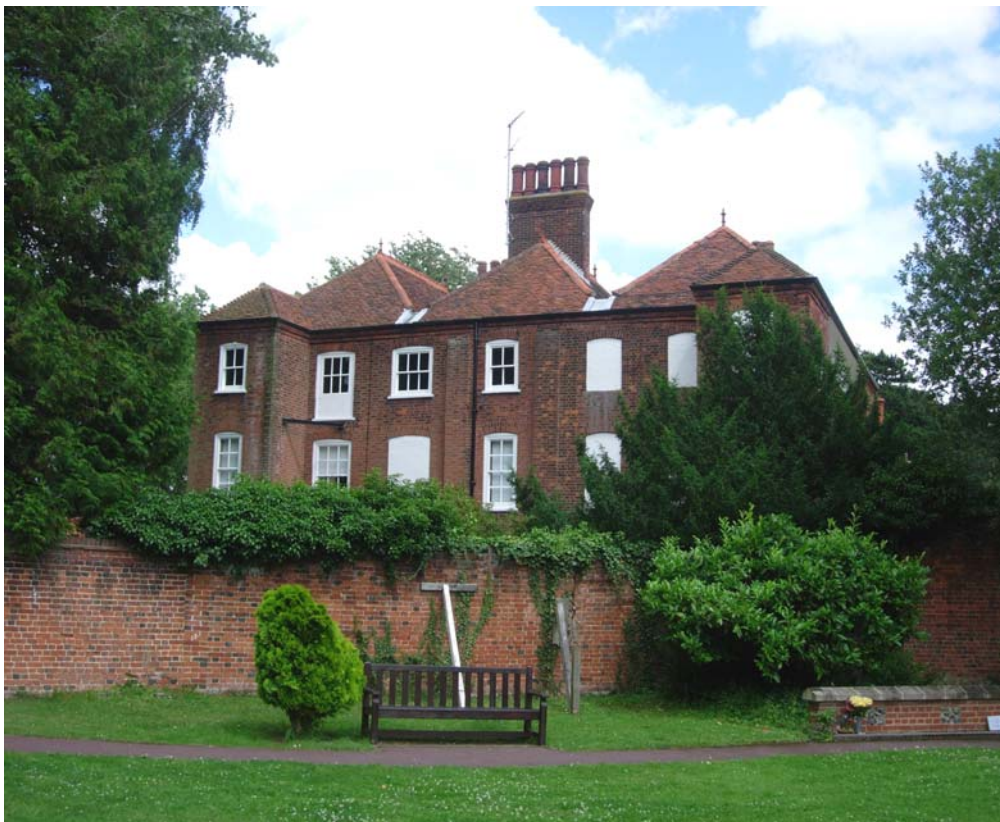
Although the church is only visible close-to, the lychgate provides a landmark visible along most of the street. The walls to the churchyard continue along the street, hiding the modern houses behind and contributing to the street scene. **Jericho Priory** is arguably the most interesting and important building in the Conservation Area, very hidden behind the conifer trees as well as the wall, but prominent in views from the churchyard (*Fig. 37*). The brick boundary walls of the Priory around the churchyard and along Church Street are visually and historically important, but the condition is poor in places with encroaching vegetation and cracks.

Fig. 37 Jericho Priory viewed from the churchyard.

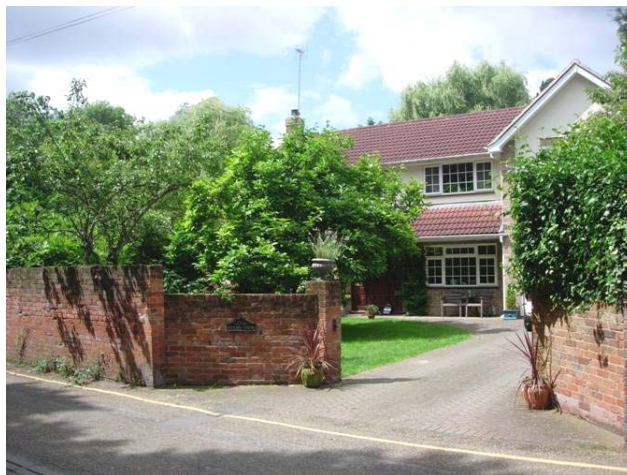
Next to the church on the western side of the road are modern houses on infill sites. They do not continue the local characteristic architectural styles or materials, but are much hidden by the red brick wall (Fig. 38). Beyond them is **Hareton House**, purchased as a Vicarage in 1891⁴, a substantial and significant Georgian house well set forward on a prominent site at a slight change of road direction (Fig. 39). Continuing northwards from Hareton House the buildings are more urban and closely set. They are a mix of modern and historic of a similar scale, and include the Grade II listed **Shaw House** and **Shaw Cottage**. **Shaw House** is substantially 18th century in date but incorporating late medieval timbers probably re-used from the building known as the Blue Boar that previously stood on the site⁵. **Shaw Cottage** is an early 19th century timber-framed and rendered vernacular cottage. **Church Street Cottage**, with two gables ends to the street and tall 18th century external brick chimney stacks on the side return, is one of the best of the historic buildings on the street (Fig. 40). It occupies a prominent corner site at the junction with Blacksmiths Alley.

Fig.38 Priory View, one of the modern houses behind traditional brick walling, Church Street.

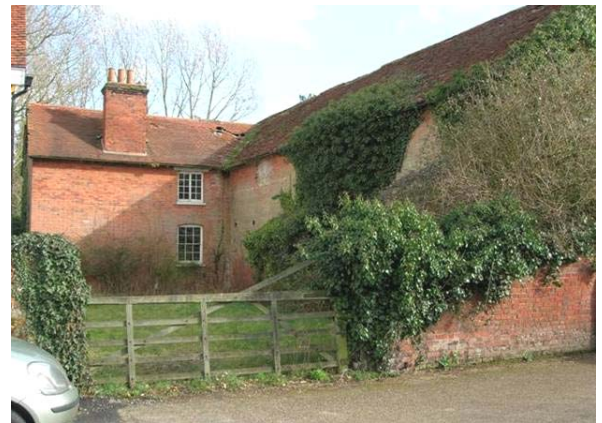
Fig. 41 Coachmans Cottage and stables.

There are fewer modern buildings along the eastern side of the road and greater spacing between buildings, giving longer prominence to the boundary walls. **Coachmans Cottage, Little Jericho** and **The Old Manor House** are distinctive and significant buildings in this part of the street. The Grade II listed **Coachmans Cottage** and associated 18th century stable range are in a sorry state, and are included on the Essex County Council Buildings at Risk Register (2007) (*Fig. 41*). **Little Jericho** is a house of c.1600, timber-framed and rendered, with a 17th century two-storey central porch. **The Old Manor House** is positioned at right angles to the street, and is an early 19th century house with a façade of white gault brick, which is unusual within the conservation area (*Fig. 42*). **The New House** occupying a previously vacant plot between Little Jericho and The Old Manor uses some good materials but is bulky and a little too cramped and has less satisfactory details such as bland stretcher bond to the brickwork (*Fig. 43*).

The recommendation is to implement a maintenance programme within the Coachmans Cottage and Coach house site to prevent further deterioration to the buildings and to consider repairs notices as necessary to halt further decline of these vulnerable buildings.

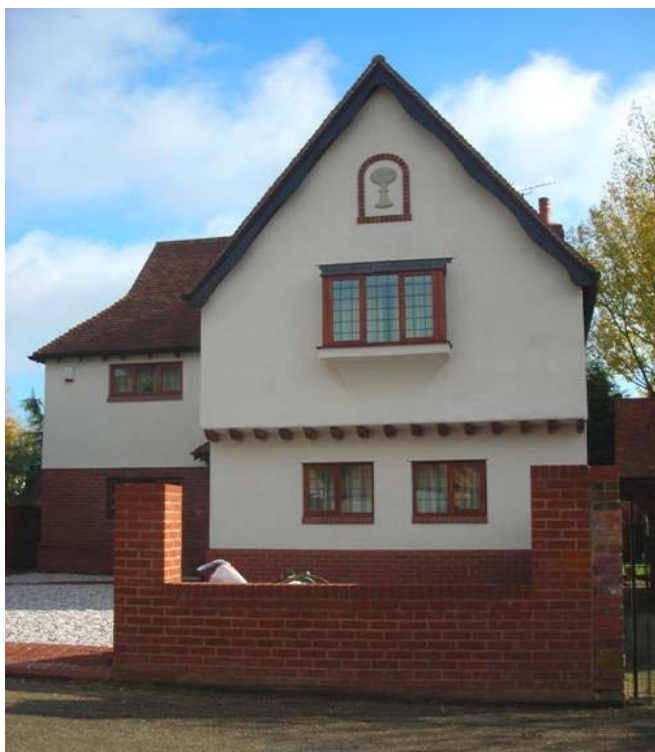
Fig. 43 The New House, Church Street, built 2005.

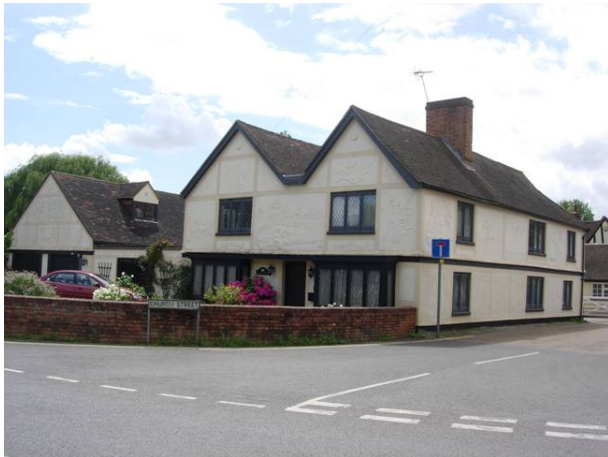
At the junction of Church Street and The Green are **Crosse House** and **Swan House**, both on prominent sites. **Crosse House** is an attractive house dating from 1634 that served as a shop until recently, but it has an unsympathetic UPVC window facing Church Street. Swan House is a 14th century timber frame house now with a rendered brick façade. It was previously an inn and later a shop, before becoming a private residence (*Fig. 46*). The render has modern pargetting.

Fig. 46 Swan House.

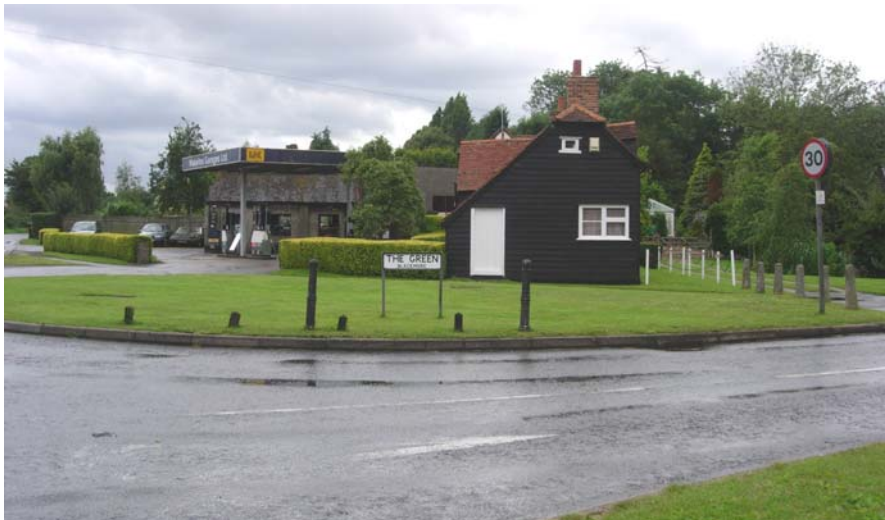
With the exception of the modern **garage** and the rather more attractive **Barge** which are on exposed sites, this part of the Conservation Area is characterised by trees and hedging (*Fig. 47*). The **garage** is a utilitarian building, but nonetheless a rare survival of its kind in a rural location. **The Barge** is a prominent building at the east end of The Green and a former ale house and shop; it has a delightful rural vernacular character with weatherboard and handmade clay tiles, and is believed to date from 1584 (Blackmore Parish Council 2000). It is Grade II listed. Where other buildings are visible at this point they are in limited views behind the greenery. To the south of the Conservation Area, tall hedging and trees (primarily oaks) form the boundary to a field and a small oak woodland along the road.

Fig. 47 View towards Ingatestone Road from The Green, with The Barge and the garage.

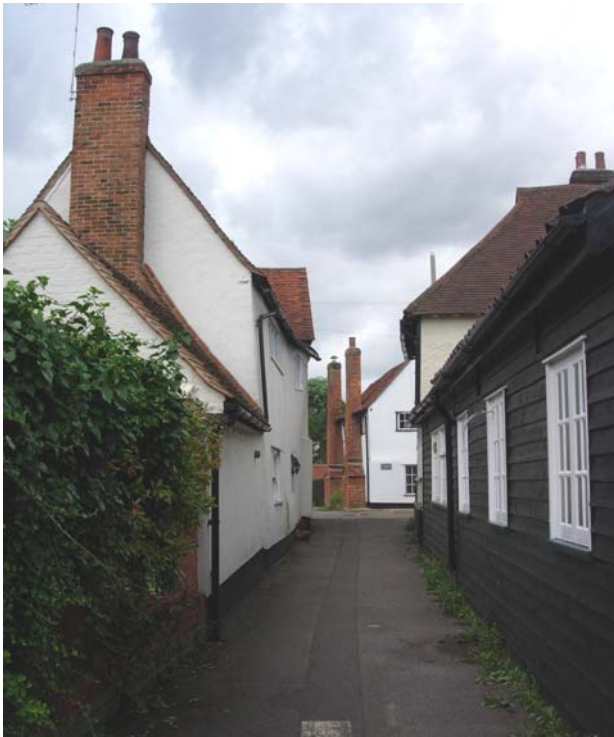
Bull Alley is the historic alley leading from Church Street to The Green and is of great visual significance (Figs 48 and 49). It is closely defined by historic buildings at its western entrance at Church Street and opens up to the east, giving good views in both directions. On both sides are significant buildings including the weatherboarded service buildings to **The Bull** and **Little Jordan**, **Rowfreys** and **Jericho Cottage**. **Rowfreys**, formerly known as Rare Tree Cottage, is set back behind a good brick wall. It is an early 17th century timber-frame and rendered cottage (Fig. 50). **Jericho Cottage** is also 17th century in origin and timber-framed and rendered. It now serves as an tea shop/antiques shop (Fig. 51). The modern infill building (**Tubbs**), between Jericho Cottage and Rowfreys, is appropriate to the scale of the adjacent buildings and generally well detailed (Fig. 49). The rather tatty fence panels at the rear of **The Bull** detract from an otherwise charming route. Along the southern edge of The Green, **Hope Cottage** is a diminutive Grade II listed vernacular building, 18th century or earlier. Around it are largely modern properties of varying quality. At the south-east end Kelby is an empty property that appears neglected and is falling into disrepair.

Fig. 48 Bull Alley looking towards Church Street, with Little Jordan (left) and outbuilding of The Bull (right).

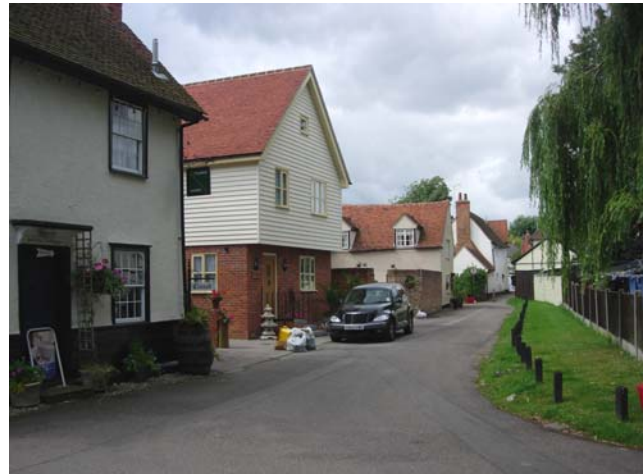
Fig. 49 Bull Alley looking west. Tubbs is the new house on the left. The boundary treatment of the rear plot of The Bull on the right is poor.

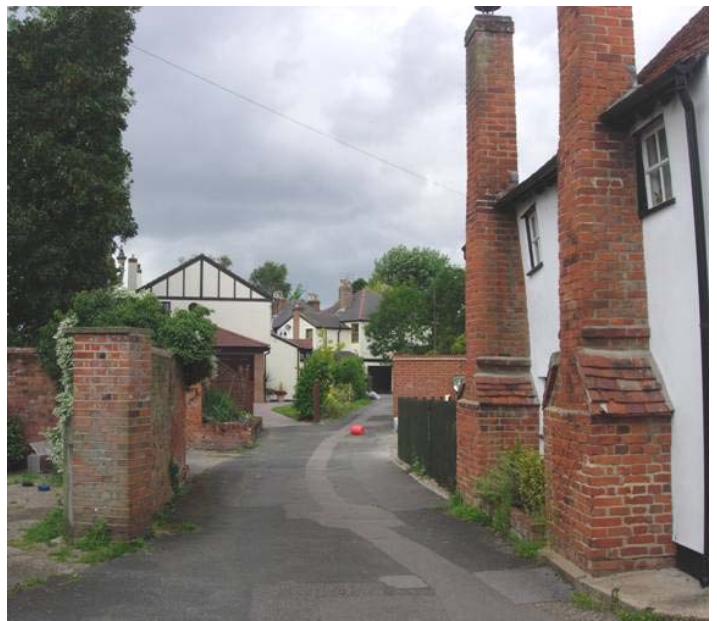
This alley follows the edge of the original Green commencing behind Church Street Cottages (*Fig. 52*). It has fewer early period historic buildings and comprises predominantly nineteenth and twentieth century houses. **Steeple View** and **Burma Bungalow** are located on the site of the first parish poor-house, Claydons, the rental of which was granted to the poor in 1580 (Medlycott 2002). Claydons was still extant at the time of the second edition OS map of 1896. The most significant buildings are **Redbrick Cottages**, the garage to 1 Redbrick Cottage and the traditional group of buildings at **Church Street Cottages** (*Fig. 53*). Views along the alley are of interest due mainly to a mix of hedging and brick walls giving good framing and visual surprise as you walk the route. The alley also gives interest by a change of direction, and the original nineteenth century brick wall at the rear of the Library is significant at this point.

Fig. 52 Blacksmiths Alley viewed from Church Street.

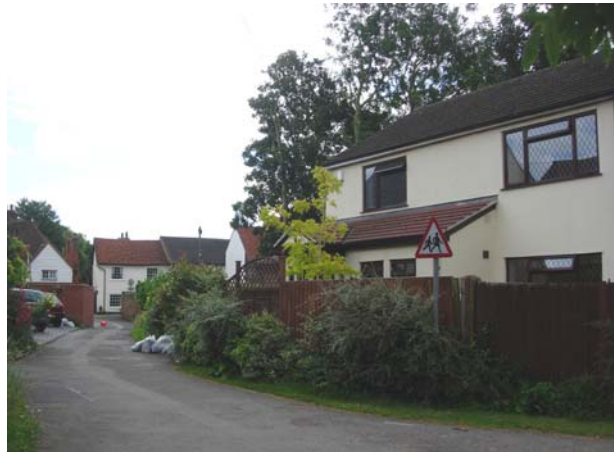
Fig. 54 Blacksmiths Alley, Farriers on the right.

Farriers is in a very prominent position at the change of direction (*Fig. 54*). Although it has some hedging (laurel, not traditional) most of its boundary is unfortunately dark stained vertical boarding. There is a muddle of timber fencing and panels along the rear of the cottages in Blackmore Road, becoming tattier towards Holly House.
