BRENTWOOD

Conservation Area Appraisal and Management Plan

This document was produced by Essex County Council for Brentwood Borough Council.

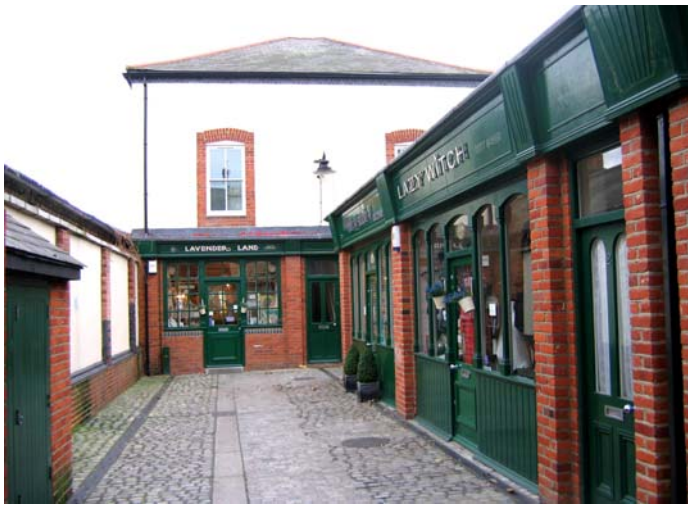
Fig. 5 The development behind the Old Fire Station in Hart Street.

A few attractive and interesting spaces do survive, such as South Street and the terrace behind Crown Street. The mews-type redevelopment behind the Old Fire Station in Hart Street shows what potential backland spaces have if carefully treated (*Fig. 5*).

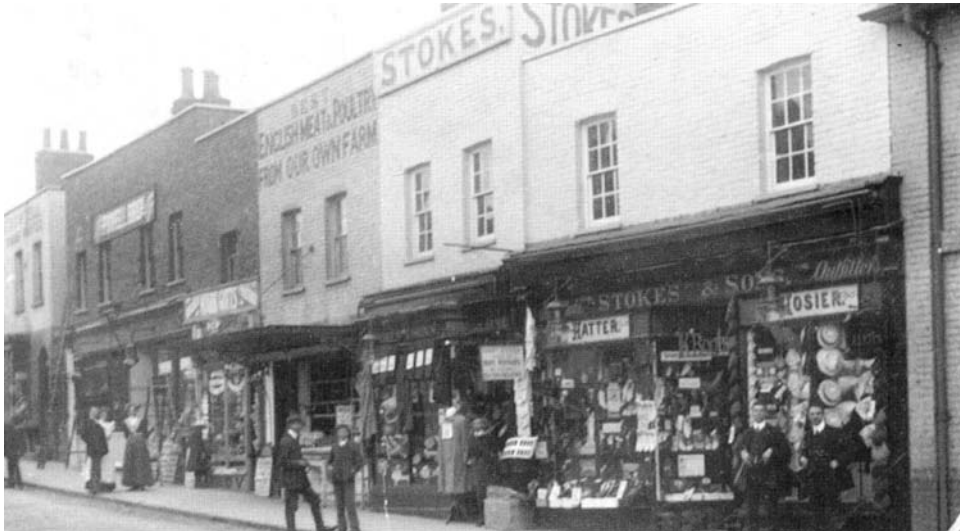
Fig. 7 Old photograph of the High Street showing buildings with brick facades encasing timber frames.

There is no unifying architectural style in the High Street. In the 19th century, it mainly comprised rendered timber-framed buildings, or brick fronted buildings, of two storeys, with sash windows and traditional shop fronts (cf. *Fig. 7*). The 20th century has done violence to that simple repertoire of architectural styles, many of the smaller and more modest old buildings being demolished. The inter-War years have contributed shopping parade type developments with formal elevations, parapets with low-pitched roofs, and metal windows, whilst the period since the 2nd World War has seen large, often three-storey, developments built of modern materials quite alien to the pre-existing character of the High Street. In the central part of the High Street, modern rebuilding has brought a degree of unity, though little of architectural merit. On the north side, from nos 39-41 (Monsoon) to Boots, the buildings are all three storey with flat facades. Similarly, on the south side from the post office to the former Burtons, the buildings are all modern though mostly two storey. Further west, the High Street is much more architecturally varied.

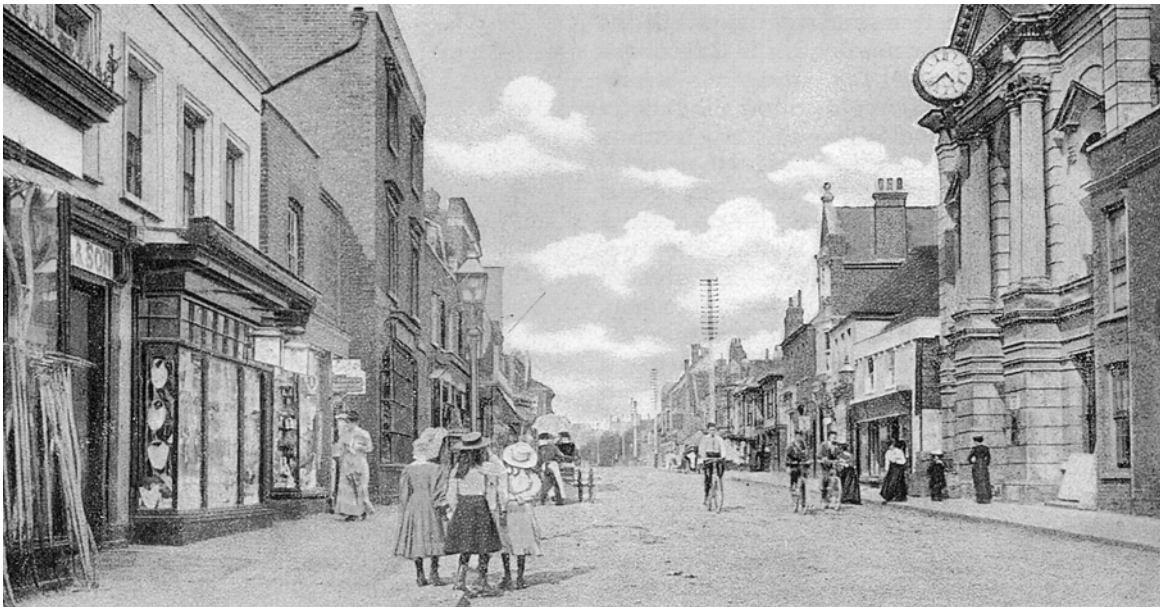
Fig. 12 The High Street in the late 19th century, with the old Town Hall on the right.

Many of the 19th-century brick fronts on older buildings have been swept away, such that now relatively few modest 19th-century buildings survive in the High Street. The imposing neo-classical Town Hall (*Fig. 12*) was demolished in 1963. The most prominent survival of the 19th century is the row of three storey buildings at the junction with Ongar Road. In Shenfield Road, there are some good but ill-treated terraces of Victorian villas.

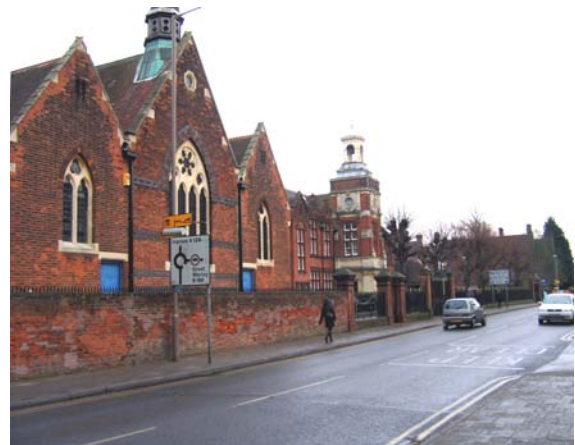
Fig. 13 Red brick buildings and boundary walls with railings at Brentwood School in Ingrave Road.

In Shenfield and Ingrave Roads, there is much red brick (*Fig. 13*), the Georgian very handsome and usually characterised by flared headers (*Fig. 14*). The Georgian brickwork was often tuck-pointed, a technique in which the joints are highlighted with fillet of white lime mortar. Little of this survives, though patches of it can be seen to good effect on Pepperell House by the ruined chapel. Red brick, whether 18th- or 20th-century, is the predominant building material in the conservation area.

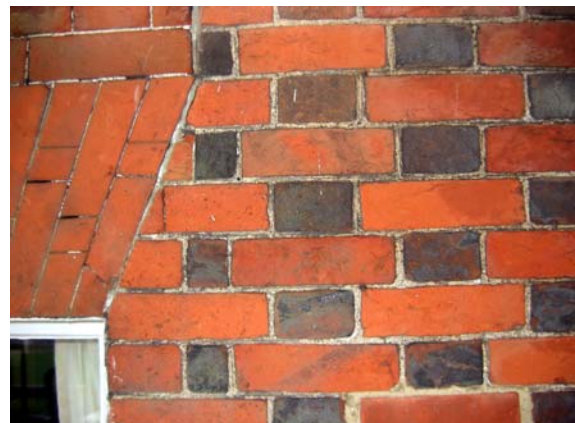
Fig. 14 Georgian brickwork with flared headers and penny-struck pointing (Roden House, Shenfield Road).

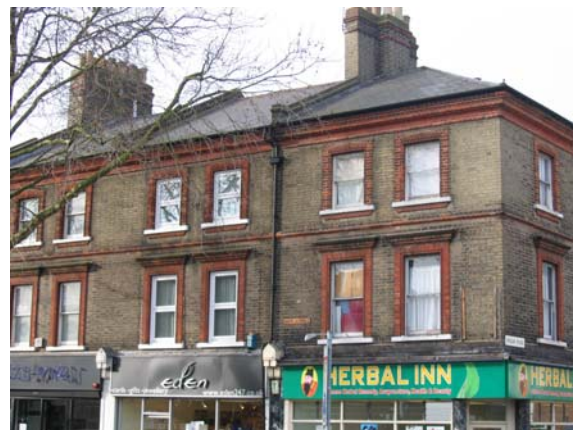
Fig. 15 Yellow stock brickwork with red brick detailing at nos 1-23 High Street.

Yellow stock brick, the principal building material in south Essex in the later 19th and early 20th centuries, is to be found mainly in the High Street, but it has often been painted or rendered. It can be seen to good effect in the row of three storey shops at the east end of the High Street (*Fig. 15*) where it is combined with red brick detailing. Stocks were an economic alternative to red bricks, which were preferred for more important buildings such as Brentwood School. Bricks, possibly both reds and stocks, were made locally to the south of the town in the area round the station. More prestigious than red brick or stocks was white brick, but this is almost unknown in the conservation area, except for the former Catholic church now used as a pre-school nursery (*Fig. 29*) and a house to the west of it. Old brickwork has often been painted or rendered, which always has an adverse effect on its character, and creates a maintenance problem. It has usually been repointed in cement, often unnecessarily, something which is potentially damaging and usually visually unsatisfactory.

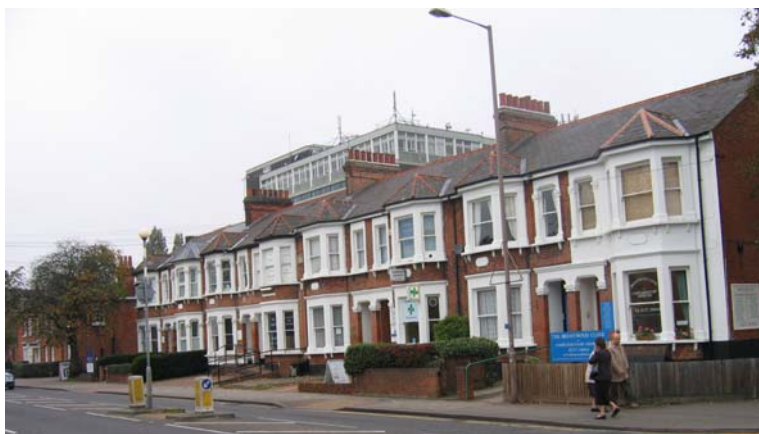
Although they still have slate roofs, and most of the windows have survived (only two have replacement ones), proliferation of signage and loss of front gardens to parking have had an adverse effect on their character. Car parking encroaches on the pavements and is a hazard to pedestrians.

Fig. 17 Nos 17-31 Shenfield Road.

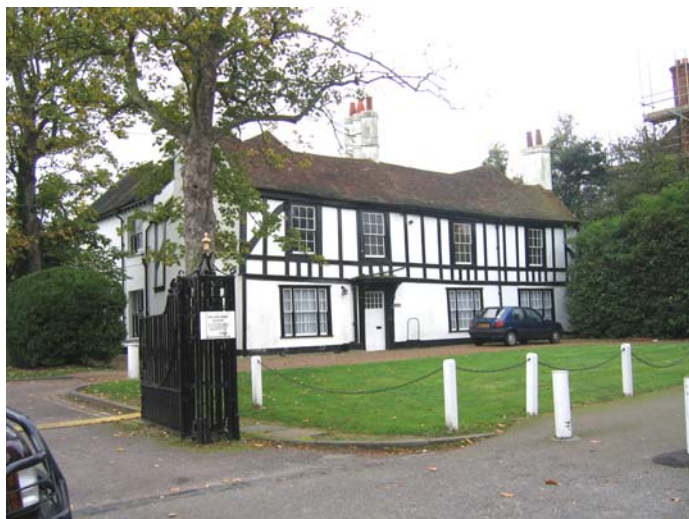
Fig. 18 Mitre House.

15th-century in origin, but remodelled and rendered with false timber framing (*Fig. 18*). Because of the rarity of buildings of this appearance, it is a particularly distinctive feature of the approach to the town. To the left is a driveway through handsome early 19th-century grade II listed wrought iron gates to modern flat-roofed single storey outbuildings belonging to the School. The gates would benefit from conservation.

One of the better preserved timber-framed houses in the conservation area is Mitre House in Shenfield Road (*Fig. 18*). It dates from the 15th century and is H-plan with a hall between two cross-wings, though a remodelling with false framing disguises its actual age. In the High Street today, only three buildings are just about recognisable as of late medieval origin, identifiable because of their relatively low height and because they present gables to the frontage. They are nos. 63-65 (*Fig. 8*) on the north side, heavily restored in 1975, and nos. 60-64 and 112-114 on the south side.

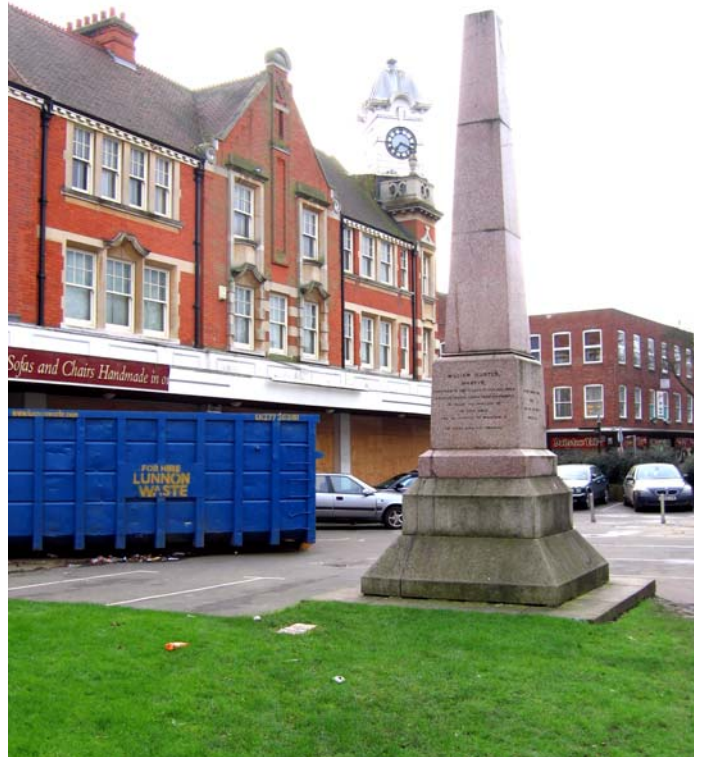
At the junction with Ingrave Road is **Wilsons Corner**, a former department store rebuilt after a fire in 1909, three storeys high, brick with stone dressings, feature gables and a clock tower which makes it a landmark in long views from east and west. A furniture store since 1978, the building has been empty since 2003. The shop fronts have been modernised, and also not improved by the construction of a flat canopy of considerable projection. In front of the building is an asphalt car park with steel and white painted concrete bollards, enclosed by low walls with shrub planting. This area needs landscaping, and the skips and litter removed. It certainly does not provide a suitable setting for the polished granite obelisk which is the memorial (1861) to the Protestant martyr William Hunter, and which is located at the junction of the asphalt and greensward (*Fig. 19*).

Fig. 19 Wilsons Corner and the William Hunter monument.

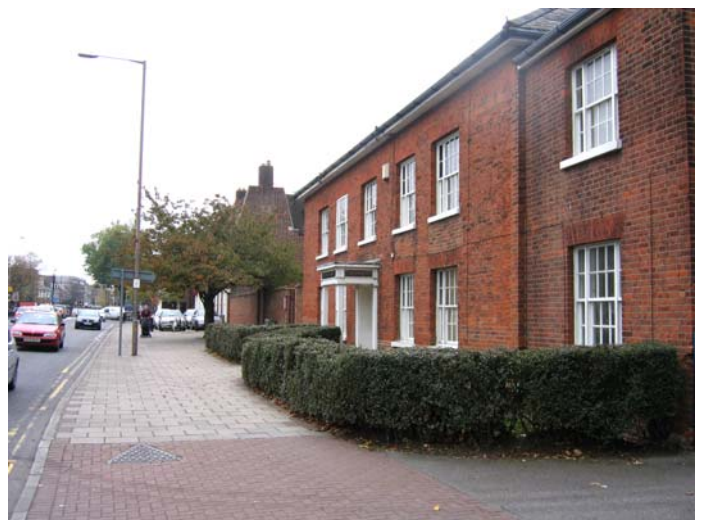
Fig. 20 The Hermitage.

On the north side, the **Hermitage** is a grade II listed brick early 18th-century house of five window bays, extended on the right hand side. The pointing was originally penny struck. The windows are tripartite sashes, all modern replacements. The porch looks rebuilt (*Fig. 20*). The evergreen hedge round the front of the building contrasts well with the red brick and creates a setting for it. The house was formerly part of Brentwood School and is now an Essex County Council community centre. It has modern additions to the rear, where there is extensive asphalt and block paving, parked cars, bins, bollards, and only a little planting. This does nothing for the setting of the listed building, and cannot constitute an attractive space for those who use it.

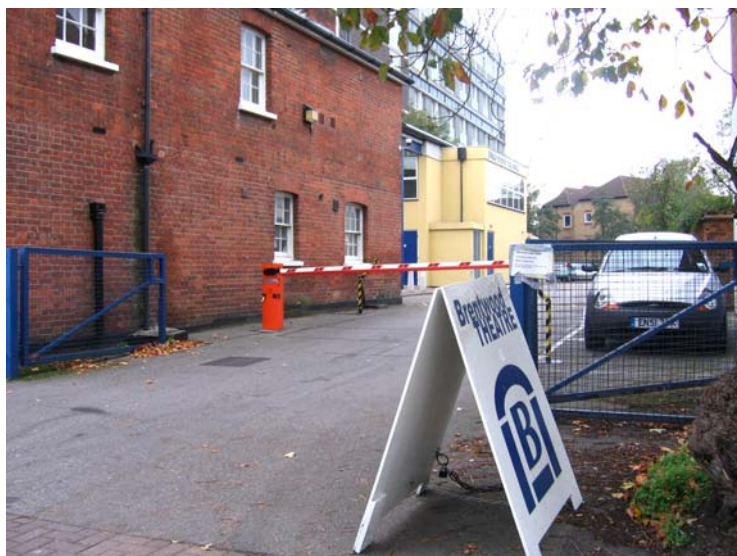
Behind the Hermitage, and barely glimpsed from Shenfield Road, is **Brentwood Theatre**, a yellow industrial style building completed in 1993. Access to the backland space on the east side of the Hermitage is barred by blue metal fencing and a red and white lifting barrier, with views beyond of tarmac and parked cars (*Fig. 21*). All this area needs rethinking and landscaping with a careful attention to detail. More conspicuous than the theatre is the tall BT building, an ugly block which looms over this part of the conservation area, though itself outside the conservation area boundary. It is ubiquitous in views in this part of the town, a malign presence which does not encourage good design or landscaping.

Fig. 21 Unsatisfactory approach to Brentwood Theatre down the side of the Hermitage.

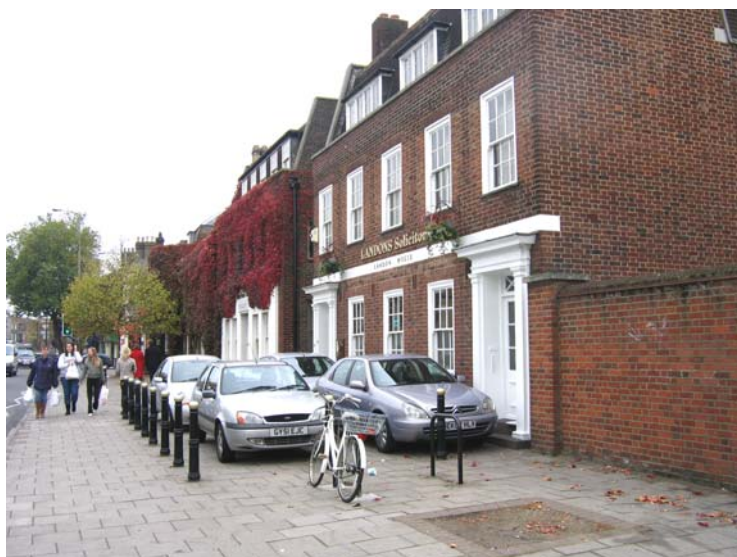
Landon House and Burntwood House (*Fig. 22*) are neo-Georgian style 'houses' built for use as offices, and replacing older buildings on the site. They were clearly designed to complement the older buildings in Shenfield Road, which they do quite successfully, even though Burntwood House has been remodelled with a full three storey rear extension terminating in a large garage. Landon House has an attractive old garage behind it, evocative of a lost age of motoring. The pavement in front of these buildings is wide, and as elsewhere in Shenfield Road, made of small square concrete slabs. The cast iron bollards in the pavement presumably mark the property boundaries, but serve to delimit an area of parking which is visually obtrusive and potentially obstructive to pedestrians.

Fig. 22 Burntwood House and the creeper enveloped Old House beyond. Parked cars do not enhance the street scene.

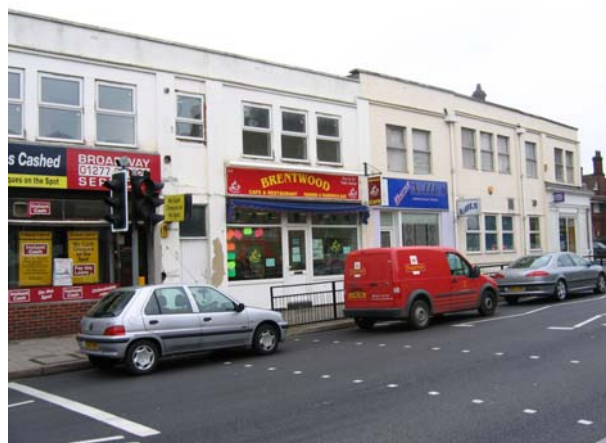
The corner of Shenfield Road and Ongar Road is occupied by a 19th-century building with shops at the ground floor and a white-painted stuccoed first floor. On Shenfield Road it presents a neat well maintained appearance, with a good wooden shop front, but it deteriorates dramatically down Ongar Road where the shops have unsympathetic signage, maintenance is poor and there are UPVC windows at the first floor (Fig. 23).

Fig. 23 Bad shop fronts in Ongar Road at the junction with Shenfield Road.

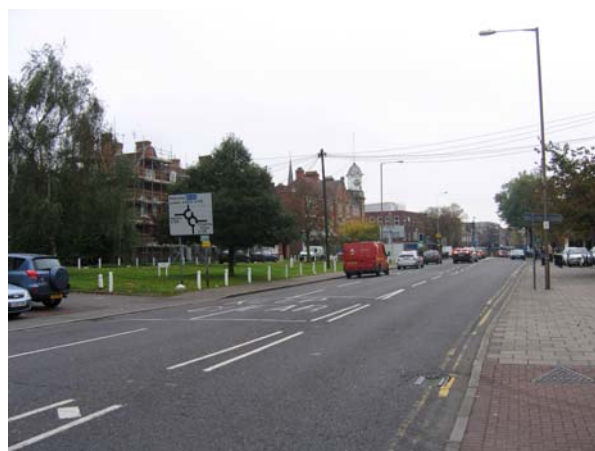
Fig. 24 Excessive road signs and overhead wire at the approach to the Wilsons Corner junction.

Rationalisation and improvement of these features would enhance the appearance of this busy junction which is the dominant feature of the western approach to the High Street.

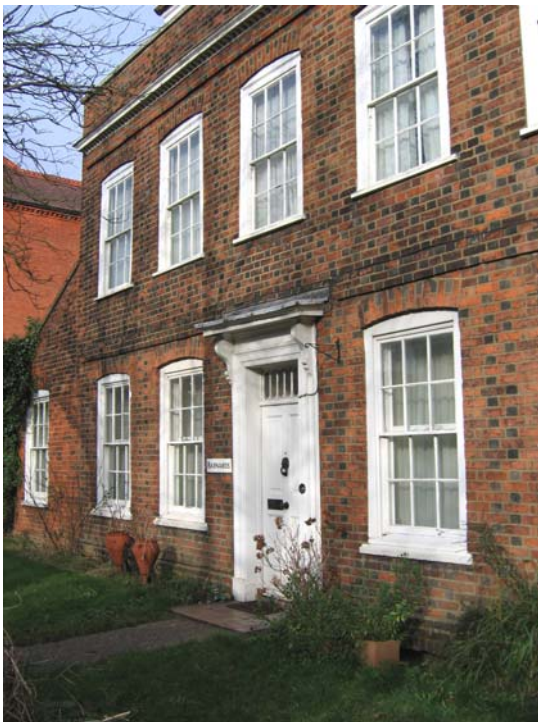
Barnards is a compact handsome five window bay Georgian house with an area in front of it for cellars (*Fig. 25*). It has been part of the School since the early 20th century. Next to it is **Old School House**, a similar Georgian building dated 1773, with a projecting bay added 1864. Both have modillion cornices below parapets, and tiled roofs. This is linked by a gabled block of 1926 to the **Big Old School**, of 16th-century Tudor brick at the ground floor with an upper floor dormitory added 1855, plain with Tudor style windows in stone surrounds. This forms a long range parallel to the road and terminated by the **school chapel** (1868) at right angles to it which projects right out to the boundary with the pavement. It is in a rather severe Early English style with lancet windows with Bath stone surrounds, the brickwork only marginally relieved by bands of black engineering brick.

Fig. 25 Barnards, a Georgian house used by Brentwood School.

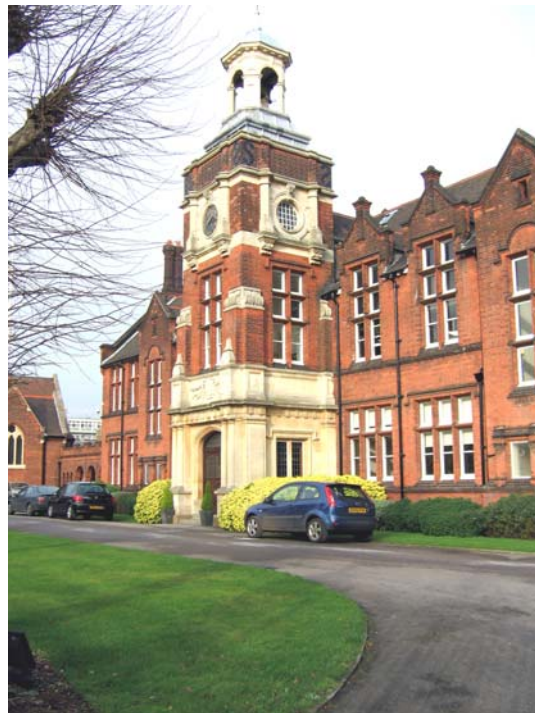
Fig. 26 Main school building, Brentwood School, by Frederic Chancellor.

The **main school building** (1910) by the eminent Essex architect Frederic Chancellor follows, a long tall block in a Tudor style with rows of gables, and a central gatehouse tower, its most conspicuous feature, with Renaissance detailed stonework at the ground floor and somewhat cumbersome above, where it terminates with a clock and a cupola (*Fig. 26*). A pretty covered arched passage on its left hand side links it to the older buildings. It is a shame that it is surrounded today by car parking, which is particularly intrusive on the north side by the chapel.

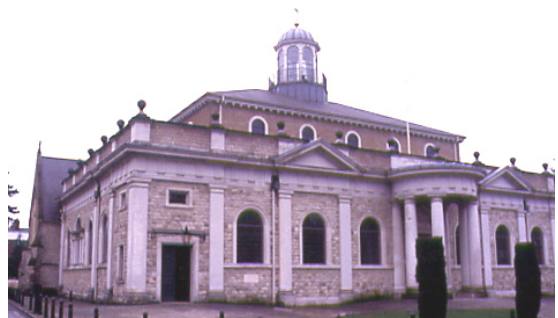
The **cathedral** is the dominant feature and a major landmark. It is a collision between Quinlan Terry's neo-classical building of 1990 (*Fig. 27*) and the earlier gothic church of 1861. Somehow, and perhaps fortunately, the earlier church has been so dwarfed by the new building that it has become inconspicuous, with the exception of its spire. The new building acknowledges the old in being built of rough-faced Kentish Ragstone, a rather curious choice for a classical building, though the clearstorey is of stock brick.

Fig. 27 Brentwood cathedral by Quinlan Terry.

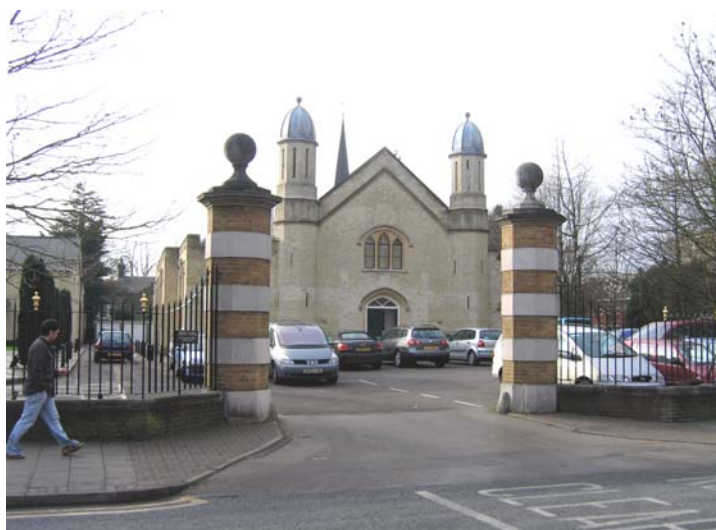
However, the surrounding buildings are all notable. The **original Catholic church** (1837), a Tudor gothic building in white brick with polygonal corner turrets,

now used as a pre-school, presents its gable end to the Ingrave Road (*Fig. 28*). It is grade II, a 1999 addition to the Brentwood list. Set further back into the site is **Clergy House**, in the same architectural style and also in white brick, with a picturesque eaves fascia and bargeboards. West of the cathedral, there is a north-south row of buildings, comprising offices (1982) designed by Lawrence King to harmonise with the gothic style of a former convent built in 1873 of Kentish Ragstone, the two being linked by a very nicely detailed neo-classical block. To the south, its lancet windows forming a very good elevation on Queens Road, is the **Song School**, a Victorian stock brick building originally a chapel, with a recent extension faithfully in the same style.

Fig. 28 The original Catholic church of 1837 built of white brick.

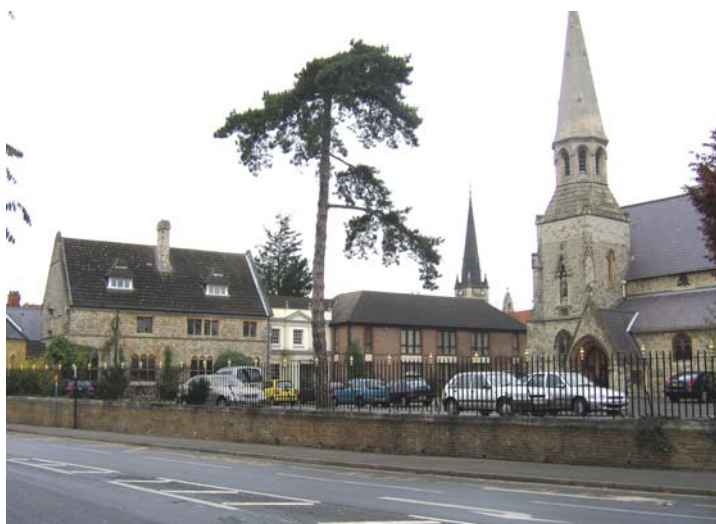
The spaces round the buildings are very important in contributing to their setting. The area adjacent to the cathedral has high quality York stone paving and granite sets. South of it, however, there is a large area of asphalt used as a car park with a dying conifer and, marooned in the middle of it, a depressed-looking Scots Pine (*Fig. 29*). Hedging should be planted behind the railings to improve the view from the road, and a setting should be provided for the tree. The tree preservation order map suggests that trees have been lost here; they should be replaced. The **graveyard** north of the cathedral on Cathedral Place is one of the few green spaces in the conservation area. It is too small a space to accommodate the large number of young trees growing there, and would benefit from active landscape management.

Fig. 29 The southern part of the cathedral precinct needs improving by better hard and soft landscaping.

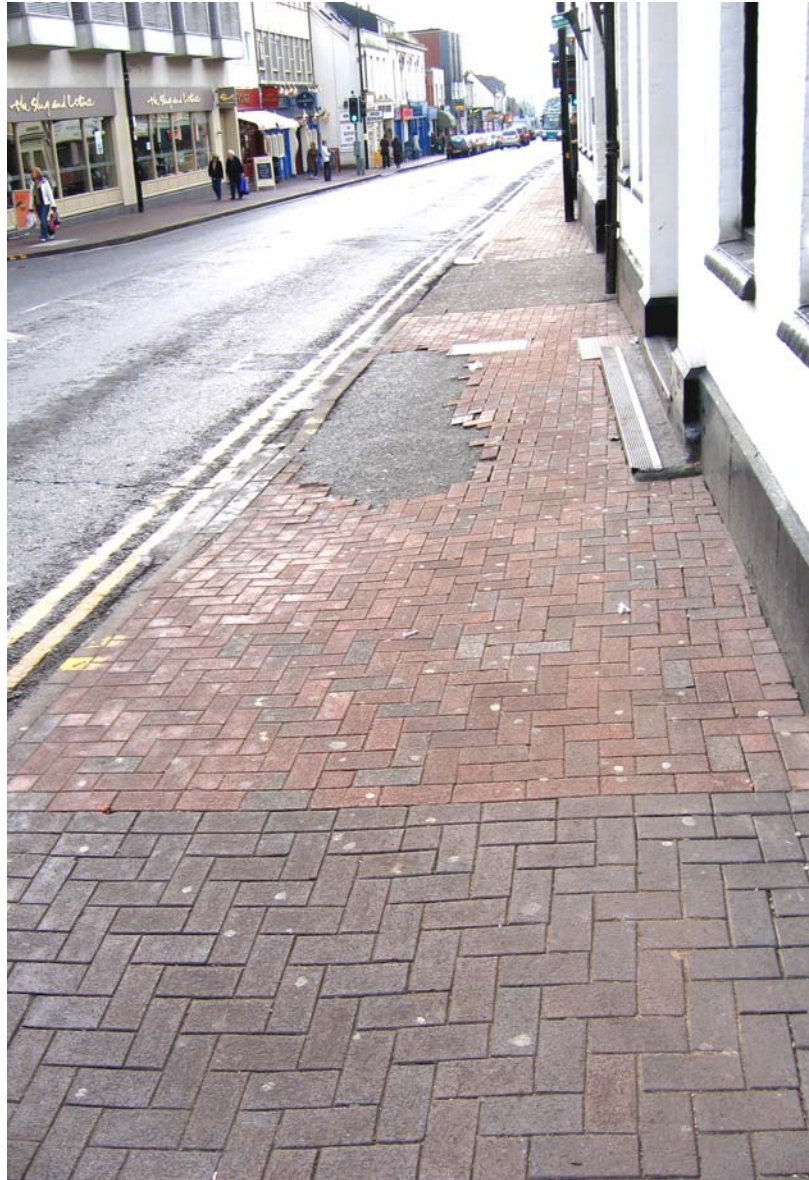
In the mid 1990s, a street enhancement scheme was carried out. The pavements were repaved with dark red concrete pavers. In the wide eastern end of the street, the road edge undulates to accommodate parking bays for bus stops and taxis, and there are irregular shaped brick planters and seats. This wider end of the street also benefits from the presence of several trees, notably planes, which make a huge contribution to creating pleasant spaces, one which will increase as they get older and bigger. Compared with enhancement schemes elsewhere, this was a simple one, in many ways a virtue as over-elaborately designed ones can easily look busy and fussy. However, the paving is now looking tired and in need of attention (*Fig. 30*). The lamp standards are of a basic utilitarian design (though more attractive ones better suited to the conservation area have been used in some side streets) as are protective railings at pavement edges.

Fig. 30 The block paving in the High Street needs refreshing.

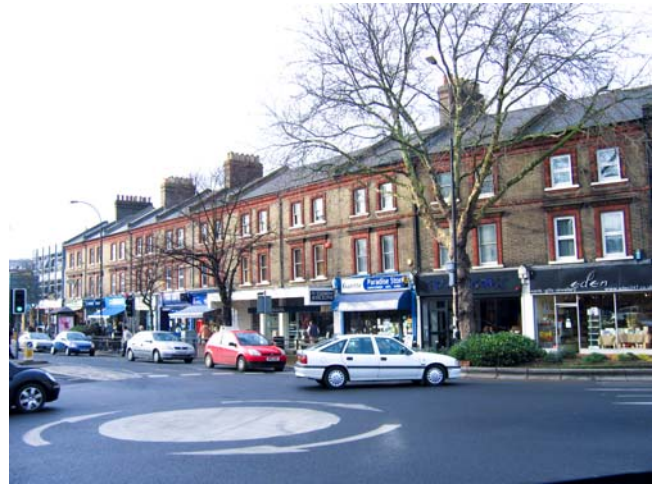
A three-storey terrace (**nos 1-23**) today containing eight shops on the corner with Ongar Road dating from 1883 forms one of the more imposing features of the High Street (*Fig. 31*). It is built of stock brick with moulded red bricks used for window dressings and other details. The shop fronts are mostly unsympathetic to the character of the building and present a contrast with its upper storeys, where four of them have replacement windows and the others need redecoration. In this context, Joscelynes, with its individually designed shop front and projecting canopy, looks alien rather than stylish. The best shop front is Caffé Uno which is traditional in style, though the colour of the lime green fascia is unfortunate.

Fig. 31 Nos 1-23 High Street, dating from 1883. The plane tree makes a major contribution to the street scene, even in winter.

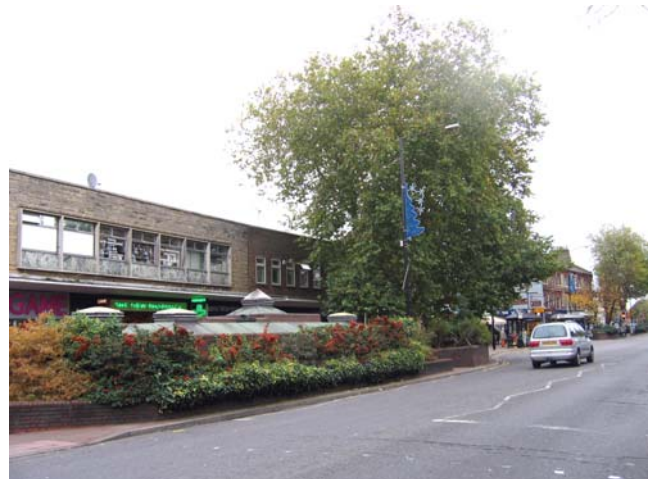
Halfords (**no. 25**) is an ugly late 20th-century remodelling of a three-storey stock brick building which has been clad in lead. Next occupies three shops, first an old building refronted in yellow brick and then a pair dating from the 1950s or 1960s, of brick at the first floor and flat roofed. The restrained style of the shop fronts and the signage highlights the poor quality of the neighbouring shops. There follows a row of three shops (**nos 33a-b**) in a post-War building with a façade made of rusticated reconstituted stone and windows with concrete reveals (*Fig. 32*). This would be almost elegant if the use of simulated stone were not so unexpected.

Fig. 32 No. 33 High Street and the public conveniences.

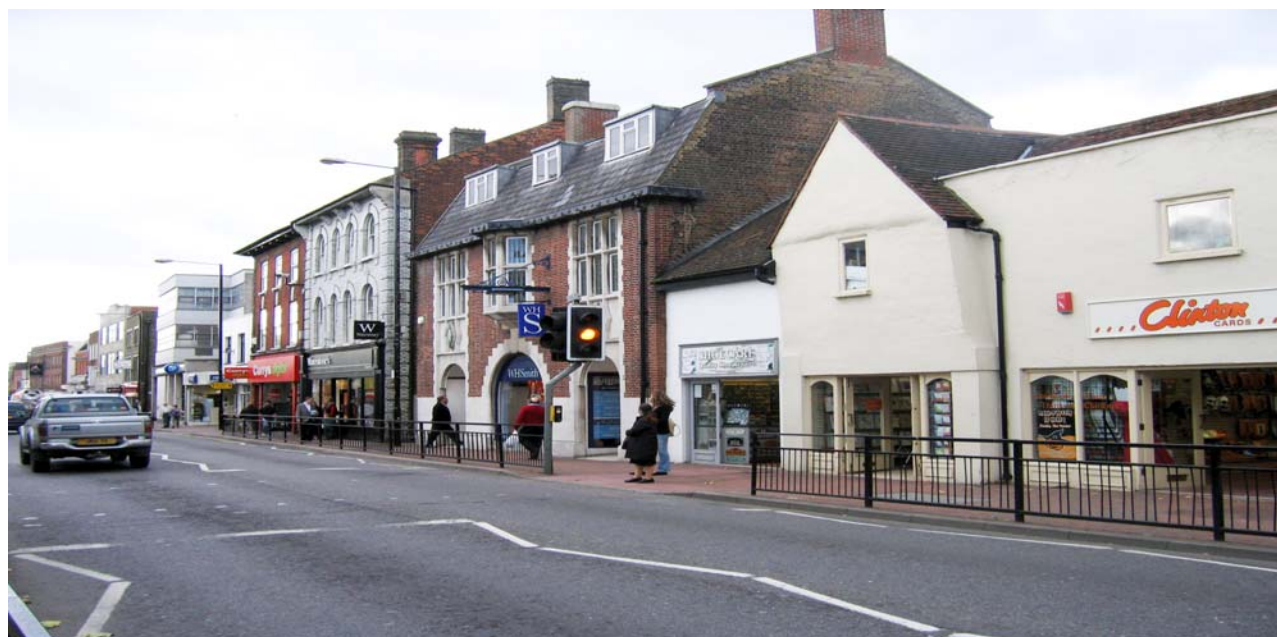
Fig. 34 Nos 63-65, one of the few surviving medieval buildings in the High Street, and beyond it the former Lion and Lamb, and nos 69-71.

Nos 63-65, listed grade II, are one of the few surviving late medieval buildings in the High Street. They are a rather unconvincing composition since rebuilding in 1973, with a central gable flanked by ranges either side parallel to the street, that to the east having a parapet to its pitched roof (*Figs 8 & 34*). The cross-wing is the oldest part, 15th-century, of two bays, with a crown-post roof, originally jettied, later extended by two bays to the north in the 17th century (Scott 1984). To the east, there was originally an open hall, replaced with the existing two-storey building (no. 63) in the 17th century. The timber-framed construction can be seen within the shop at no. 65. The first floor windows are rectangular holes in plain wooden frames and do little to complement the building.

No. 69 is a three-storey Victorian building in the Italianate style, with strongly projecting eaves, rusticated quoins and raised brick surrounds to round-arched windows with key stones, its stock brickwork being painted white, a treatment surprisingly successful. It is well complemented by the plain black Waterstones fascia. **No. 71** is similarly imposing, of much the same date, built of red brick with detailing in stocks, but the sash windows have been replaced in UPVC and the bright red Currys fascia is an eyesore (Fig. 34).

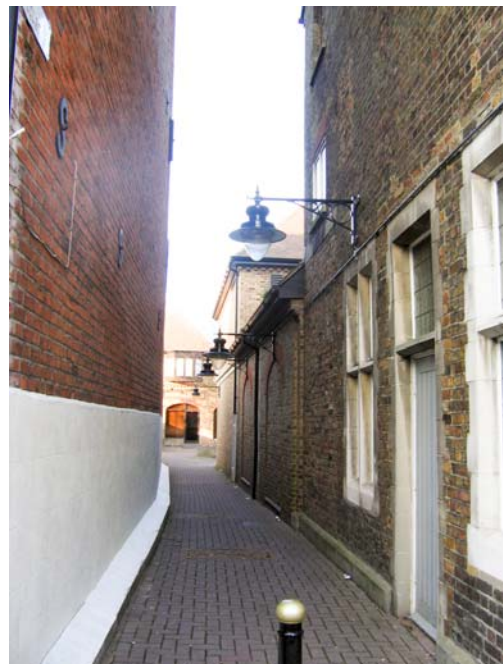
Lion and Lamb Court is one of the better alleyways off the High Street. A new stock brick building with good detailing (red brick window arches, eaves dentil course, stone quoins and string course) has been built on to the rear of the Lion and Lamb, whilst the view to the north is closed by another new stock brick building (Imperial Peking). The alley is surfaced with block pavers and lit by modern lamps of sympathetic design (*Fig. 35*).

Fig. 35 Lion and Lamb court. Careful new design and attention to detail have made this an attractive alleyway.

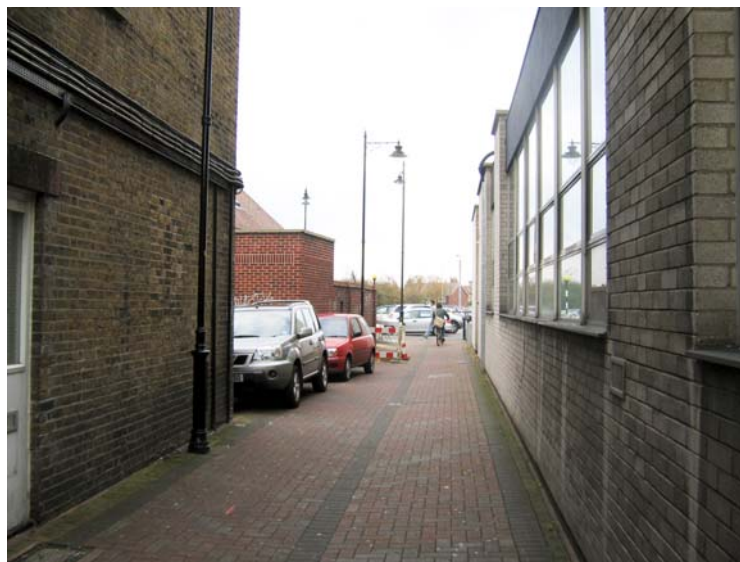
Nos 73-73a (Rosebys and Krisp) are a four window bay inter-War shopping parade development, two storey with a flat roof, rendered with rusticated quoining. The black painted wooden window frames are a nice contrast with the white render. It is slightly set back, presumably to an old frontage line, but the Rosebys shop front projects forward in a clumsy way to the line of the adjacent **Barclays bank**, a hideous modern building, despite a potentially interesting attempt at a ground floor portico, constructed of grey concrete bricks with a grimy glazed curtain wall above. The unattractive brickwork and curtain wall continue round the side into **Bank Place** where there are views of the car park in William Hunter Way (Fig. 36).

Fig. 36 Bank Place, an alleyway where good paving and lamps do not compensate for the view of the car park beyond, and where parked cars have intruded into what should be a pedestrian space.

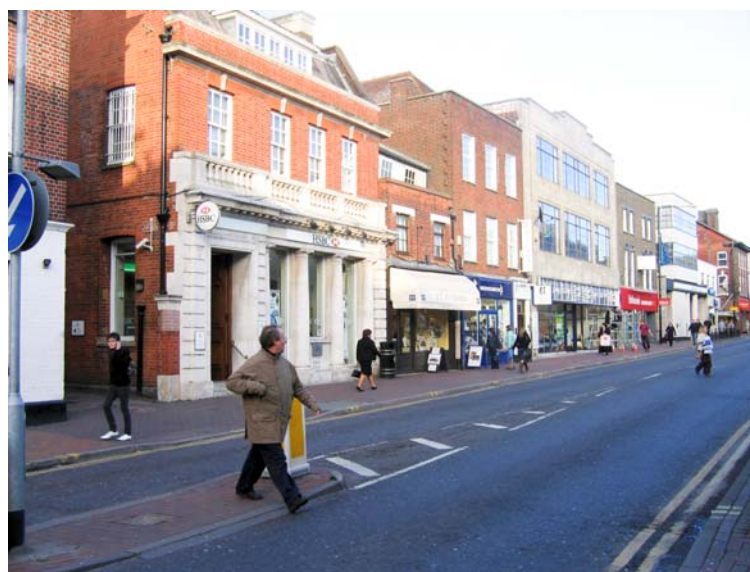
Nos 77-79 is of stocks, three storey, a parapet to the roof, the windows with stone lintels with their sashes intact (Fig. 37). Like Currys, it has an unfortunate over-large bright red fascia (Britannia Building Society).

Nos 81-85 (MT) is an inter-War shopping parade development, built of some form of concrete or reconstituted stone block, with a stepped parapet rising in the middle, and metal windows with a strong horizontal emphasis. Quite a good quality building of its kind, it represents an isolated moment in this part of the High Street (Fig. 37).

Fig. 37 HSBC bank, and beyond no. 87, nos 81-85, nos 77-79, and no. 73.

HSBC, a former Midland Bank branch erected in 1921, is a well preserved bank building with a typically grand classical presence on the frontage, the ground floor with rusticated stonework and four Doric columns, red brick above with sash windows (*Fig. 37*). The cash dispenser and disabled access have been carefully located in the side alley, leaving the front unmutated. The alley is enclosed by a long flat-roofed extension to the rear of HSBC and the tall white painted rendered flank wall of the White Hart, largely featureless except for down pipes, soil pipes and prominent service ducting. Views down it, of a car park enclosed by a flint brick wall, are not enhanced by litter or the clumsy white railings of the ramp to the bank entrance.

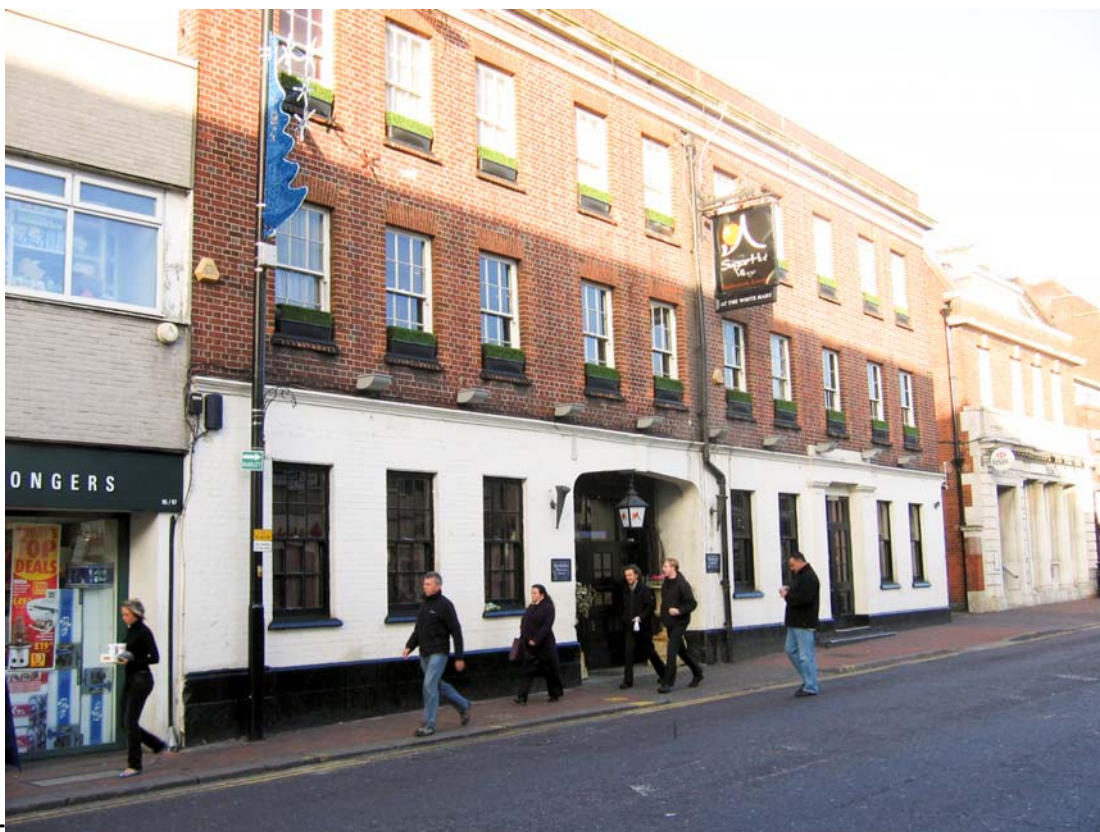
The grade II* **White Hart**, now the Sugar Hut, is a forlorn reminder of the Brentwood's significance as a coaching town (*Fig. 38*). The Georgian brickwork of the three-storey façade was totally replaced in the same style in the 20th century. The new use as a club is unlikely to be sympathetic to its historic character. The remarkable feature of the building, which explains its II* status, is the timber-framed galleried range of c.1500 on the west side of the courtyard to the rear (*Fig. 9*). At the first floor, there were a series of two-bay rooms with crown-post roofs. Some internal wall painting survives. This is a rare and very complete survival of a type of building formerly characteristic of late medieval inns. To the rear, facing William Hunter Way, the galleried range has a few exposed timbers which are becoming eroded because of adjacent cement render. There is also an untidy service yard enclosed by a painted blockwork wall.

Fig. 38 The former White Hart, now the Sugar Hut

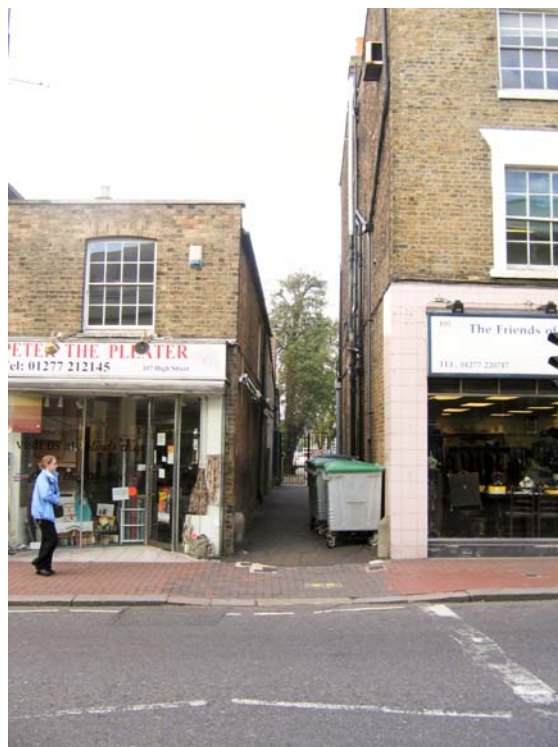
Fig. 39 Alleyway with skips between nos 105 and 107 High Street.

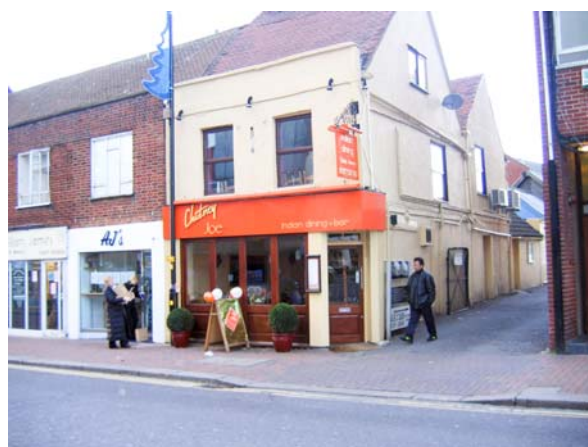
No. 117 (Chutney Joe) is a double pile 19th-century or earlier building, its brick front rendered and cream painted, with mahogany effect UPVC windows (*Fig. 40*). To the rear there is a row of somewhat ramshackle outbuildings. Such buildings are typical of backland spaces and contribute to their character but now are rare in Brentwood. **Nos 119a-121** are probably a 1950s refacing of older buildings, with a parapet and Crittall windows. Kino has a well balanced shop front, with a central shop sign over a central door.

Fig. 40 No. 117 High Street, with outbuildings to the rear.

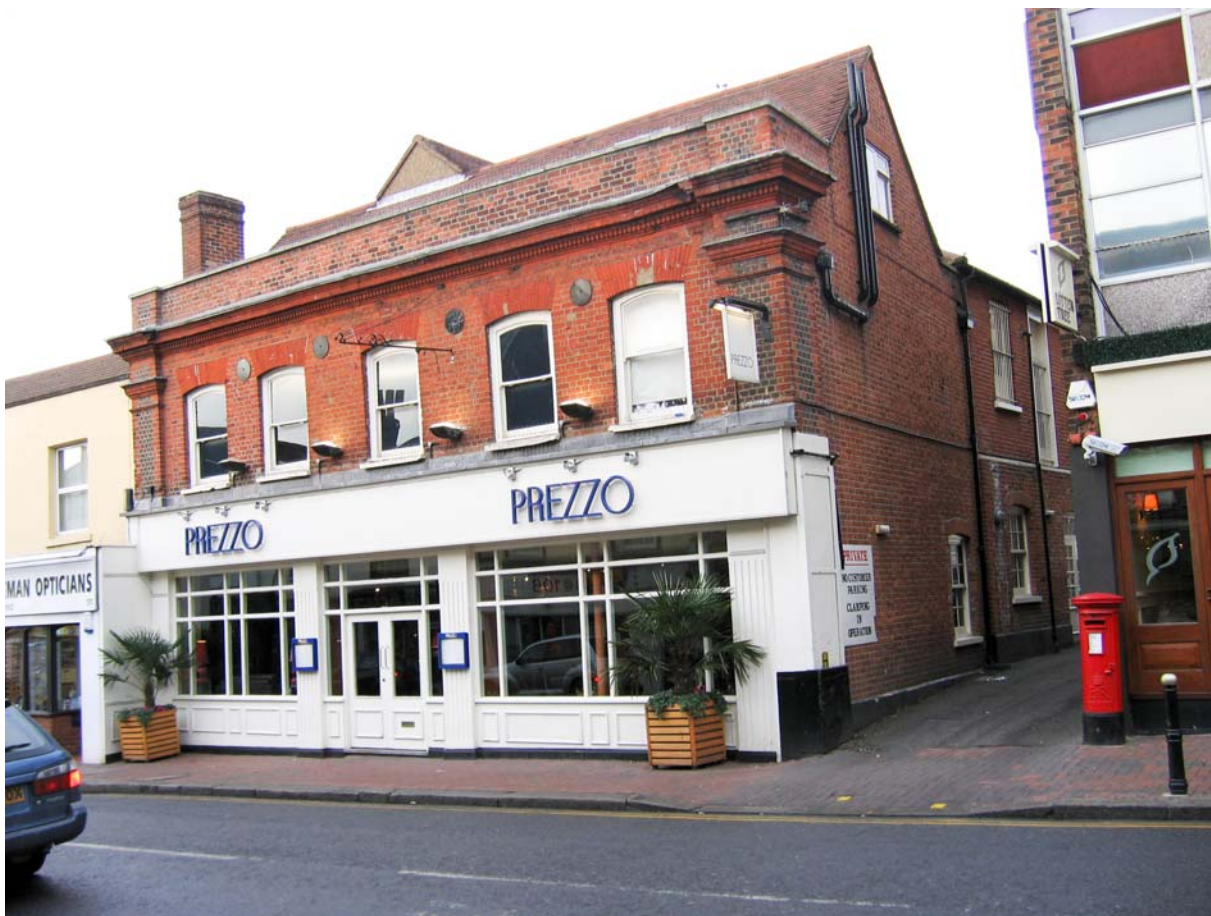
Nos 129-129a (Prezzo), listed grade II, has a traditional shop front set in an impressive early 19th-century brick façade, with rubbed brick capitals to full height corner pilasters and a rubbed brick cornice to the parapet (*Fig. 41*). The sash windows have gauged brick arches. Ornamental brickwork of this quality is rare in the town. However, the brickwork is in poor condition and there are four tie bars. It is a casing on an earlier timber frame. To the rear there is a weatherboarded outbuilding and a yard with skips.

Fig. 41 Nos 129-129a High Street, late 18th-century brickwork with classical detailing encasing an older timber frame.

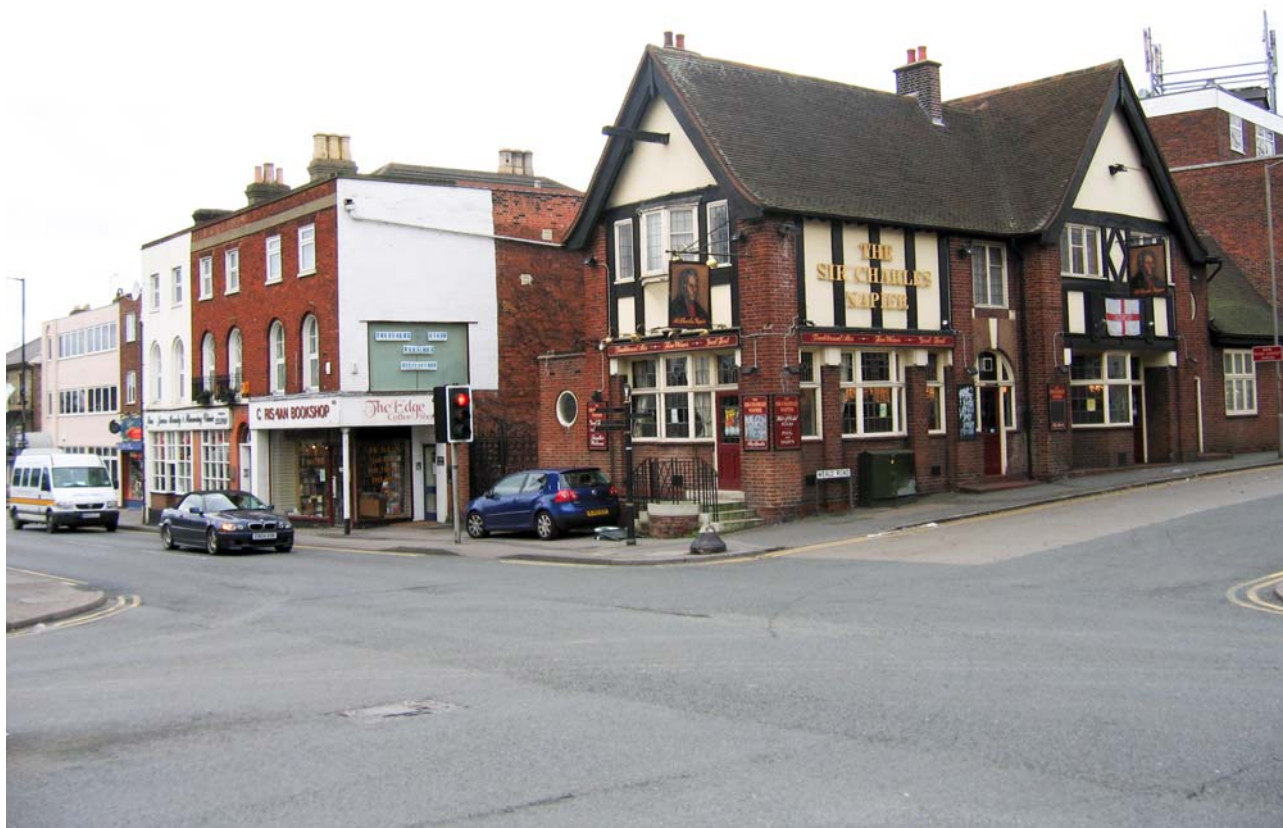
The **Sir Charles Napier** on the corner with Weald Road is another well detailed public house dating from the inter-War years (*Fig. 42*). It is built of hand made brick, with false half timbering at the first floor and in the gables, and timber casements with leaded lights. On the west side are good wrought iron gates to an untidy yard.

Fig. 42 The Sir Charles Napier and nos 143-147 High Street.

Nos 143-147 at the conservation area boundary are an interesting and potentially distinguished Georgian brick buildings badly treated (*Fig. 42*). It has round arched windows to the first floor with distinctive glazing bars, but the bottom half of the sashes have been replaced in UPVC. No. 147 has its brickwork now painted. The door to the upper floors is of a design inappropriate to the building. The shop fascias do not fit with the architecture, and the brickwork of no. 143 has been removed at ground floor corner and replaced with a spindly looking iron column.

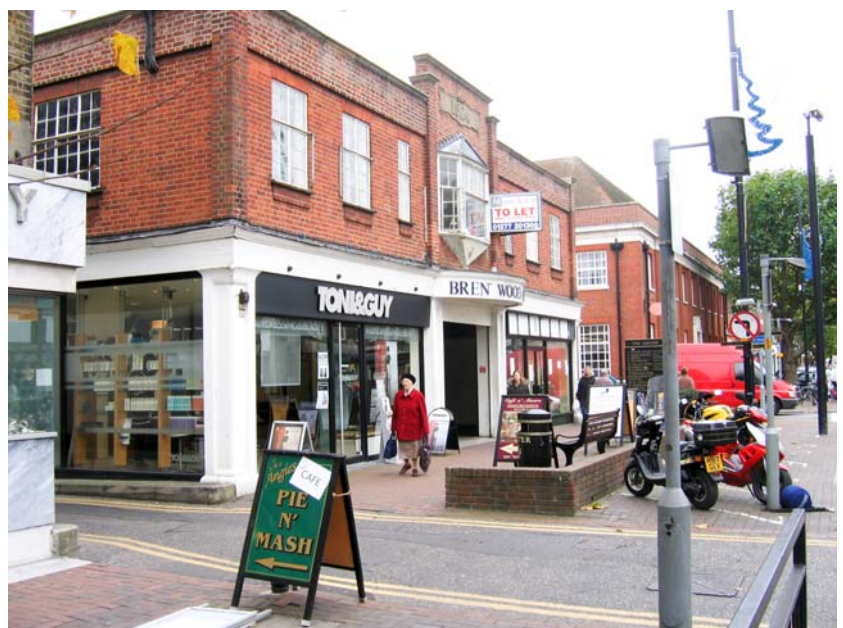
Fig. 43 The Arcade.

The Arcade (**nos 26-28**), converted by the 1954 remodelling of the rear of a former garage originally built in 1924, is a low key but attractive feature of the High Street (*Fig. 43*). Its façade is symmetrical, with a shop either side of the passage, above which is an oriel window. There are Crittall metal windows at the first floor. The passage through it is plain but clean and bright, and is of course an unambiguously pedestrian space. On the pavement in front of it is a raised brick plinth enclosed by a low wall, with a seat, a planter and a forest of temporary signs, a peculiarly uninviting prospect for the weary shopper or anyone else.

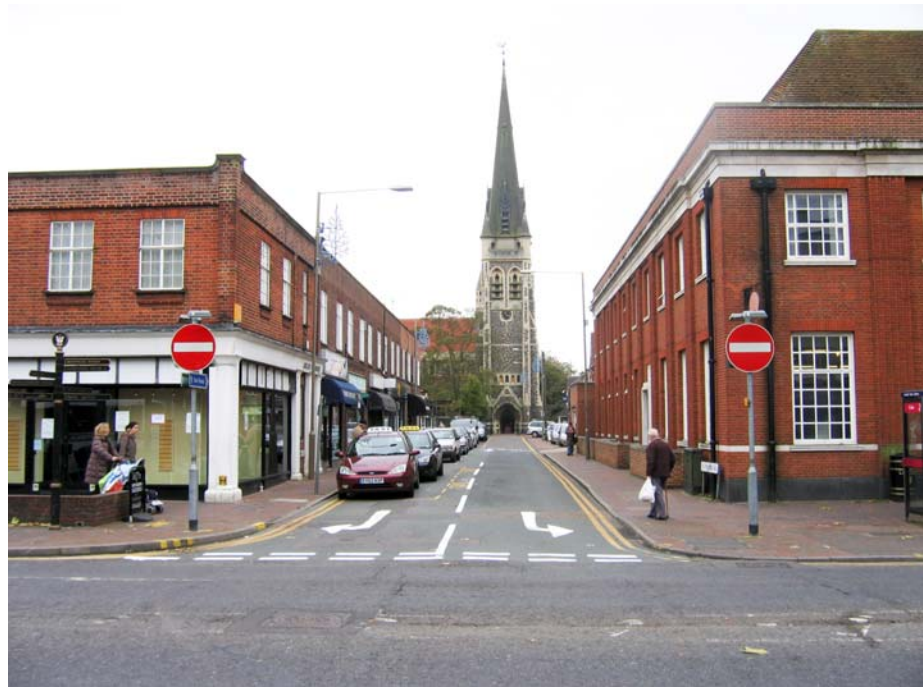
At the junction with **St. Thomas Road**, there is a splendid view of the tower and spire of the parish church, but it is not enhanced by No Entry signs, double yellow lines and prominent road markings, and parked cars (Fig. 44).

Fig. 44 The High Street entrance to St. Thomas Road
