BRENTWOOD

Conservation Area Appraisal and Management Plan

This document was produced by Essex County Council for Brentwood Borough Council.

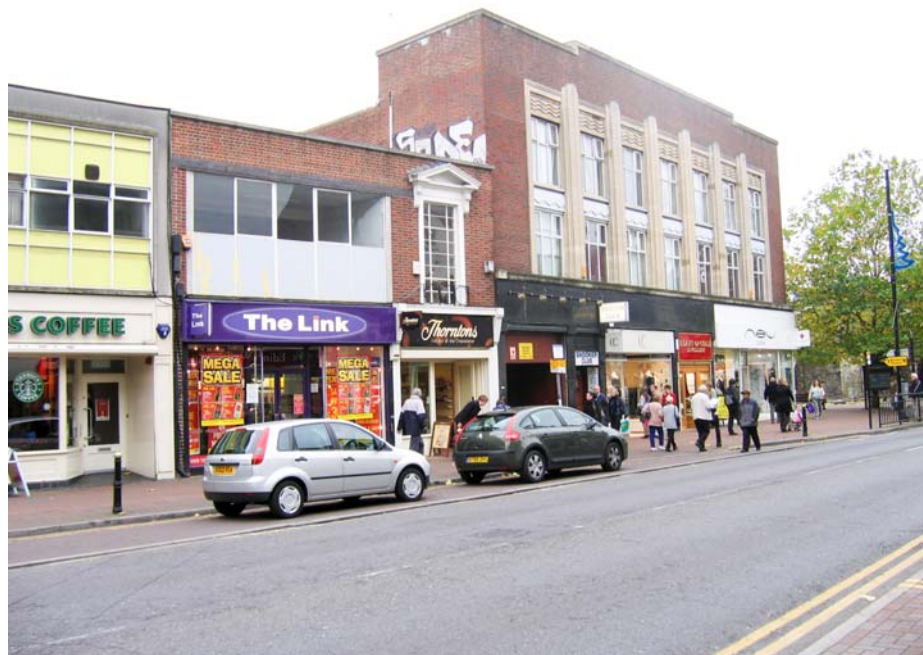
The **Post Office** of 1939 is a large handsome brick building in the neo-classical style with metal sash windows. From the Post Office to the former **Burtens** store, the frontage is all late 20th century and of no architectural merit. **No. 32** (Iceland) is totally out of keeping, a large modern building, its front at both floors consisting almost entirely of glazing within a red metal frame. **Nos 34 and 34a** are a pair of modern shops, their fronts framed by tiled piers, with a brick first floor with windows in concrete surrounds. **Nos 36 and 36a** (Boots and Starbucks) make use of inappropriate modern

materials at the first floor, prefabricated pebbledashed panels and lemon yellow panels above and below the windows of the right hand unit, these contrasting with the good shop front at the ground floor (Fig. 45). **Nos 38 and 38a** present a strange dichotomy between **Thorntons**, a traditional shop front with a tall imposing metal window above it in a stone surround (now painted) with a pediment, and **The Link**, its shop windows cluttered with advertising and the first floor consisting of unsympathetic continuous glazing above grey panels (Fig. 45).

Fig. 45 Nos 36-38, and the former Burtens store.

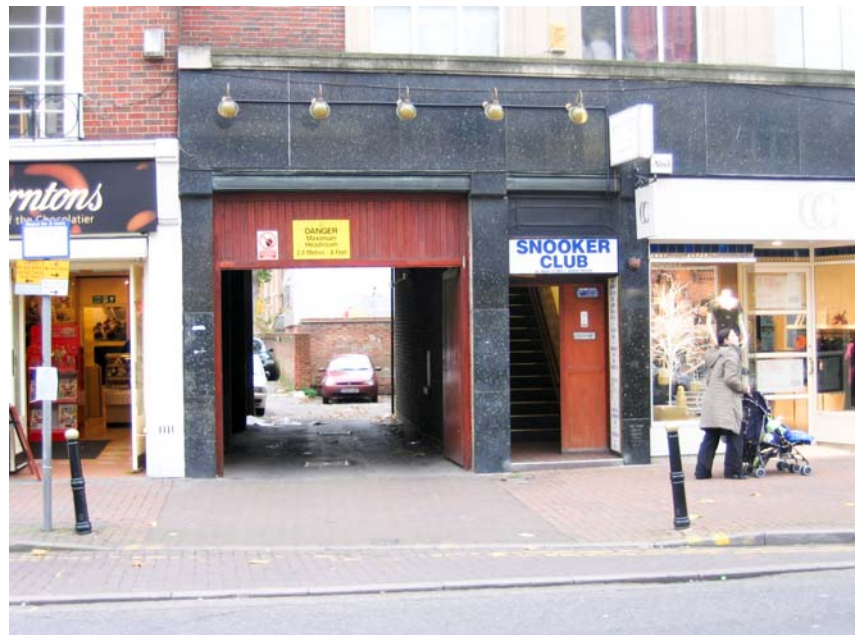
No. 42 was formerly Burtons the Tailors, as a foundation stone laid in 1939 by Austin Stephen Burton records. The building is in the muted Art Deco style favoured by Burtons, and this together with its height make it a landmark in the High Street, which hitherto has been predominantly two storey on this side (*Fig. 45*). Although the character of the distinctive upper storeys with their stone window surrounds is intact, apart from the replacement of the window frames in UPVC, the black marble fascias of the ground floor shop windows have suffered through the subdivision of the store into several units. The New Look shop sign in particular is simply planted onto the old fascia, taking no account of its original design. Also at ground floor, the carriage arch looks through to a yard with litter and parked cars, the wooden gates to it being decorated with an unsympathetic reddish varnish, and there is excessive signage round the doorway to the Snooker Club (*Fig. 46*).

Fig. 46 Gateway through to the rear of the former Burtons store.

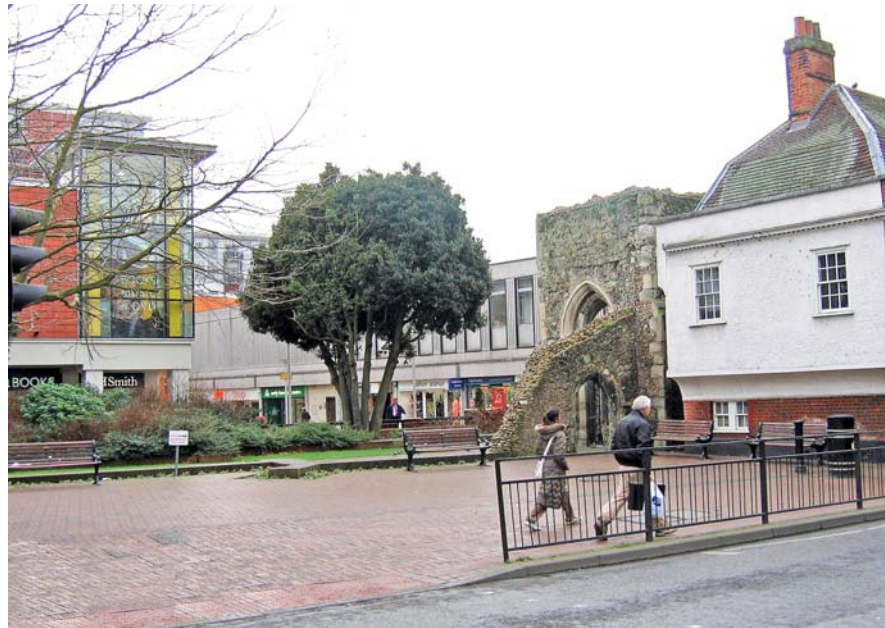
The late 14th- or early 15th-century ruin of **St. Thomas chapel** is one of the most interesting features of the High Street. It was built of flint rubble with some Kentish Ragstone and Reigate stone used for the surrounds to the openings in the walls and elsewhere. All that survives today is part of the north and west walls of the nave, and the tower, which unusually was located inside the nave, in the north-west corner, something which could indicate a shortage of external space at the time of its construction. The ruin is a scheduled ancient monument (county monument no. 29398). The scheduled area includes not just the ruin but the land around it (*Fig. 1*). No work can be done to a scheduled monument without the consent of the Department of Culture Media and Sport and English Heritage. The land to the north has been used as a graveyard.

Old repairs to the ruin have been carried out using a distinctive mix of small flints and tile, following what seems to be a feature of some of the tower masonry. More recently the masonry has been consolidated using cement mortar which is potentially damaging to the softer stones incorporated in it. Recent damage to the west wall needs repair. Repairs should be carried out using lime mortar by contractors with experience of this type of masonry.

The footprint of the chapel is marked out with lines of robustly mortared rounded flints, which look quite good and are fairly maintenance free. On the west side of the tower, there are good railings erected in 1902 when restoration work was carried out. The crazy paving in the chapel area is inadequate for this situation and ought to be replaced in stone.

Fig. 47 The chapel ruin seen from the High Street.

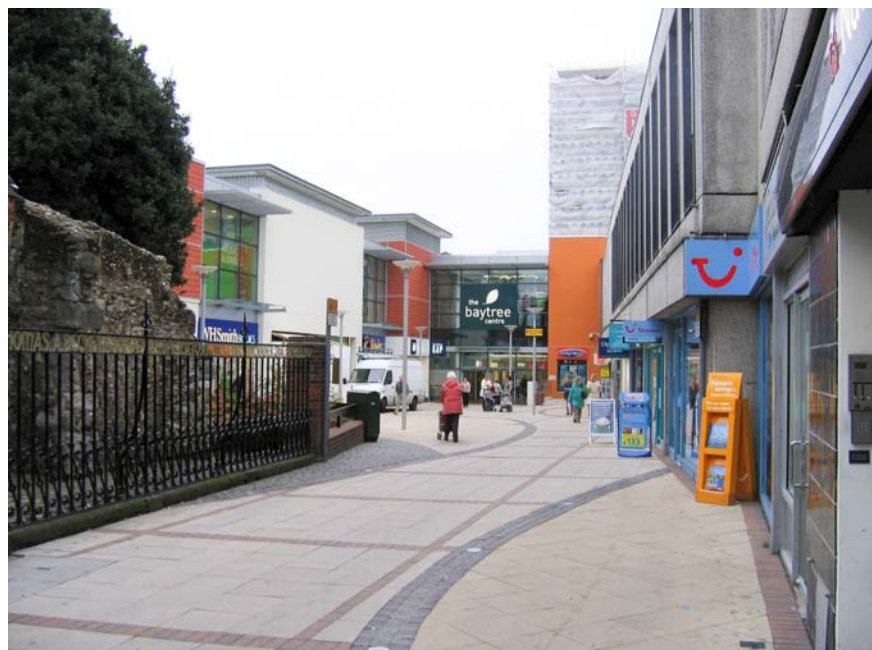
In the Essex volume of the *Buildings of England* (1954), Nikolaus Pevsner wrote of the chapel, 'Brentwood could make better use of this accent in a visually not very successful town'. This problem remains today, despite the enhancement scheme in the 1990s and recent repaving of the approach to the Bay Tree Centre. There can be no doubt that it is a difficult space to handle: it represents a gap in the street frontage, the chapel being set back from it, and there are pedestrian thoroughfares either side of it to and from the Bay Tree shopping precinct (*Fig. 47*). It ought to function as a piazza-like space, as a place of public resort, but there is a poor sense of enclosure. Between the chapel and the road, there is a desolate expanse of hard surfacing. The low brick wall with a black-painted box section metal rail on top

of it has a strong horizontal emphasis, reinforced by the lines of the modern building to the west of the chapel, whereas what is required is more height and verticality, which is provided only to some degree by two large bay trees. Another plane tree on the street frontage, and railings with planting behind them, might be one approach to tackling this problem. The repaving scheme is quite successful, but there is too much unrelieved hard surfacing and it would have looked better if some real stone had been used as well as concrete paving. Another problem is the failure to integrate the structures and spaces around the chapel. The large expanses of glazing and coloured panelling of the new shop building occupied by WH Smith and the remodelled Bay Tree Centre take little account of their surroundings and represent a missed opportunity (*Fig. 48*).

Fig. 48 View down the west side of the chapel to the Bay Tree Centre.

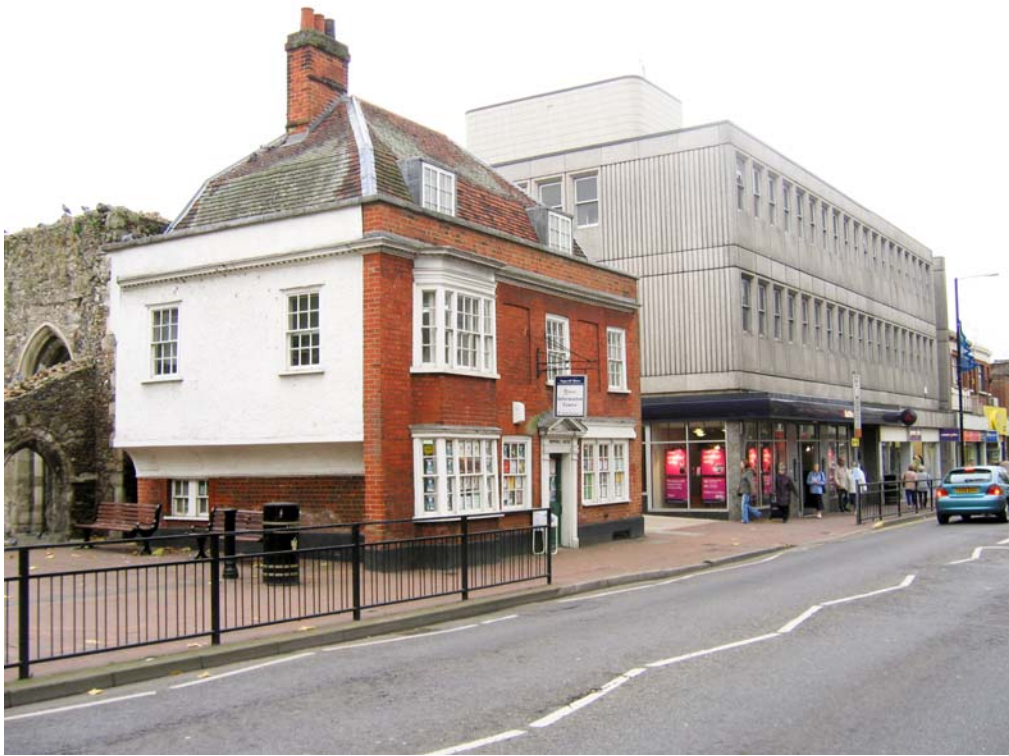
Fig. 49 Pepperell House.

No. 44, Pepperell House, grade II listed and one of only three Georgian buildings in the High Street, stands in front of the chapel tower (*Fig. 49*). Aspects of its plan and the jetty on its east side suggest it incorporates a late medieval building. Its brickwork has traces of tuck pointing. It has distinctive sash windows separated by wide mullions in the form of fluted columns with capitals. The house is very attractive, but its situation does little for it, as it stands amidst new development uneasily marooned in the large area of paving around the chapel. The bins parked at the rear of the house look particularly unsightly in what is in effect public open space.

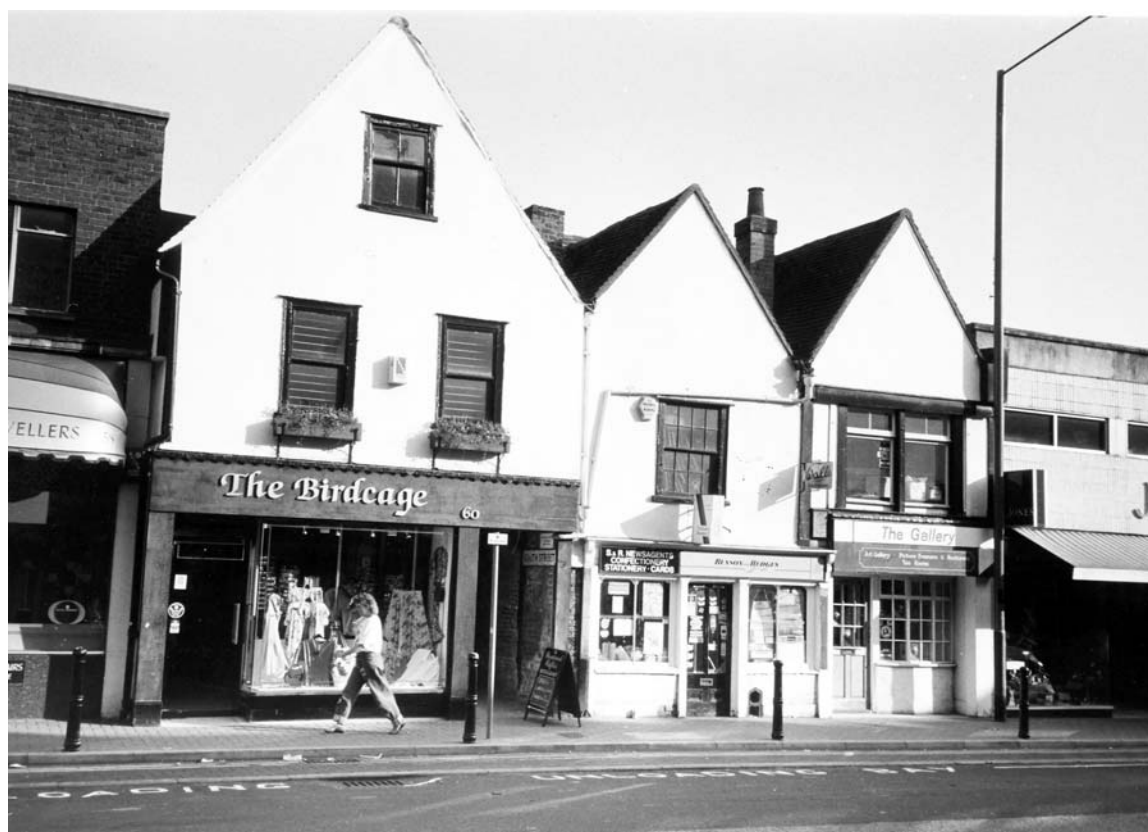
Nos 60-64 are a group of surviving late medieval buildings, grade II listed (*Fig. 50*). They are difficult to assess because of alterations and because the fabric is obscured, but 62 seems originally to have been a c.1400 hall, possibly aisled, with 60 and 64 being cross-wings forming an H-plan house. Today they present three gables to the street, the hall roof having been remodelled, a building form which proclaims their early date and is quite distinct in today's High Street. After the chapel, these are the oldest surviving buildings in the High Street, and any works at them should be closely monitored for information on their history and development. An alleyway has been cut through no. 60 leading to South Street, creating a magical space with on one side the flank of no. 62 with a magnificent arched medieval door and some exposed framing, now largely replaced in Tudor brick, and views through to the irregular small scale buildings at this end of South Street. The alley is much used by pedestrians. It is not enhanced by graffiti.

Fig. 50 Nos 60-64 High Street, some of the few surviving medieval buildings in the High Street, with the narrow entrance to South Street (photographed 1989).

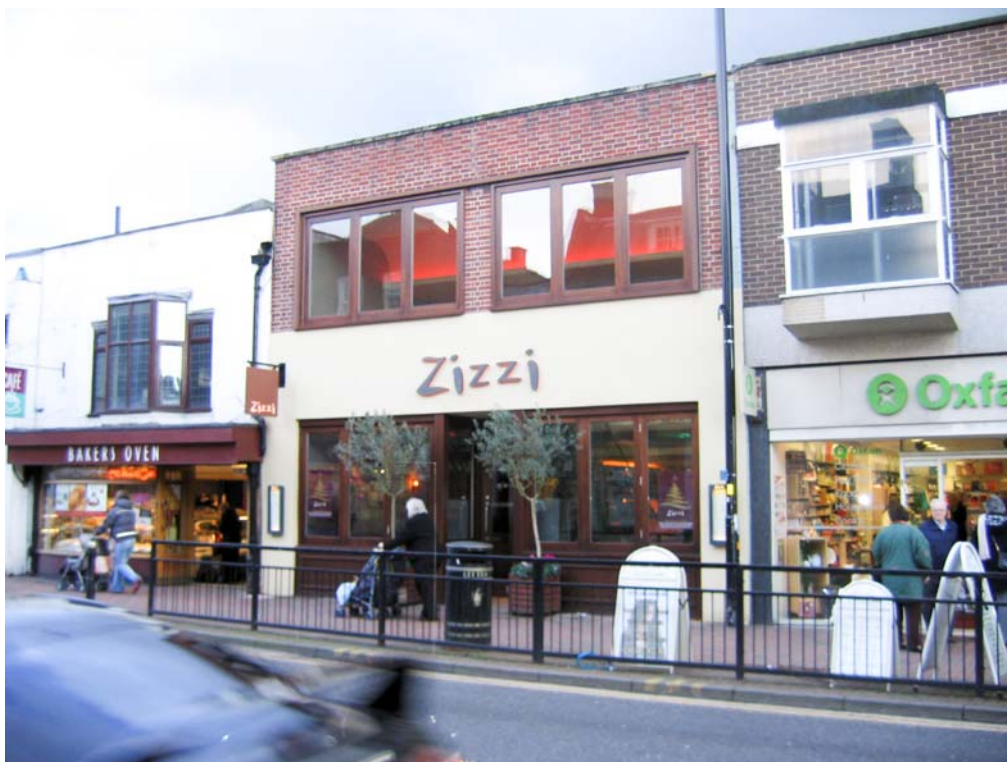
Fig. 51 Nos 72-74 High Street.

No. 66 (M & Co.) has a large glazed shop front, and a narrow horizontal clearstorey window in a tiled surround (now painted) at the first floor. The Bakers Oven (**nos 68-70**) has a curved shop front in a fairly traditional style, with a canted oriel window, now unfortunately in brown UPVC, above, projecting from a painted 19th-century brick façade which might conceal something older behind. Beyond this point, the frontage was redeveloped as far as Crown Street in the 1960s. **Nos 72-74** (Zizzi) has recently been refurbished in the dark wood which is currently fashionable for shop fronts. The plain finishes, traditionally proportioned shop window, expansive cream painted fascia with raised lettering, has made a harmonious composition of a very ordinary brick flat-roofed building (*Fig. 51*). **Nos 76 and 76a** are not so attractive, having boxy oriel windows with metal frames, and a token string course below the parapet made of small tiles. The building extends round the corner and forms part of the cluster of poor modern buildings which make the junction with Crown Street and Hart Street so unappealing.

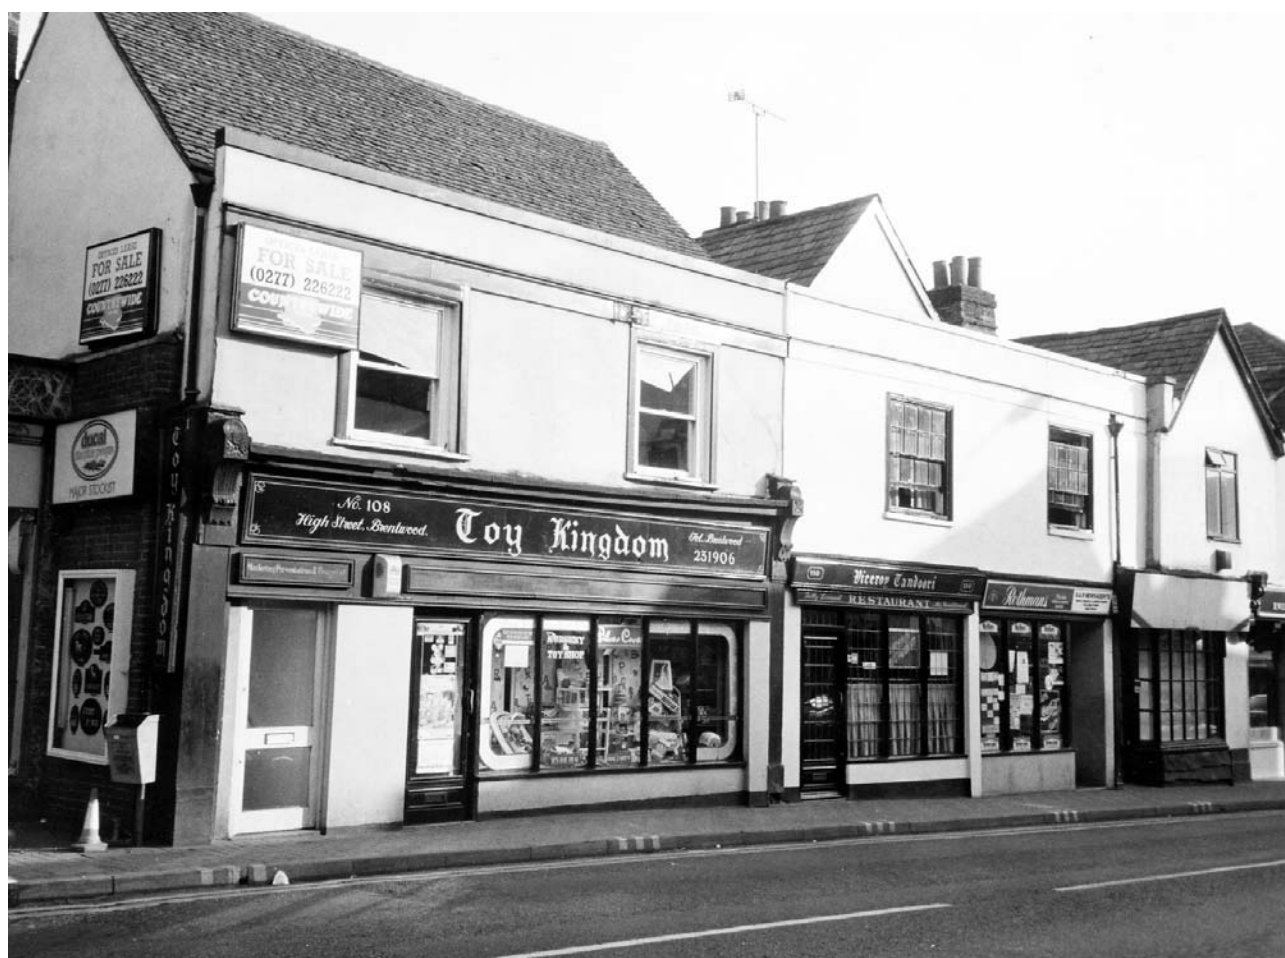
Nos 108-114 are a row of older buildings, some of which are amongst the oldest in the High Street, all grade II listed (*Fig. 52*). Visually they form an attractive and potentially coherent group. They are all timber-framed: 108-110 are brick fronted, the rest are rendered. 110a and 112-114 are gabled and thus medieval in appearance. 108 has 17th-century framing at the first floor. 110 is a two bay 16th-century cross-wing with a crown-post roof, possibly once jettied and housing a medieval shop. 110a is the site of a medieval hall, now completely rebuilt. 112 is a large early 16th-century two bay cross-wing. With 110 and 110a, it may have formed an H-plan house. 114 has some 17th-century framing but is mainly 19th- and 20th-century. The sash windows of these buildings mostly survive, their shop fronts generally respect their character, but maintenance is poor.

Fig. 52 Nos 108-112, timber-framed buildings at the west end of the High Street (photographed 1989).

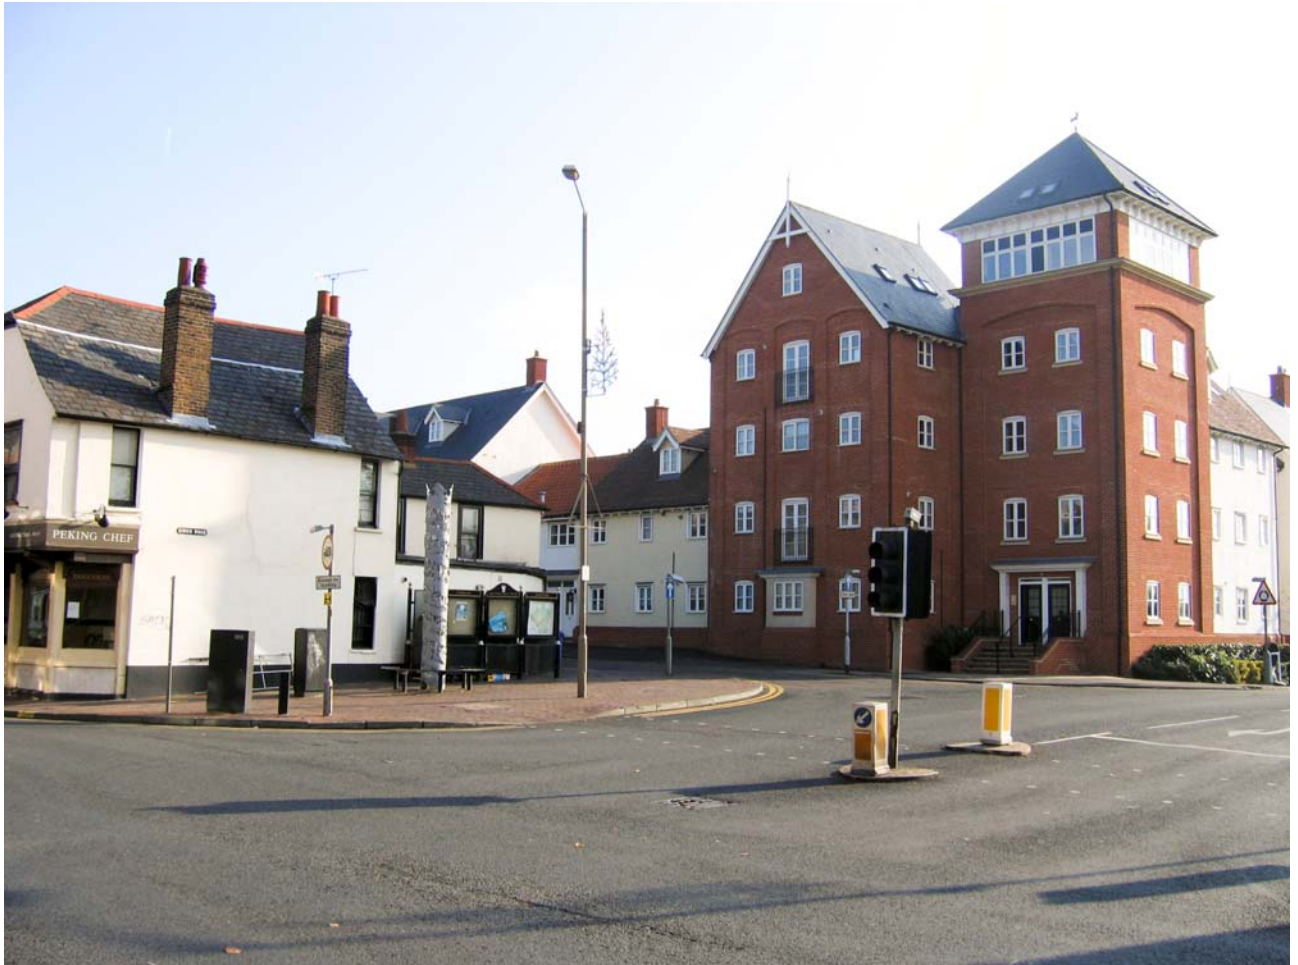
Fig. 53 The side wall of no. 114 at the High Street/Hart Street junction, with the Heritage Column dwarfed by buildings and the lamp standard, and surrounded by street signs and clutter.

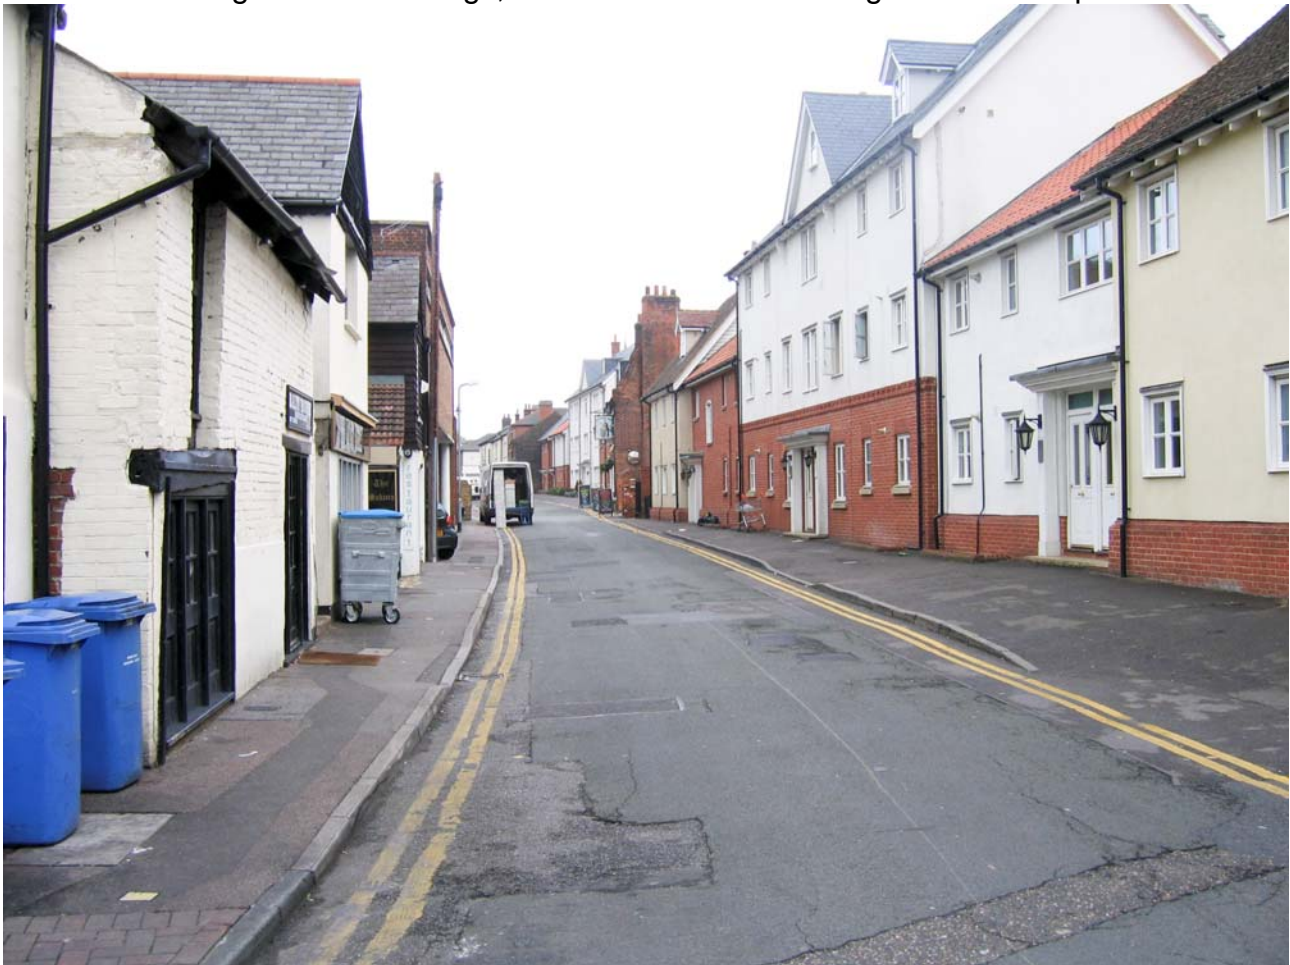
Fig. 54 Looking east down Hart Street, the frontage of The Square on the right hand side. As elsewhere in the conservation area, skips and brightly coloured bins are an eyesore.

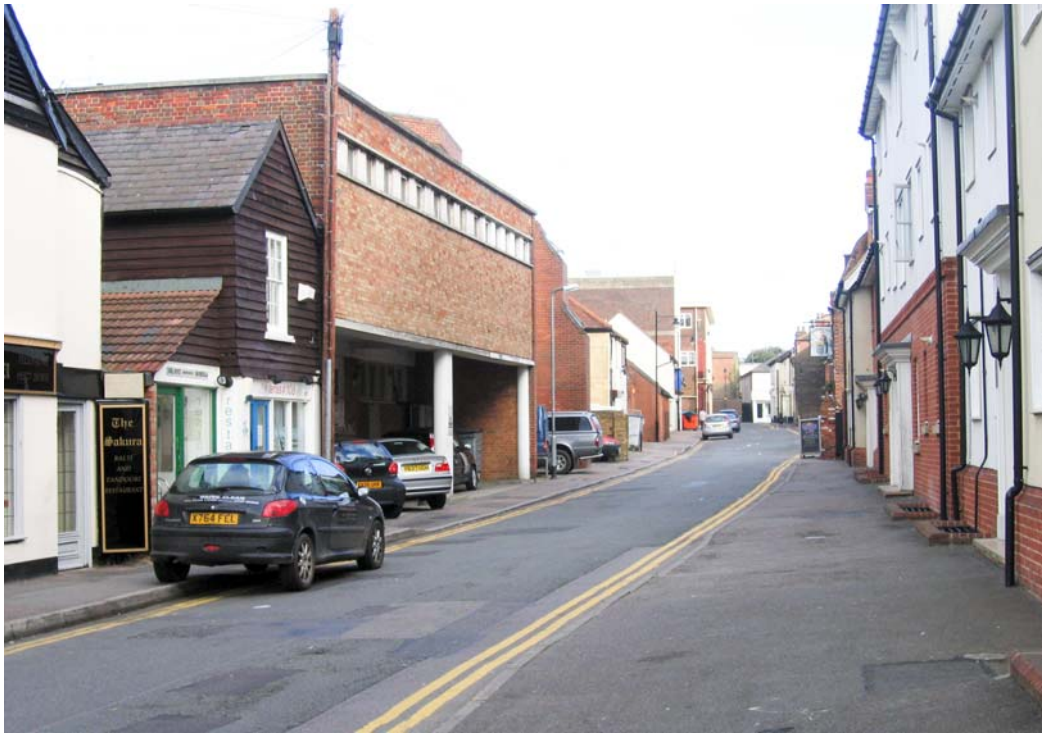
Fig. 55 Looking west along the north side of Hart Street.

With this appearance, the street feels as if it might be a pedestrian zone, but in fact it is one-way. The prominent double yellow lines that run down it are ignored and parked cars litter both sides. Car parking also intrudes into the limited open spaces on the north side. There are clay pavers outside the new Market Terrace development, but the asphalt pavements and also the road surface are in poor condition (*Fig. 56*). These negative features (yellow lines, car parking, poor surfacing) have an adverse effect on the view looking west down the street.

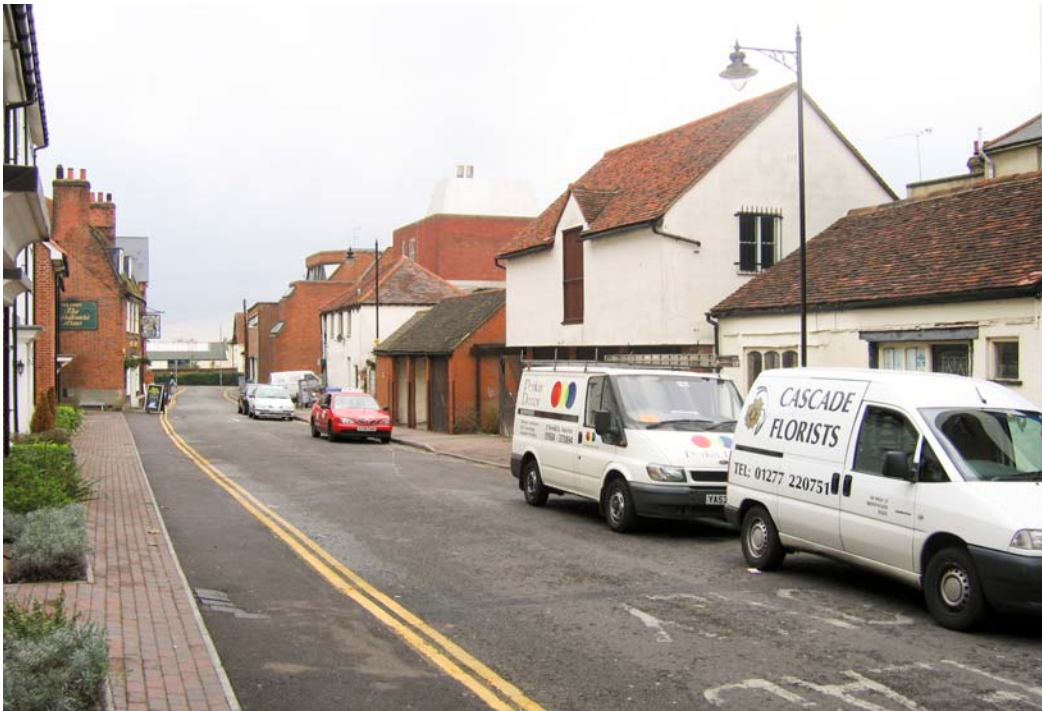
Fig. 56 View west down Hart Street, showing conspicuous yellow lines, parked cars and poor surfacing.

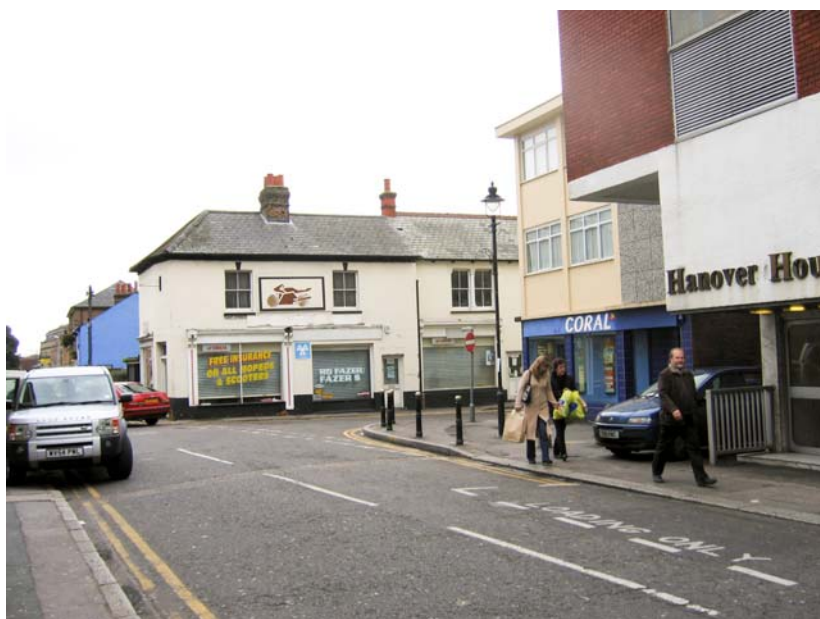
The Crown Street approach to Hart Street is unattractive, being enclosed by the rear elevation of the modern buildings on both corners. A wide area of paving on the bend on the west side, with an isolated lamp post behind cast iron bollards, is an unsatisfactory space in the shadow of **nos 1-3**, a concrete framed building which has had its windows replaced in UPVC (*Fig. 57*). Between this and Hanover House, there is a narrow space open to pedestrians occupied by concrete bollards and skips, and full of litter and broken glass.

Fig. 57 Junction of Crown Street and Hart Street.

On the corner of Hart Street and Crown Street, there is a Victorian building (**no. 5 Crown Street**), white painted and rendered, but with its slate roof, sashes and shop windows largely intact (*Fig. 57*). Formerly a motorbike dealership, it is now empty. It has the potential to make a valuable contribution to the appearance of the area, like its neighbour, the **fire station** built in 1902 and restored in 2004. This has been given a traditional style shop front at the ground floor, whilst a wrought iron arch at the side leads to a cobbled footpath round nicely refurbished outbuildings remodelled as small shops (*Fig. 5*). This is a successful mews style development, a scheme which has made good use of backland space. The footpath leads through to the **Crown Street/Kings Road car park** which could do with some soft landscaping and resurfacing. **Nos 5-7** (the Teriss Bar) is a stock brick building which has had its sash windows replaced but retains a satisfactory appearance.

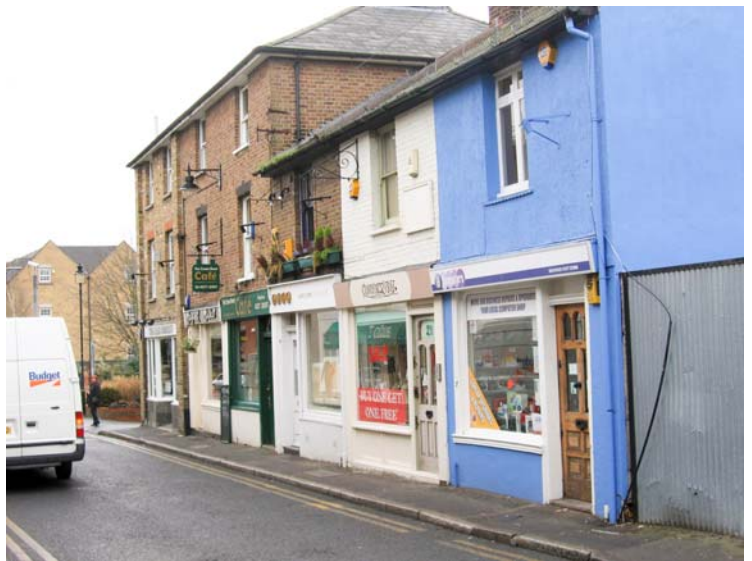
On the west side of the street, behind the former motorbike dealership there is an open space occupied by outbuildings and mainly used as a car park. This contributes nothing to the street scene and is a potential infill site. Further south is a row of stock brick Victorian shops, some of them three-storey, most of them with their sash windows preserved and the shop fronts quite acceptable (*Fig. 58*). The frontage is again interrupted, this time for the **Crown Street/Kings Road car park**, the large gap being screened by an inadequate low brick wall with exotic planting (*Fig. 59*). This should at the least be given better landscape treatment, whilst an infill development would restore the street frontage.

Fig. 58 Shops on the west side of Crown Street.

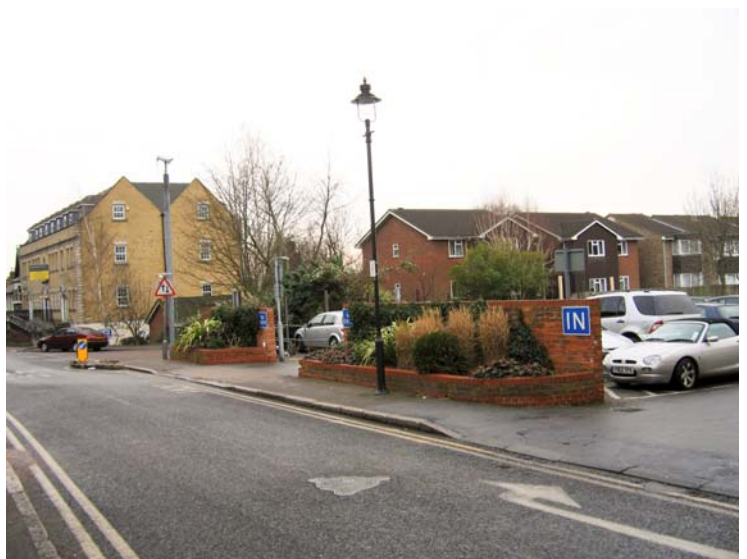
Fig. 59 Entrance to the Crown Street/Kings Road car park, a weak link in the Crown Street frontage.

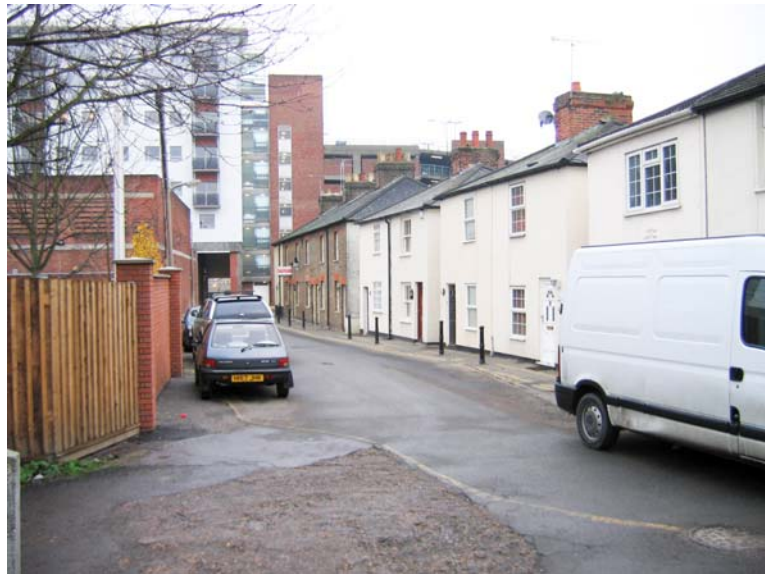
On the 1st edition OS map of 1872, South Street is called Chapmans Alley, a good description for the north end of it where a narrow passage provides access from the High Street. Where it widens out to the south, its west side was built up with cottages in the 19th century (*Fig. 60*).

Fig. 60 Looking south down South Street, with Becket House in the background.

The bend where the road turns round to join Crown Street is asphalted for residents' parking. Although this may be a necessary convenience, in visual terms this is a very unsatisfactory use of a corner plot. The planting intended to soften the area is untidy and needs attention. Partial enclosure with a wall, and better planting, could improve this space.

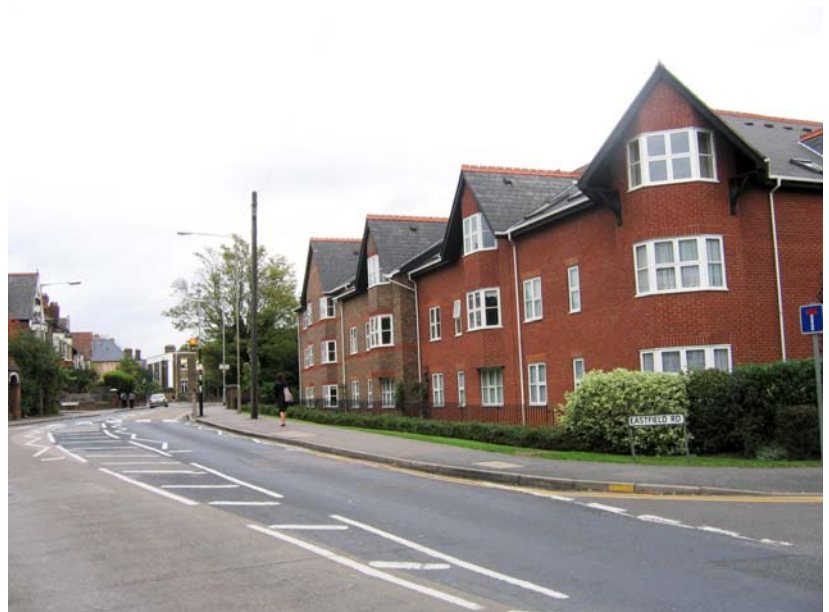
Queenswood House on the south side is a three storey block of flats in red brick and red stock-type brick (*Fig. 61*). It has timber windows. Large gables are a feature of it, helping to break up the mass of the building and giving it a slightly Victorian look appropriate to the area.

Fig. 61 Queens Road, Queenswood House.

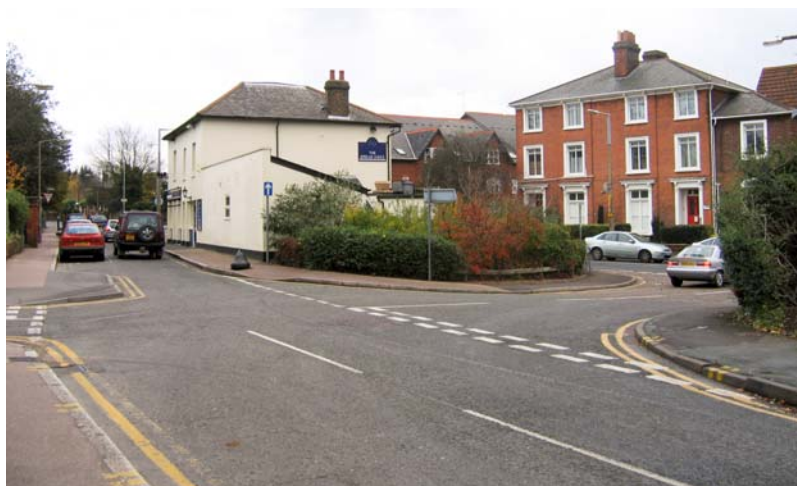
A pair of semi-detached red brick three storey houses dating from the early to mid 19th century are now incorporated in the Ursuline High School (*Fig. 62*). They have distinctive stucco window surrounds and are in reasonable condition, though their sash windows have been replaced with metal frames.

The Spread Eagle is a Victorian public house occupying what is now an island plot where Coptfold Road joins Queens Road. It is rendered and lined out in imitation of ashlar stonework. Maintenance is good and signage restrained. Its appearance is worthy of its prominent position. Not quite so satisfactory is the small area of open space to the west of it where the shrub planting could do with attention (*Fig. 62*).

Fig. 62 Queens Road, the Spread Eagle and the pair of early 19th-century red brick houses now part of the Ursuline School.

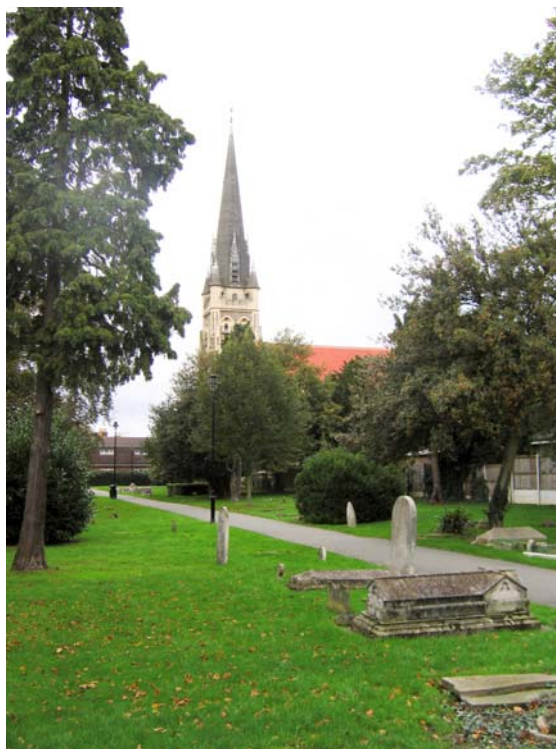
On the north side of the road is the boundary wall to **St. Thomas' churchyard**, of stock brick with thin weedy modern railings and red brick piers. The churchyard is the most significant green space in the conservation area, occupying a long narrow rectangular north-south plot. It is closed for burial and maintained by the Borough Council. It was refurbished in 2002 for the royal jubilee. The central path running through it is flanked by lamp posts, evergreen trees and graves, which reinforce its strong directional emphasis (*Fig. 63*). It is a pleasant space, very green as many of the graves have been cleared. A bound gravel surface would improve the appearance of the asphalt path. The lamp posts are of a modern design appropriate to the setting. Unfortunately there is no bench in the churchyard. The wooden fencing with concrete posts on the east side, to the rear of the properties in St. Thomas Road, should be replaced with more sympathetic materials such as a brick wall.

Fig. 63 St. Thomas churchyard.

St. Thomas' churchyard could be improved by substituting bound gravel for the asphalt surface of the footpath, providing a bench, and a better boundary treatment, ideally a wall, on the east side to replace the inappropriate fence with concrete posts.

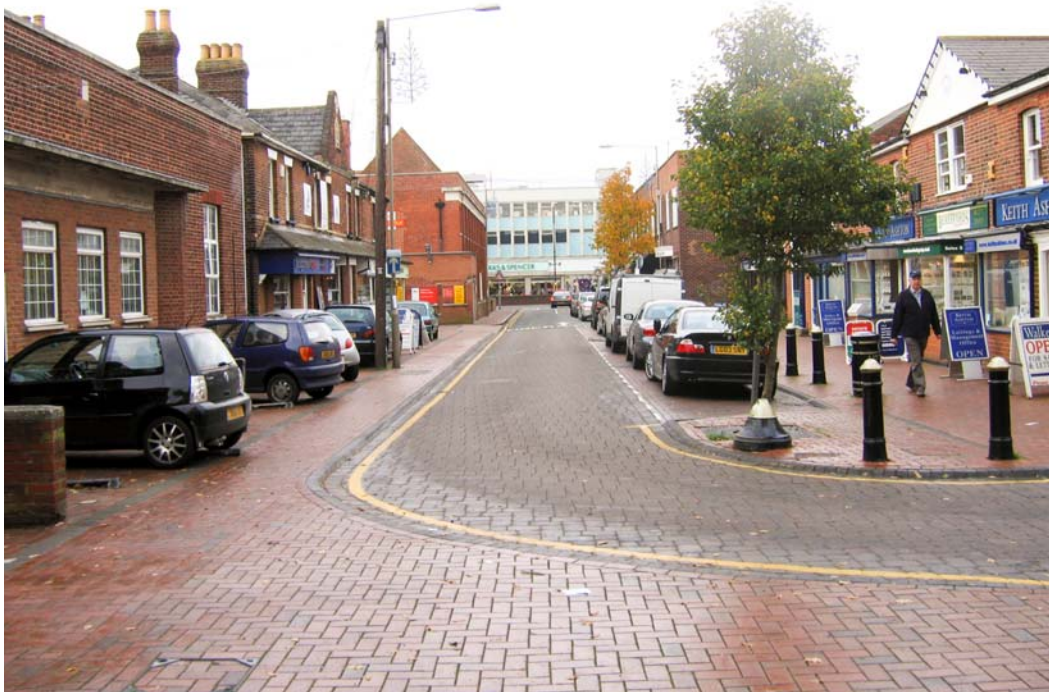
The north part of the road is aligned directly on the church tower which makes for good views from the High Street. Except for the junction with the High Street, the pavements are made of reddish clay pavers, and the road surface of 'tegula' or similar. The road here has a pedestrian feel to it, but this is deceptive: it is a one-way street, there is parking on the pavement on the west side and a parking bay on the west. The cars and road markings have an adverse effect on the character of this end of the street (*Figs 64 & 65*). On the west side are St. Thomas Villas of 1895, on the east the houses bear a plaque 'Haywards 1903'. These houses have all been converted to shops, and most are estate

agents, the uniformity of use and architectural style creating the appearance of almost a small village centre, although the signage, especially the boards on the pavements, has become intrusive. Some original sash windows survive in these buildings. The yard behind the post office on the High Street is very busy and has a lot of signs round it; the street scene would benefit from better boundary treatment here.

Fig. 64 St. Thomas Road, looking north.

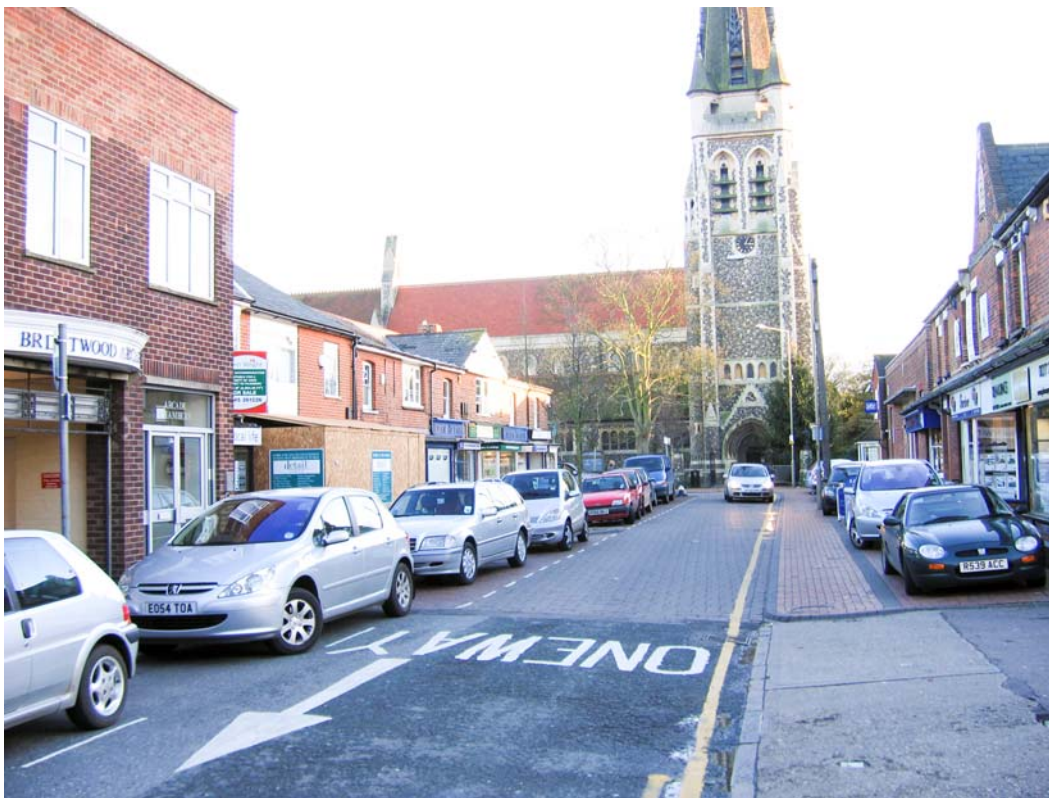
Fig. 65 St. Thomas Road, looking south.

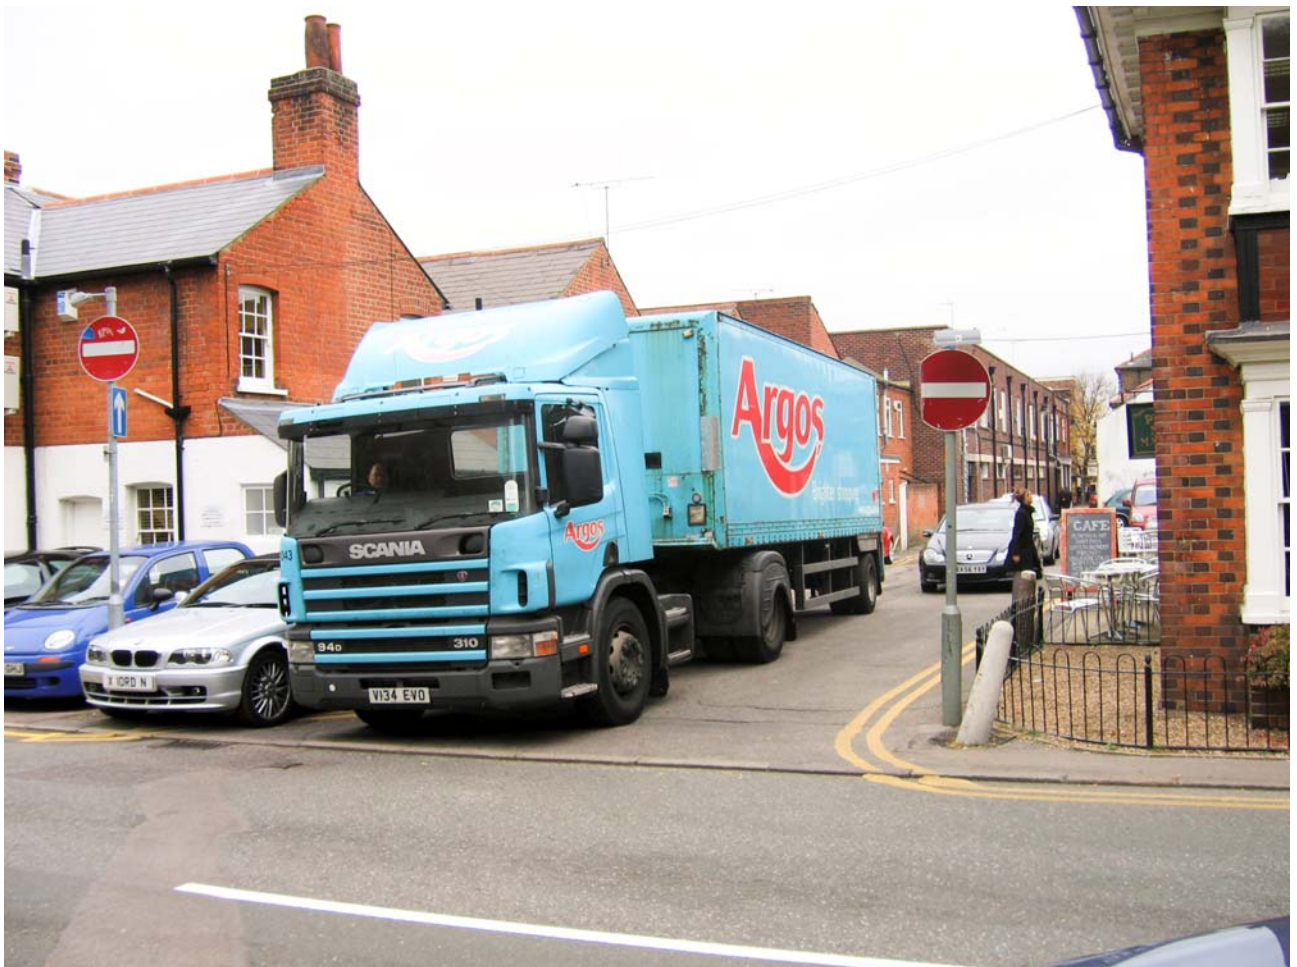
Fig. 66 Traffic jammed at the south end of Moors Place.

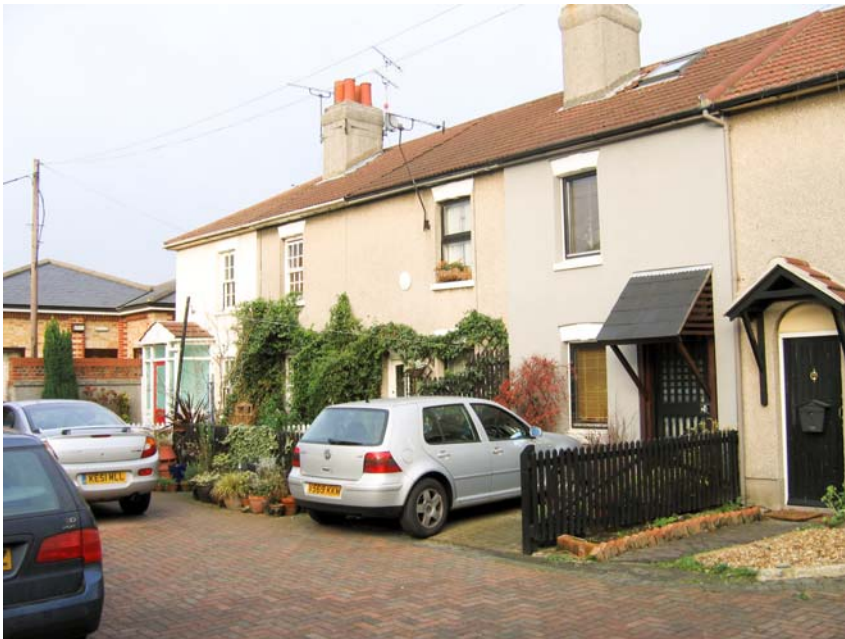
Fig. 69 Terraced cottages between Crown Street and South Street, the appearance of which has suffered from modern improvements.

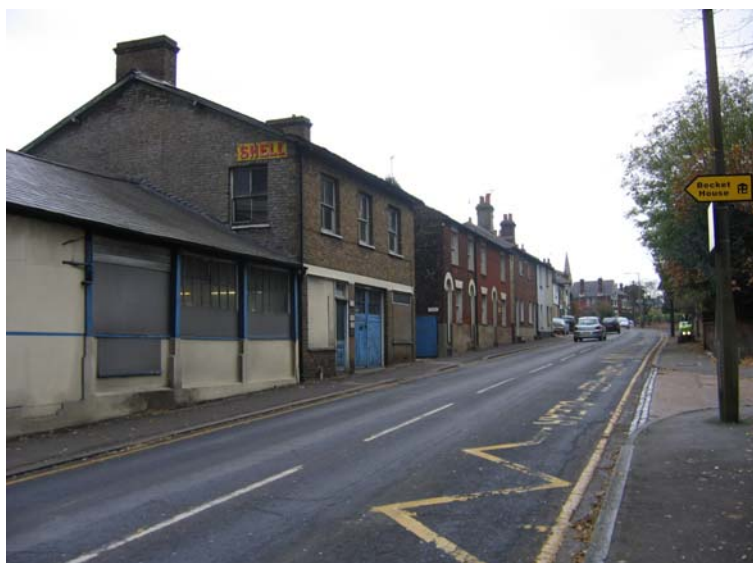
Fig. 70 Victorian terraces in Queens Road which would benefit from the protection of being included in the conservation area.

A small extension to the conservation area is proposed on the south side to include the block of buildings between Queen Street, Library Hill and Coptfold Road, and three shops on Coptfold Road by the junction with Alfred Road. These late 19th-century shops are relatively unaltered and form a good group. One has wide sash windows used to display wares. Behind them are some old outbuildings which contribute to the street scene. Unfortunately the terraced houses in Alfred Road have suffered badly with insensitive improvements, and it seems correct to omit it from the conservation area, though

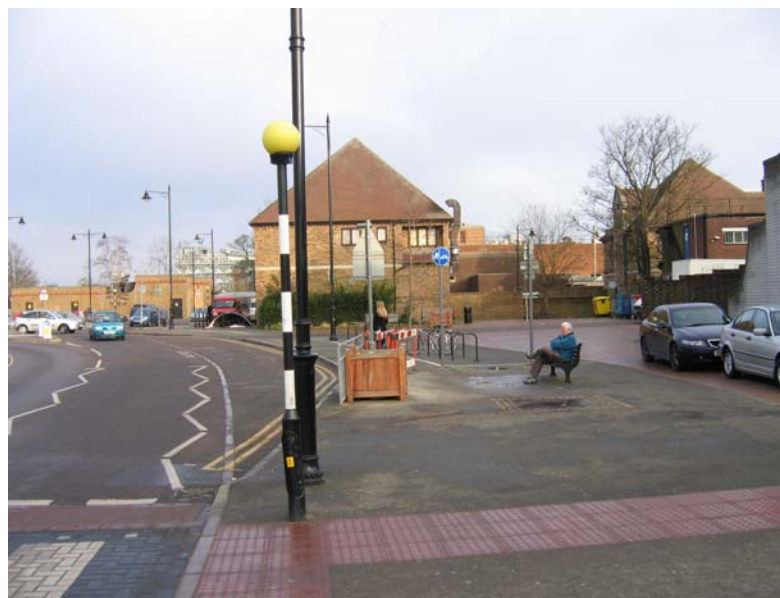
Fig. 73 That part of the William Hunter Way frontage included in the conservation area. The landscaping scheme here needs review and improvement.
