# HIGHWOOD HOSPITAL

## CONSERVATION AREA APPRAISAL AND MANAGEMENT PLAN

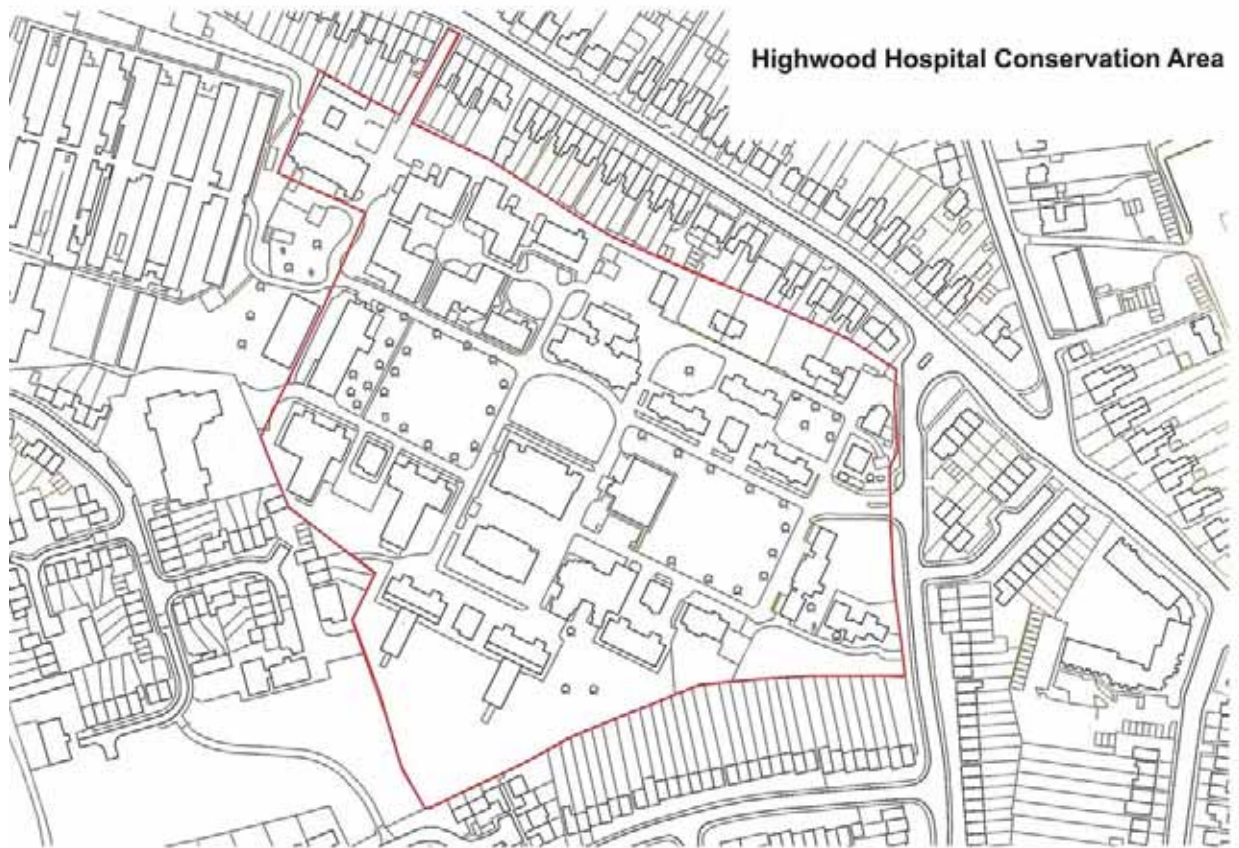
*Fig.1 Conservation Area Boundary*

The Highwood Hospital Conservation Area was first designated on 12 July 2001 and is one of thirteen Conservation Areas in the Borough. It covers an area to the south of the Ongar Road and lies between Geary Drive and Costead Manor Road. The Conservation Area centres on the area between East Green and West Green lying to the north of the South Access Road and to the south of the North Access Road (Fig.1)

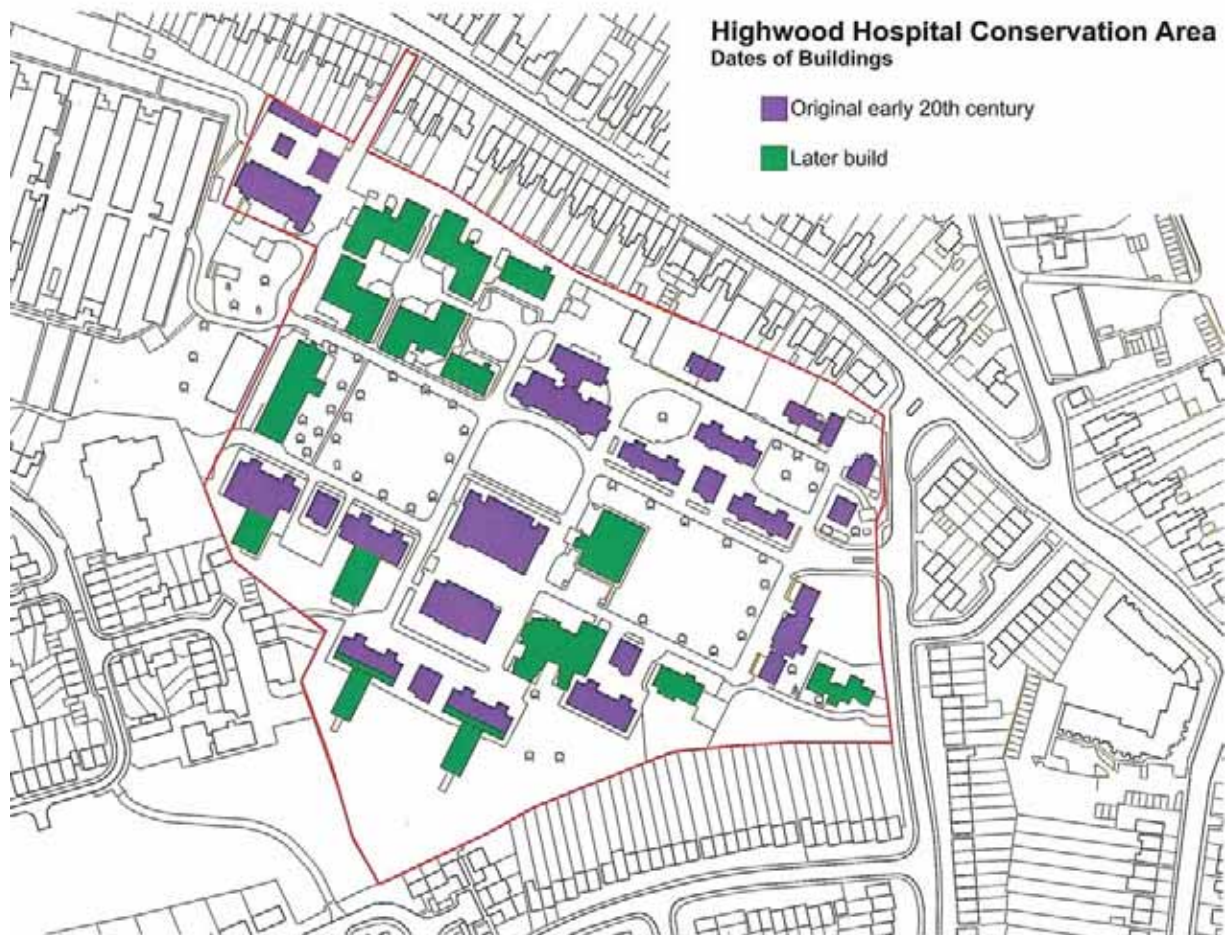
*Fig.2 Dates of Buildings*

the careful detailing gives it unique qualities. Although changes have been made to the buildings over time, at present, the character of Highwood's origin still remains. Many of the house cottage groups are still together and larger individual buildings still retain many architectural features (Fig.2)

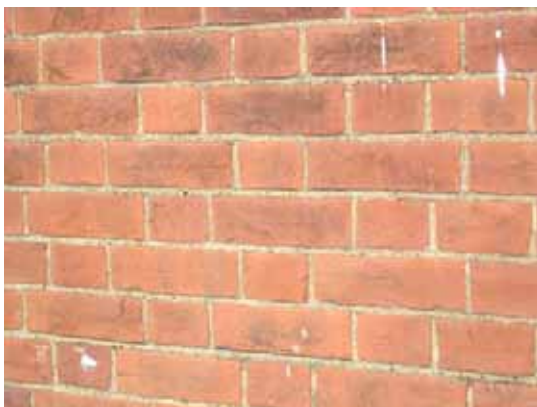
*Fig. 6 Example of brickwork*

The Henmans used a simple architectural style of soft red brick, Welsh grey slate, white painted windows and doors and stone window cills throughout the site.

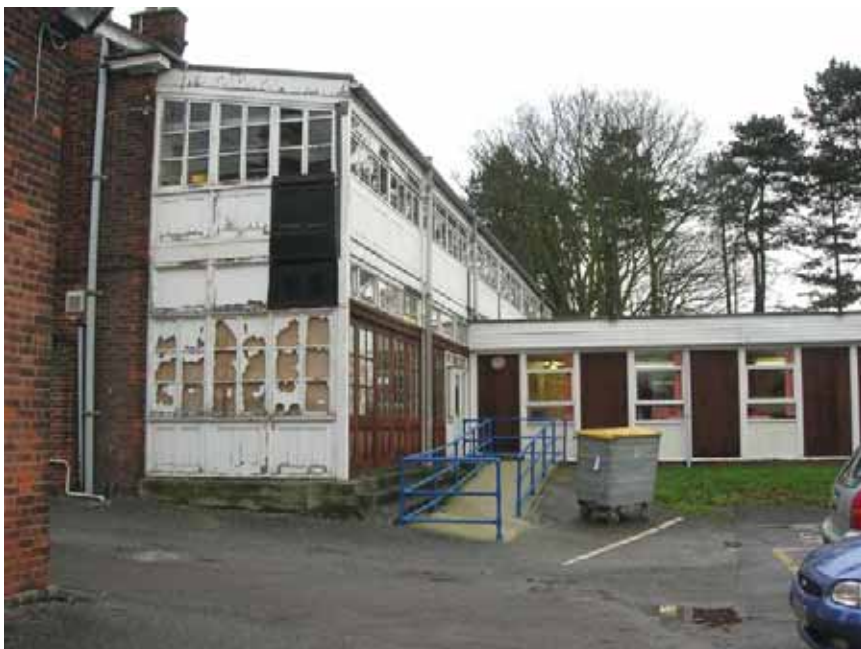
*Fig. 9 Ward extensions*

The early 20<sup>th</sup> century saw the introduction of the metal clad TB open air wards. In the later 20<sup>th</sup> century timber clad ward extensions were made to some of the buildings (Fig.9)

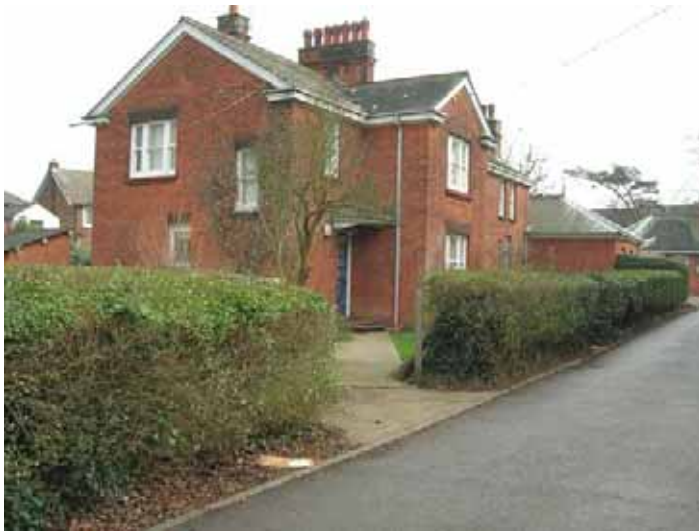
*Fig. 10 Gable roof*

The gable is the traditional roof form at Highwood's, (Fig.10) with brick as the external wall finish and slate as the original roof finish, though some plain tiles and synthetic slates have replaced the natural slate over the years. There are also a small number of 20<sup>th</sup> century bungalows that have concrete tiles on their roofs. The normal pitch for a slate roof is between 35 and 40 degrees, concrete tiles can accommodate a more shallow pitch.

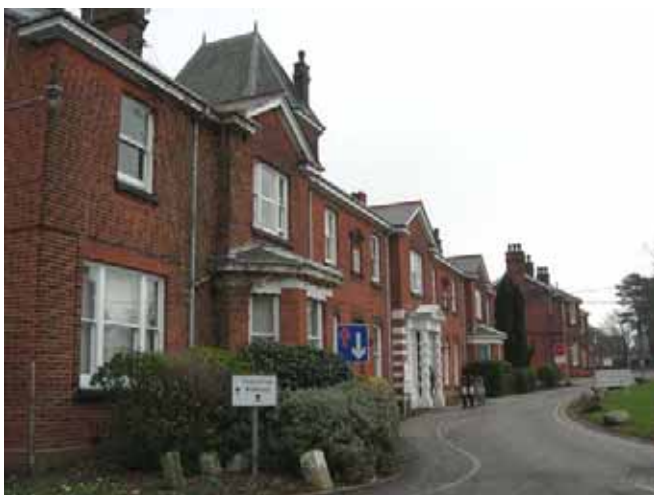
*Fig. 11 Roofscape*

The roofscape at Highwood Hospital is very interesting, (Fig.11) with a mixture of towering red brick chimney stacks, dormer windows, variety in height from single storey through to two and a half storeys and even a louvered ventilator crowned with a weather vane. The roofline is dominated by the central red brick water tower on the main administration office block.

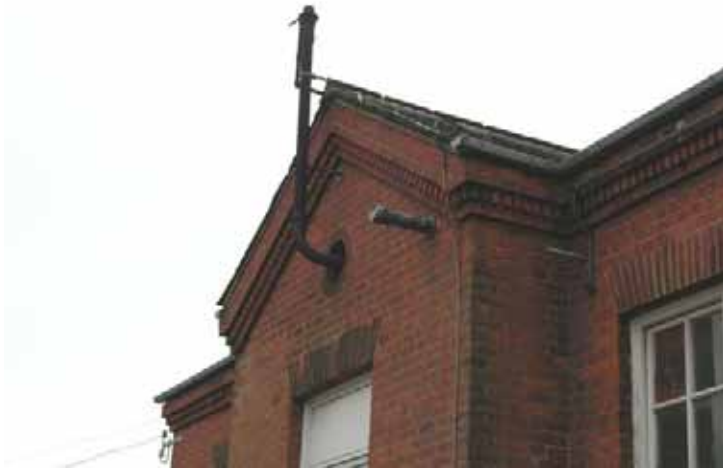
The original Henman buildings all have gauged arch heads to their window and door openings and traditional Flemish bond brickwork. There are also a number of denticulated brick eaves throughout the site (Fig.12). Stretcher bond brickwork can be seen on the modern buildings on the site and is monotonous in comparison to the traditional bond (Fig.13).

*Fig. 12 Flemish bond brickwork showing brick arches and denticulated eaves*

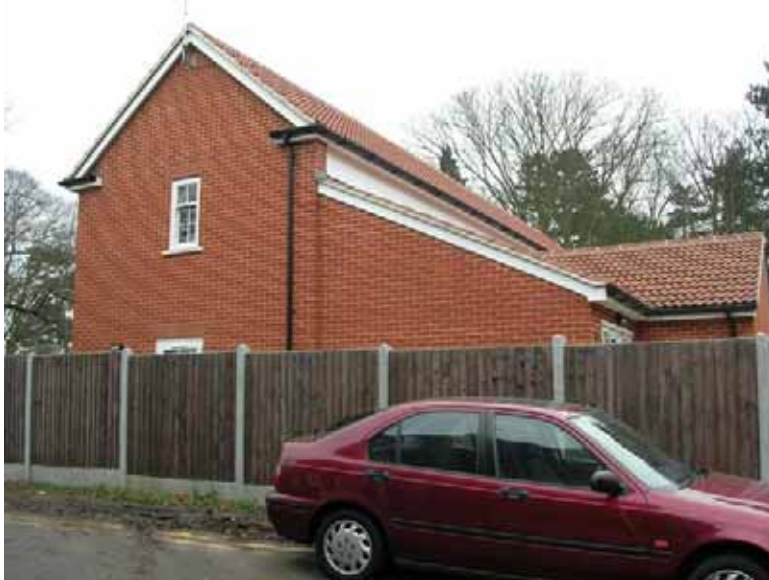
*Fig. 13 Stretcher bond brickwork*

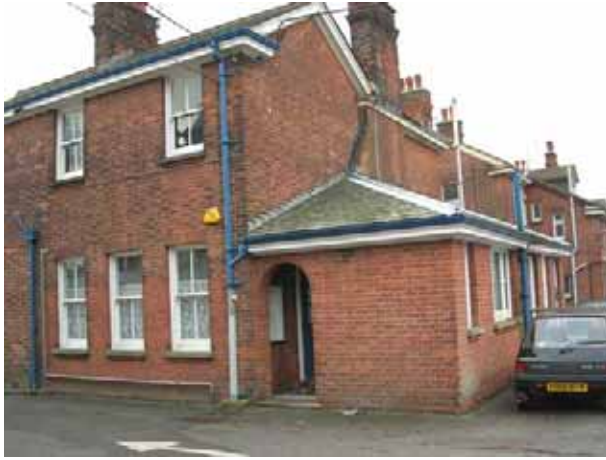
Windows vary from the traditional vertically hung sashes on the original buildings (Fig.14), followed by the Crittall metal windows on the 1930's veranda extensions (Fig.15), through to the modern casements on the 20<sup>th</sup> century new additions (Fig.16). To date no UPVC windows have been introduced.

*Fig. 14 Original windows*

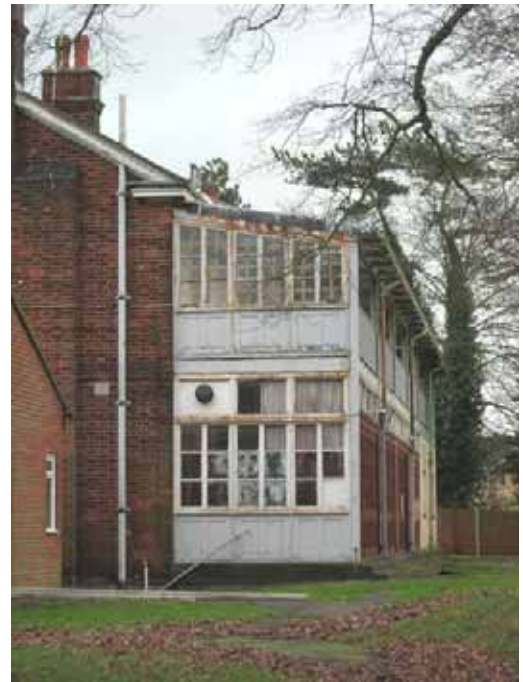
*Fig. 15 Crittall window*

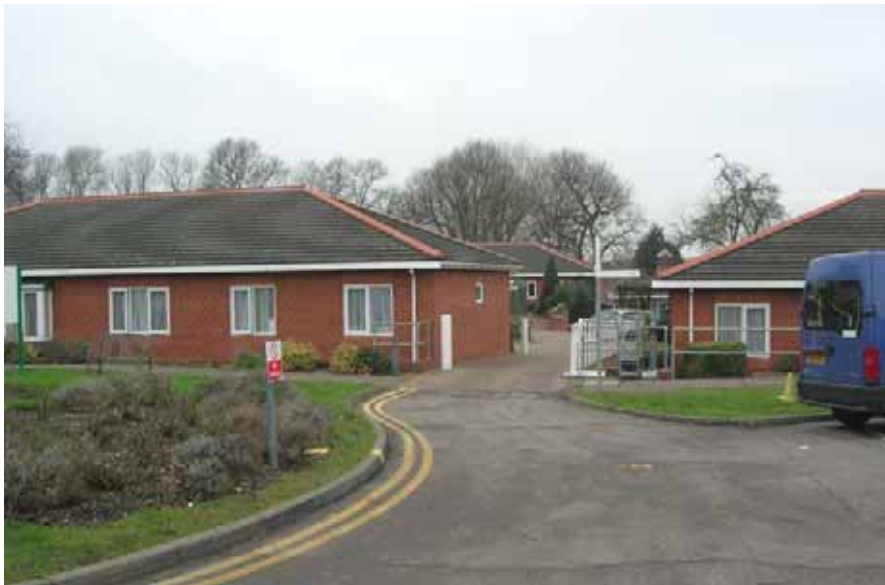
*Fig. 16 Modern casement windows*

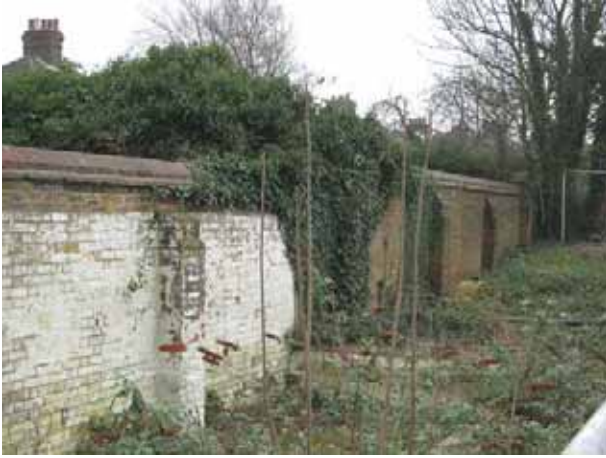
*Fig. 17 Original brick wall boundary*

Boundary treatments can make a significant impact on the Conservation Area. The Highwood Hospital site has a variety of boundary treatments, ranging from the original brick walls and piers (Fig.17), to traditional metal railings and gates (Fig.20), to modern metal and timber fencing (Figs.18 & 19). Within the site there are established hedges and trees, bollards, railings and modern timber fencing, but mainly the site is open plan around the central green areas.

**It is recommended that the mature hedging, trees and original brick walls and railings be retained in any future development of the site to preserve the character and appearance of the Conservation Area.**

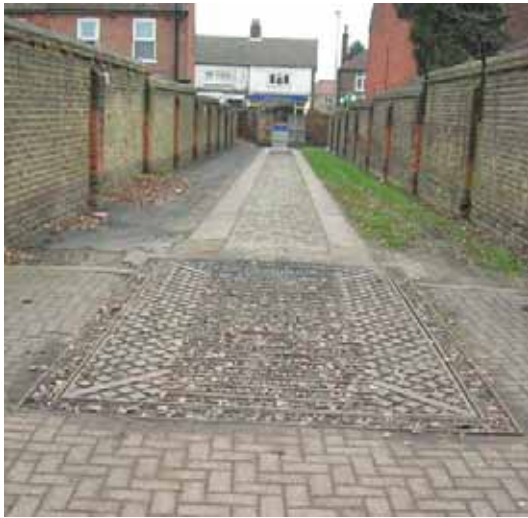
*Fig. 21 Original cobbled entrance from Ongar Road*

The roads through the site are mainly tarmac with concrete kerbs (Fig.22), but some original granite kerb stones remain along with examples of cobble paving (Fig.21)

**It is recommended that the features and character of this original access from Ongar Road should be preserved in any new development that might take place.**

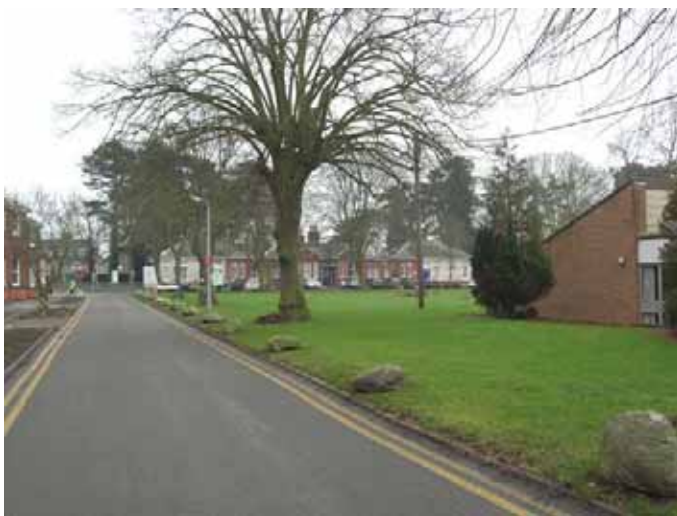
*Fig. 23 Established planting to east green*

The leafy suburban character is very much kept with the two large greens planted with established trees, shrubs and flower borders (Fig.23).

**It is recommended that these strong open green areas, the established trees and shrubs within the greens, and the very strong mature tree boundary to the Conservation Area giving separation to the surrounding modern housing, should be retained in any new development that might take place.**

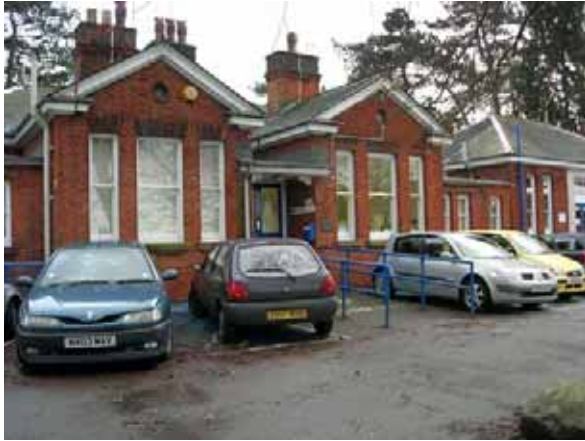
*Fig. 28 Cedars Day Ward*

Entering the Conservation Area from Geary Drive and turning left, this three block building is the first you come to. Cedars Day Ward (Fig.28) is an original Henman building but not a design that is replicated elsewhere on the site. The building consists of three blocks connected by short corridor links. It is built in the soft red bricks used throughout the site and has the characteristic slate roof, but unusually, both the north and south blocks have rendered facades. The main entrance is flanked by gabled projections, but each block has a hipped roof. Cedars faces the east green and is in a very prominent position at the eastern end of the Conservation Area backing on to Geary Drive. A small modern brick extension has been added to the rear of the central block. Internally the entrance doors are original, but very few other details remain.

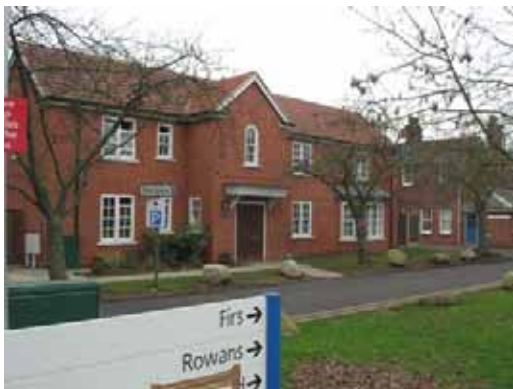
*Fig. 29 Geary House*

Geary House (Fig.29) is a modern brick built house probably of the 1980s and is situated in the south east of the Conservation Area. It has tried to imitate the Henman design with the brick aches above the windows, the canopy over the front door and the bay window to the front elevation, but has failed on other important details such as the stretcher bond brickwork instead of the Flemish bond used by Henman. Also the pan tiles on the roof are an alien material used nowhere else in the Conservation Area and the windows have small panes of glass unlike the rest of the buildings on the site. It is unfortunate that more care was not taken with the detailing of this building as it is in a very prominent position at the beginning of the south access drive.

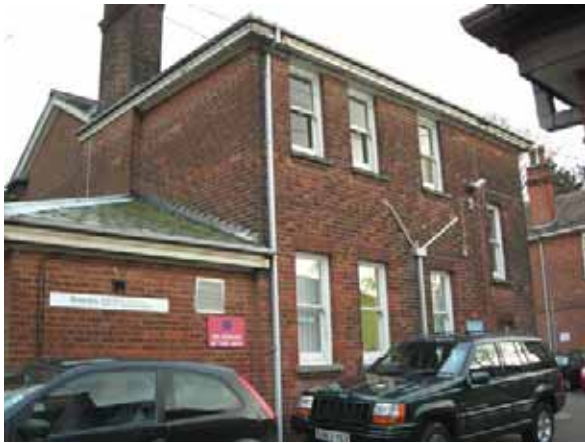
*Fig. 30 Rowans*

Rowans (Fig.30) is an original Henman design, built in Flemish bond soft red brickwork with a slate roof. It follows the building line of Geary House and looks out onto the east green, sitting to the north of the x-ray building and to the east of Firs ward. This building was originally the cottage for the charge nurse.

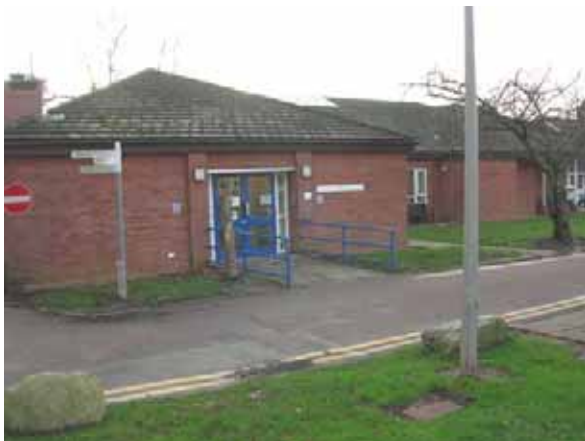
*Fig. 31 Firs Ward*

Firs Ward is a late 20<sup>th</sup> century, single storey building (Fig.31). It is still built out of red bricks but in modern stretcher bond and not the traditional Flemish bond brickwork of the original Henman buildings. It also has a concrete tiled roof and not the traditional slate. Although the materials used on this building could have been more sympathetic to the Henman design, It does sit relatively comfortably within the Conservation Area without making too much of an impact. This building is in use as a ward.

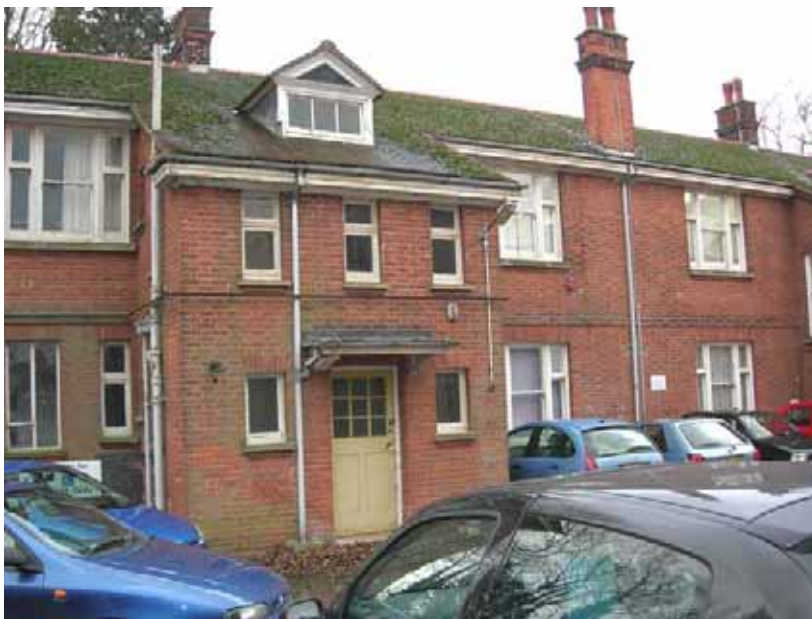
*Fig. 32 X-Ray*

The x-ray building sits back from the South Access Road behind Geary House and Rowans (Fig.32). It is built of Flemish bond soft red brickwork but the original slate roof has been replaced with machine made plain tiles. The two projecting entrance bays, east and west, both have denticulated brick eaves and original canopies over. The west entrance has the addition of modern handrails leading to the door. A rear extension comprising of a two storey veranda and balcony were added in 1937. Other verandas on the site have more recently been extended, but this one remains relatively unaltered and complete with the first floor balcony open sided to the south. Both ground floor windows on the east elevation have been replaced with metal casements. Internally many original details remain including cast iron fire surrounds, cupboards, windows and doors. Part of this building is used as an x-ray department and part of it is currently not in use.

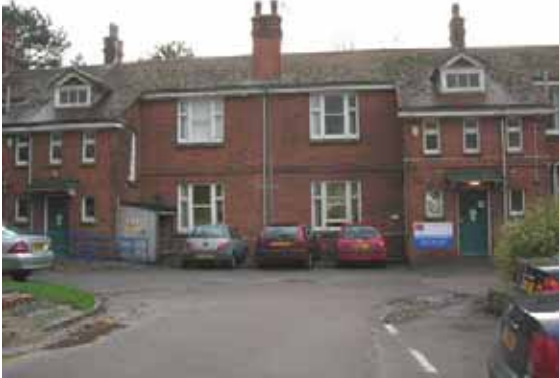
*Fig. 33 Maple*

Maple is an original Henman building (Fig.33), built of Flemish bond soft red brickwork and originally would have had a slate roof, but this has been replaced with machine made plain tiles. It has a 1937 veranda and a further 1971 extension to the south elevation. A concrete ramp and handrails lead to this later extension. The north elevation has two projecting entrance bays with original canopies over both doors, and a modern concrete ramp and handrail to the east entrance. Original staircase and doors are remaining internal features. Part of this building is in use as a day centre.

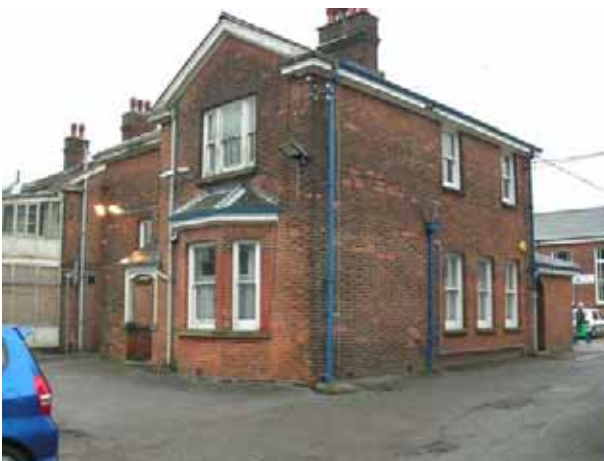
*Fig. 34 Estates Office*

This is an original Henman building built of soft red Flemish bond brickwork and still has its original slate roof (Fig.34). The main entrance is on the south elevation and it has an original bay window and porch over the door. A modern timber ramp accesses the north elevation. The east elevation has an original

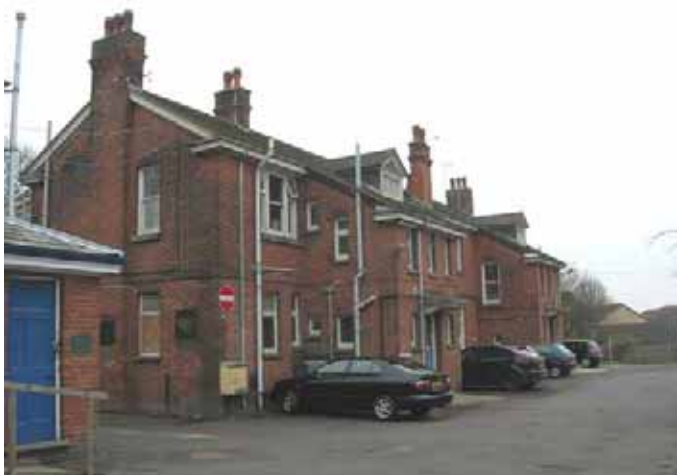
*Fig. 35 Cherry*

Cherry is another original Henman building of soft red brick in Flemish bond, but its original slate roof has been replaced with machine made plain tiles (Fig.35). The west entrance has two projecting porches both with original dormer windows to the roof and canopies over the doors. The rear of Cherry has a 1937 part glazed veranda and balcony with a single storey 1971 extension attached. Internally original doors, staircase and cupboards remain. This building is currently not in use.

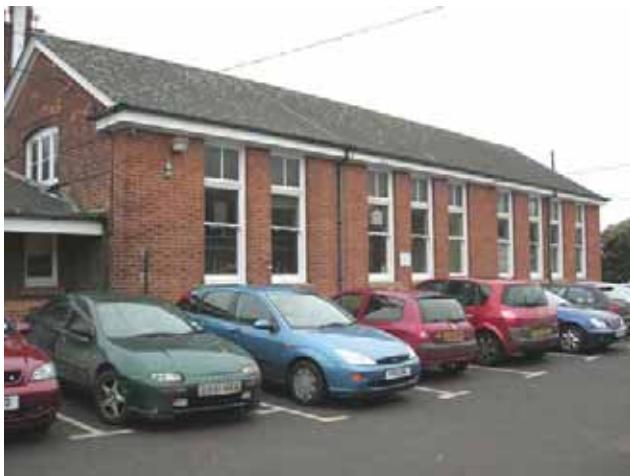
*Fig. 36 Occupational Therapy*

This original Henman building was built as the Infants School in the traditional style of soft red brick walls and slate roof (Fig.36). Its original slate roof has been replaced with synthetic slates that do not give the building the same character. Synthetic slates also tend to attract moss and lichen where traditional slate does not. The main entrance has a modern concrete ramp with handrails as the access. Internally, original doors, roof lights, wall brackets and architrave remain. The main hall was originally open to the roof with high level sash windows between columned bays.

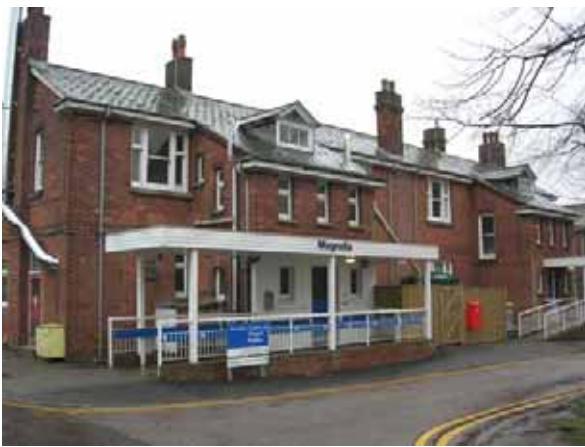
*Fig. 37 Magnolia*

Magnolia is built of soft red brick and has a replaced slate roof, but is an original Henman building (Fig.37). It has east and west projecting bays with dormer windows to both. There are modern canopies over modern covered walkways to both entrances. A recent single storey brick extension has been added to the rear of the building for use as a staff canteen. An original staircase remains internally, but sadly most other original features have been removed when this building was modernised.

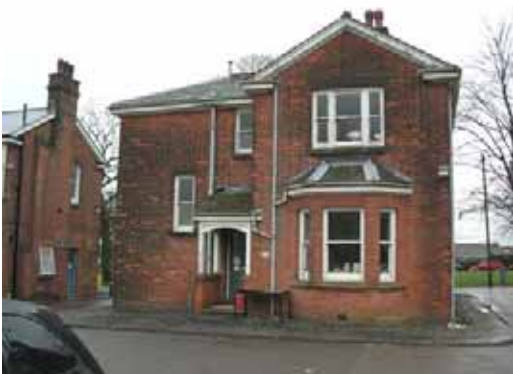
*Fig. 38 Poplar Madigans*

This original Henman building is built in Flemish bond soft red brickwork and has a replacement slate roof (Fig.38). The south elevation has an original bay window and porch over the front door. The rear has a single storey element with a brick arch entrance very similar to the Firs Staff House, but without the addition of the modern walkway. Internally the staircase is original, as are doors, windows, cupboards and architrave.

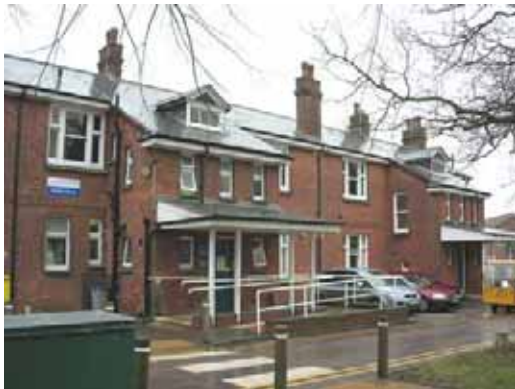
*Fig. 39 Poplars*

Another original Henman building in the style of the two projecting entrance bays and original dormer windows, all in red Flemish bond brickwork but with a replacement synthetic slate roof (Fig.39). The Poplars has the addition of modern canopies to both east and west entrances, and a modern concrete ramp and handrails to the east. A door has been inserted in place of two small windows in the west end of the front elevation leaving a noticeable repair to the brickwork. A modern rear single storey extension has also been added with a concrete access ramp. Many internal modern alterations have been carried out with the loss of original features.

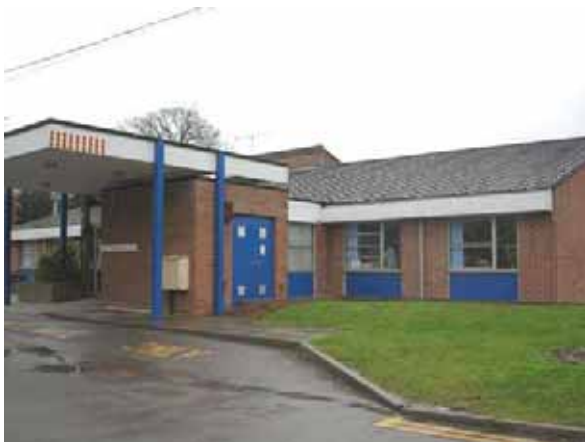
*Fig. 40 Day Hospital*

The day hospital is a single storey red brick building in modern stretcher bond and with concrete tiles on the roof (Fig.40). It was built in 1974 as a geriatric day hospital. It has a slack pitched roof element to the front and rear but in the middle a flat roof runs the full length of the building. This is not in the same style as the Henman buildings or indeed the other 20<sup>th</sup> century buildings. Although it sits low between the east and west green it is in a prominent position in the Conservation Area and interrupts the vista from all angles of the site.

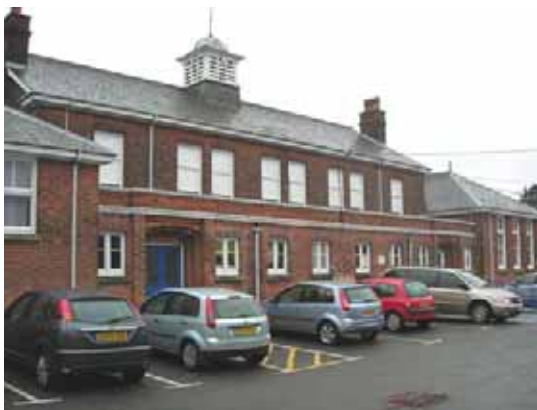
*Fig. 41 Physiotherapy Ward*

This was originally built by Henman as the Senior School and is currently used as a physiotherapy unit (Fig.41). It is built of red Flemish bond brickwork with a slate roof and unusually, a louvered ventilator on the roof crowned by a weather vane. The north elevation shows a single storey element and one and a half storey wings to each end with an east and a west entrance. The east entrance has good recessed brickwork to the doorway, but has the addition of a modern concrete ramp. The red brick chimneys are a dominant feature of this building. Internally many original features remain such as glazed brickwork, fireplaces, doors, windows and cupboards.

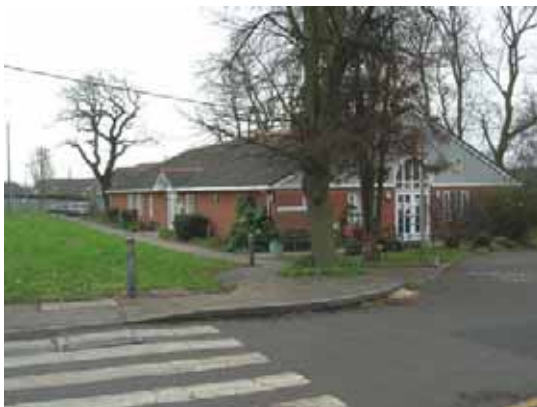
*Fig. 42 Brambles Surgery*

This modern single storey doctor's surgery sits at the western edge of the Conservation Area and backs on to an established line of trees marking the boundary line between the Conservation Area and Little Highwoods (Fig.42). Brambles is built of modern stretcher bond red brickwork with concrete tiles on the roof and a modern corrugated steel sheet to each gable. The main entrance faces the west green. This building is surrounded by established trees and shrubs and although very modern has little impact on the Conservation Area.

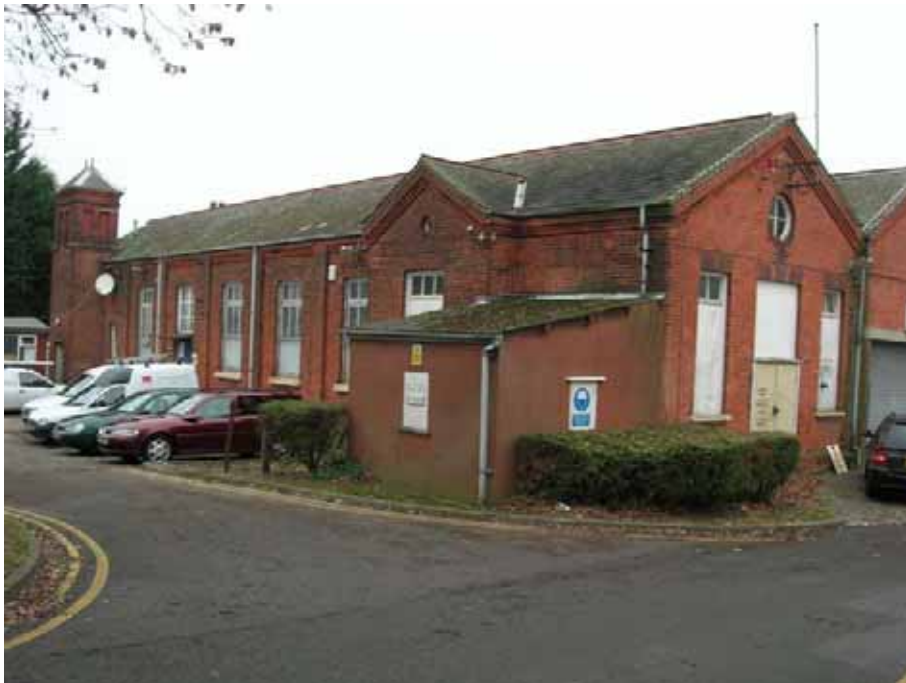
*Fig. 43 Workshop*

The workshop sits in the north western corner of the Conservation Area and is an original Henman designed building although there is a later single storey lean-to extension to the south elevation (Fig.43). This elevation also has a projecting gable, a common Henman feature, and a not so common feature, a square turret with pyramidal roof. The west elevation also has the unusual feature of a chimney stack sitting between the two gable ends. There is a good arched entrance to this elevation. Denticulated brick eaves and flat arches above the windows are very good detailing. The east elevation has a steel roller door inserted into an original opening that has glazed bricks on the reveals. Although mostly boarded up, the original windows remain. Internally the original glazed brickwork covers most of the building. A modern mezzanine floor has also been inserted internally, but the five cast iron columns holding up the original timber roof survive.

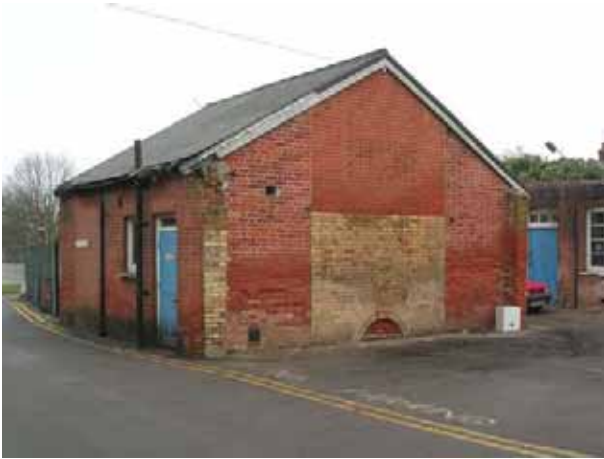
*Fig. 44 Gardeners Stores*

This original Henman building was a store and incinerator (Fig.44). Up until quite recently a large circular brick chimney stood on its east elevation. The store has been re-roofed at some time using synthetic slates. Internally the original furnace door survives.

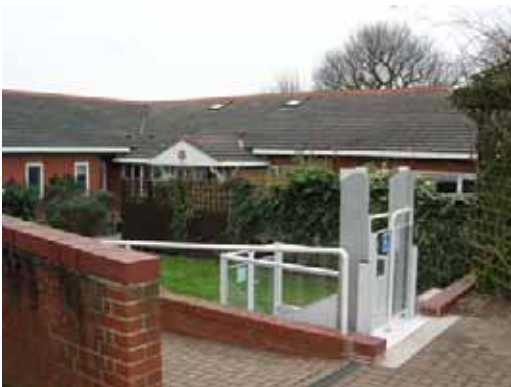
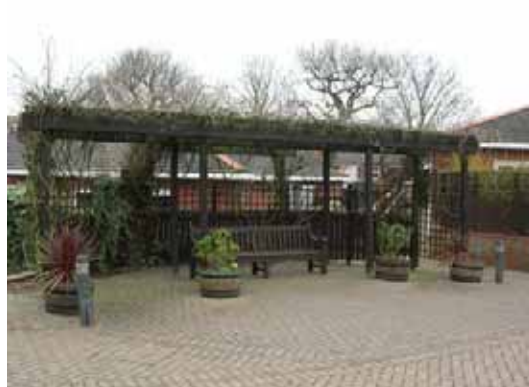
*Fig. 45 & Fig. 46 Buildings surrounding the courtyard*

These are all modern single storey red brick buildings, in stretcher bond brickwork that have a slack pitched concrete tiled roof. They are built around a block paved central courtyard with modern ramp and lift disabled access (Figs.45&46). The buildings have a mixed use as offices and day centres and surround a well designed courtyard of hard and soft landscaping. Although these are very modern buildings and not in the Henman style, an effort has been made to landscape this block of buildings so that they have a minimum impact on the Conservation Area.

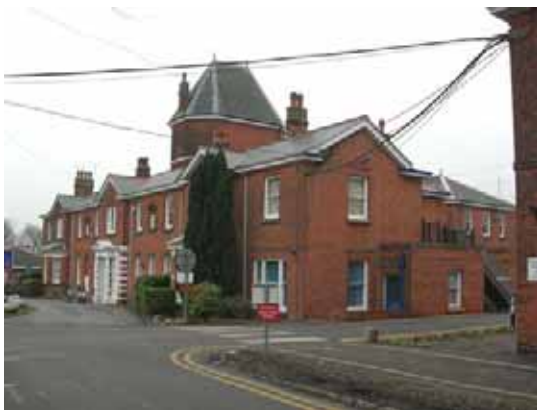
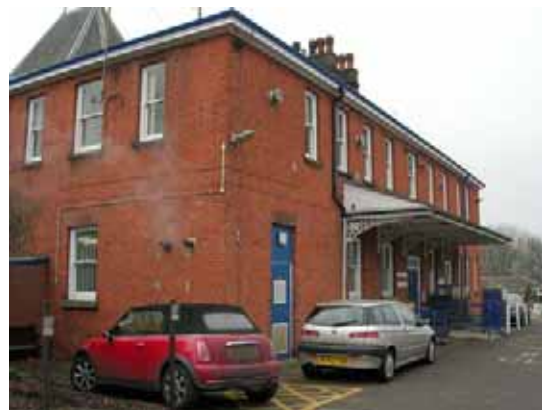
*Fig. 47 Front of Administration Unit*

The administration block is central to the Conservation Area and faces west green. This is a very prominent building that has central and east and west projecting gables to the south elevation (Fig.47). The east and west gables have bay windows to them, and the central gable has the projecting white painted stone door case with the central water tower behind. There are two stone panels either side of the main entrance, one showing the initials MAB and the other with the date 1903. To the eastern elevation there is a flat roof extension, a very modern lean-to store and metal stair fire escape. A substantial amount of cast iron soil and vent pipes also survive here. To the rear an impressive original 5 bay canopy on cast iron brackets survives and faces a car park (Fig.48). The east wing of the administration block has been recently re-slatted. Internally this building is relatively unchanged and has an impressive original stone staircase with cast iron balusters, along with the original timber and glazed entrance door and screen. Large sections of terrazzo floor also remain internally along with architrave, fireplaces, cornice and picture rails, cupboards and doors. This building is relatively unspoilt both internally and externally and this should be taken into consideration in any future re-development of the site.

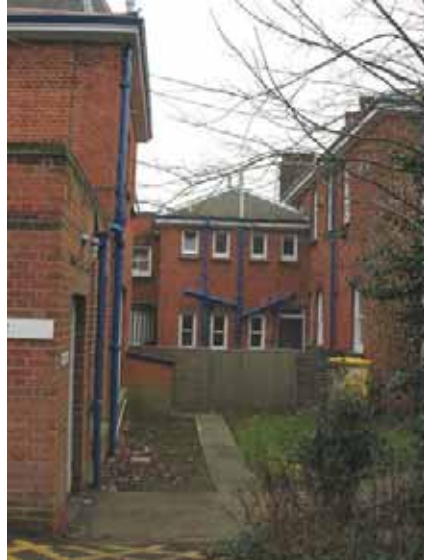
*Fig. 49 Limes 3 & 4*

Originally the West Double Cottage, this Henman building replicates the East Double Cottage, again with the south elevation facing the green. An unaltered building as is the east cottage. Original cast iron down pipes survive at the rear (Fig.49), but the concrete disabled access ramp is a modern addition. Original cupboards, staircase, doors and architrave remain internally.

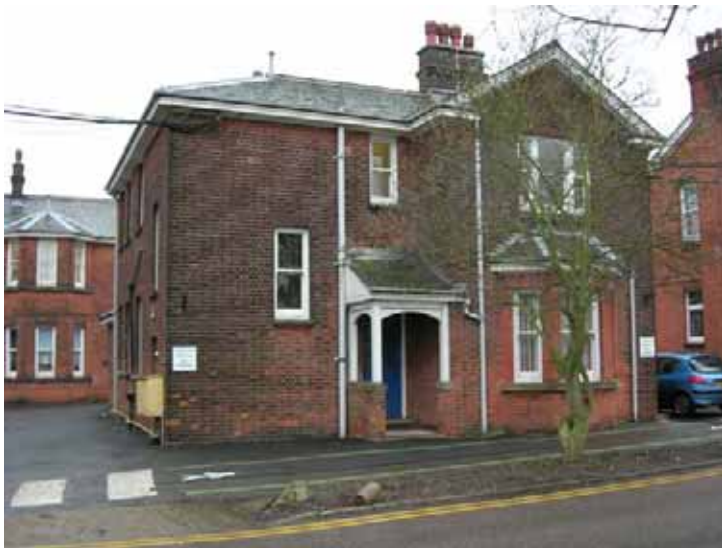
*Fig. 50 Limes Grove House*

Moving west along the North Access Road and in line with the committee rooms is a Henman building originally known as the cottage for the charge nurse (Fig.50). Its south elevation also faces the east green and it has an original bay window and original canopy over the main entrance. There is a single storey element to the rear with a modern metal ramp leading to the arched rear entrance. Original cast iron fireplaces, doors, architraves and stairs remain internally.

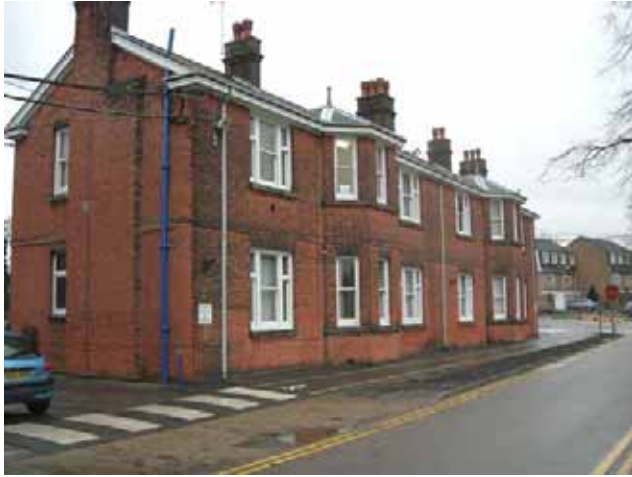
*Fig. 51 Limes Committee Rooms*

This original Henman building built of red brick with a slate roof has five red brick chimneys dominating the roofline (Fig.51). It is a large building with its south elevation facing the east green and it has east and west projecting bay windows. The north elevation has the projecting east and west entrances with original canopies over the doors and dormer windows in the roof. Internally many modern partition walls have been inserted, but original staircase, doors, architrave and fireplaces still remain.

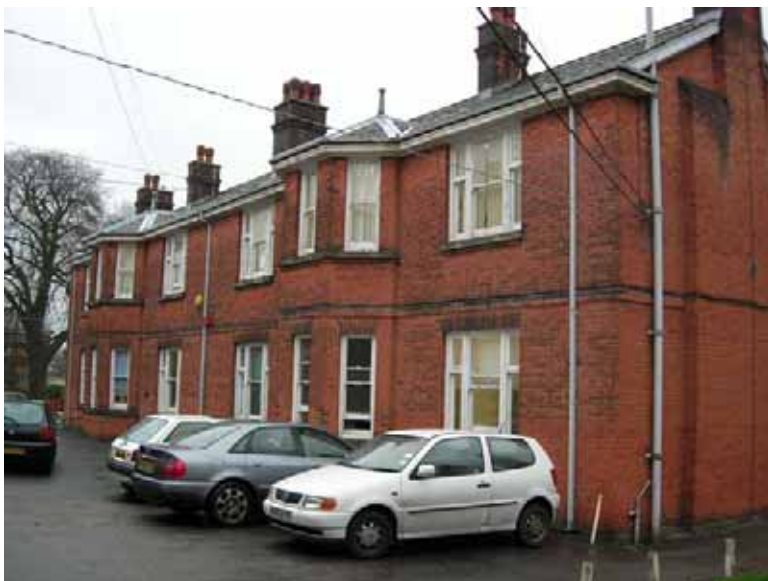
*Fig. 52 Brentwood Community Clinic*

Currently used as a community clinic (Fig.52), this is an original Henman building in the same style as the other double cottages on the site and sits to the north of Limes Grove House which faces the east green. Externally, it is the original build except for the addition of a concrete access ramp to the rear and a very small modern brick extension to the west elevation. Internally there are modern partitions and ceilings but original cupboards, doors, staircase and architraves remain.

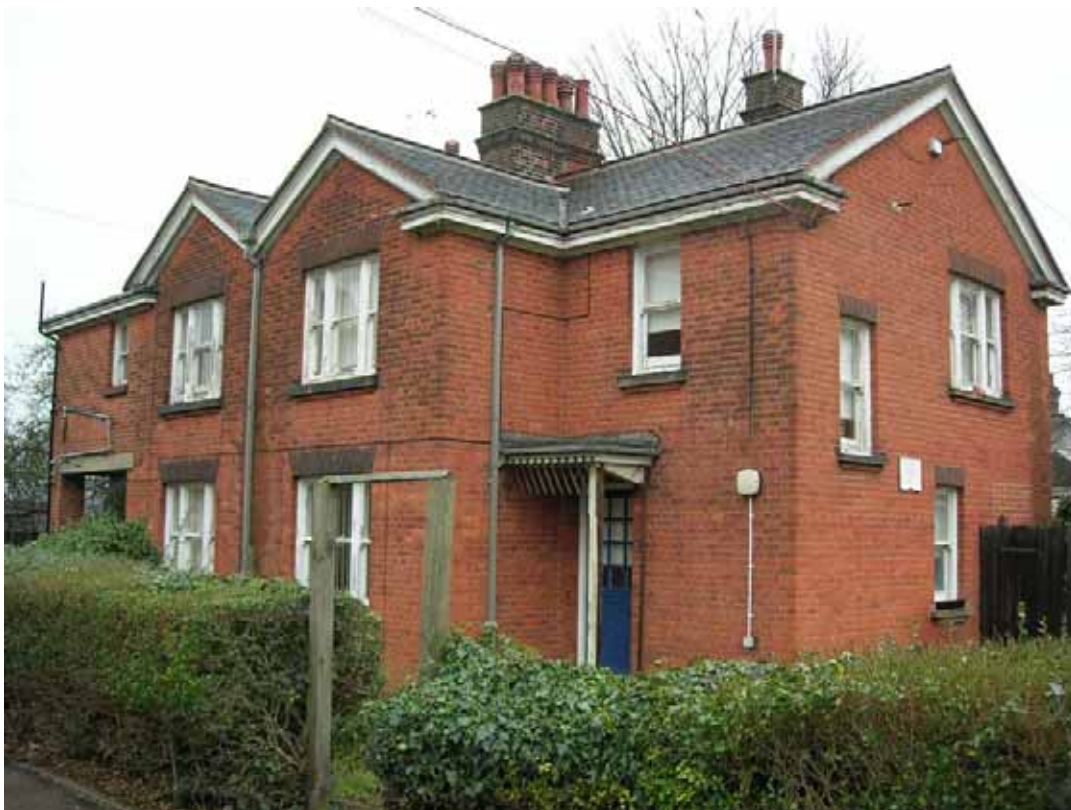
*Fig. 53 Staff Cottages 3 & 4*

Moving west are two more semi detached staff cottages of the original Henman build (Fig.53). Cottage 3 is to the right and cottage 4 to the left. A first floor flat roof extension above the ground floor entrance to cottage 4 is very noticeable as not being a traditional Henman design. Like staff cottages 1 & 2, the rear gardens back onto the northern boundary of the Conservation Area and the gardens of the houses facing Ongar Road. Internally, original staircases, doors, architrave and fireplaces survive.

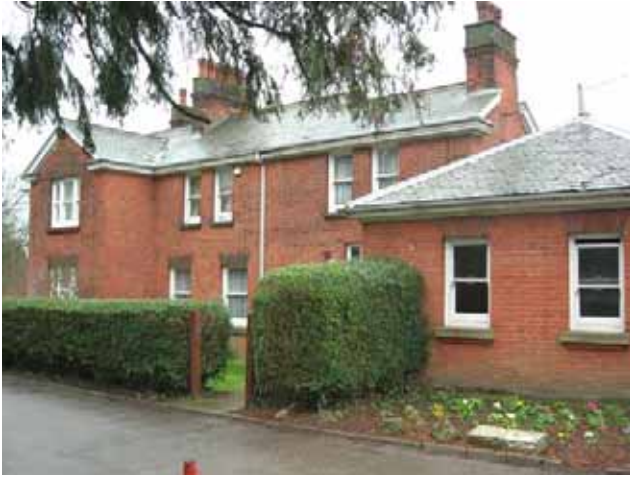
*Fig. 54 Staff Cottages 1 & 2*

To the rear and north east of the community clinic there are a pair of semi detached cottages originally designed by Henman as staff accommodation for the porter and carpenter (Fig.54). Cottage 1 is on the left and cottage 2 on the right with their rear gardens as the northern boundary of the Conservation Area backing onto the rear gardens of the houses on Ongar Road. Established hedges and trees form the front and rear boundaries to this pair of cottages. The rear entrance porch to cottage 1 has been rebuilt along with the addition of a modern small brick shed. Two modern windows have been inserted to the rear elevation of cottage two. The original 70 ton coal store which is linked to cottage 1 originally had large door openings which have been bricked up and smaller doors inserted at some stage. The coal store was designed in the same style as the rest of the buildings across the site. Internally, original staircases, cupboards, architraves, skirting and cast iron fireplaces survive in the cottages.

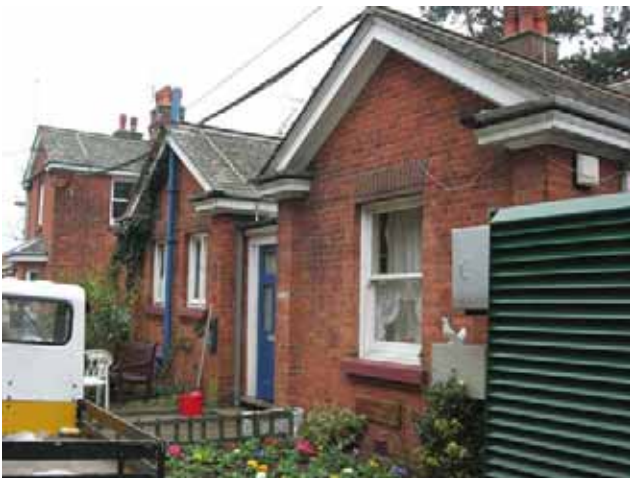
*Fig. 55 Gate Cottage*

Built as the Porters Lodge, this is an original Henman building sitting at the north eastern corner of the Conservation Area next to the original hospital entrance (Fig.55). The eastern entrance to the cottage has been rebuilt and a modern window and door have been inserted, but the original walled garden and outside toilet remain along with two small circular windows overlooking the original main entrance. Internally, the original staircase, cupboards, panelling, cornice, picture rail and flooring remain.

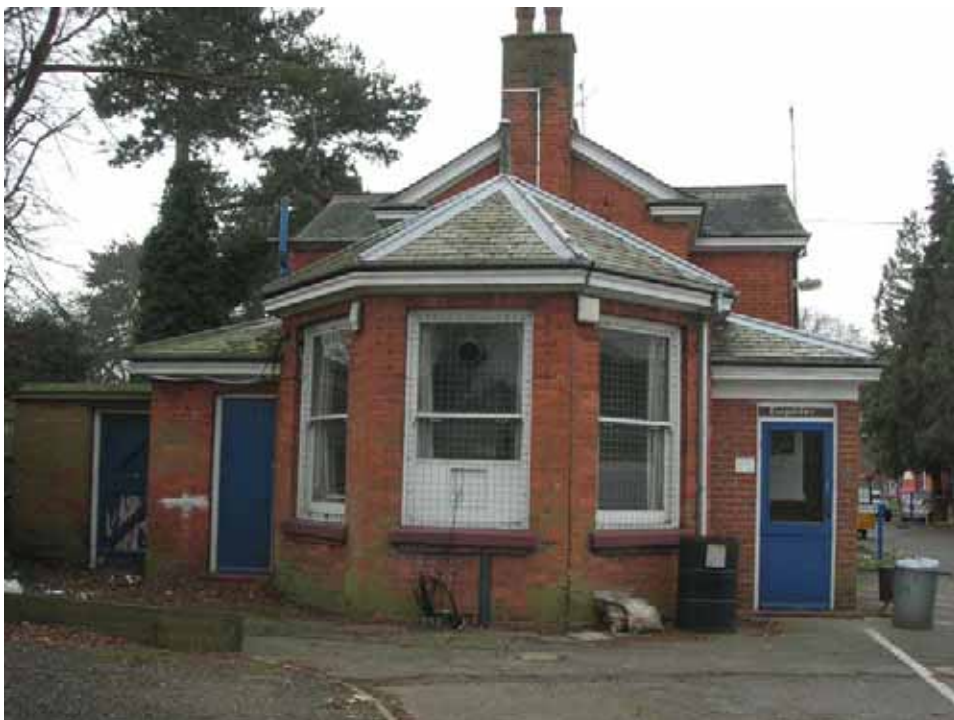
*Fig. 56 Porter's Lodge*

Built by Henman as the Receiving Rooms in the traditional style of red Flemish bond brickwork and grey slate roof (Fig.56), this building sits on the north eastern boundary of the Conservation Area and backs onto Geary Drive next to the main entrance to the hospital. This building is one and a half storeys high with two small projecting wings with entrance door between. A small memorial garden area bordered by a tiny picket fence is between the building and the access road. Unfortunately a new substation has been built between this building, now used as the caretakers flat, and the main access drive restricting the view to the north elevation of the Porters Lodge, Gate Cottage and the north eastern boundary of the Conservation Area. Internally original door architrave, cove ceiling and flooring remain.

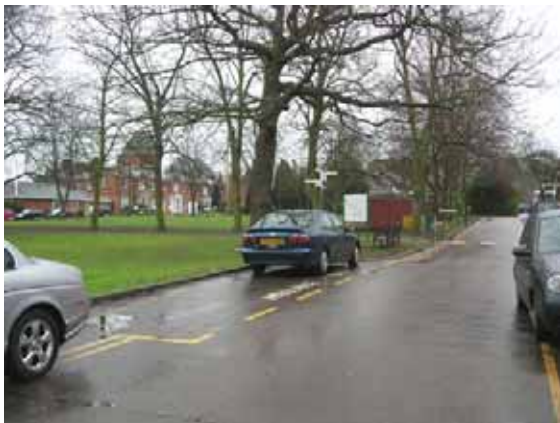
*Fig. 57 view across the east green*

The public open spaces within the Highwood Hospital site are the east and west greens. These are the centre of the Conservation Area and around which the buildings were designed. The greens feel spacious with established trees lining the sides which soften the views to the buildings from one side to the other (Fig.57). Large stones line both greens that have become a feature of the Conservation Area which need to be taken into consideration in any future development of the site. Flower beds also run along the north and south access roads to give separation between the road and the pavement.

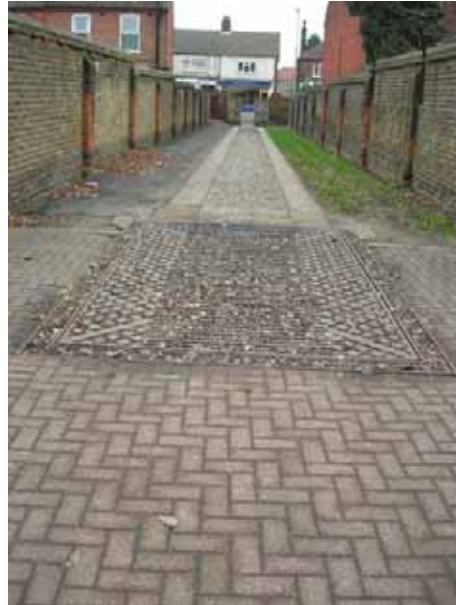
*Fig. 58 Original access from Ongar Road*

The pedestrian access leading from Ongar Road into the Conservation Area at the north-west corner is an alley between two houses fronting Ongar Road, with original brick boundary walls to both sides and a cobbled carriageway that gives character to vistas both in and out of the Conservation Area.
