# HIGHWOOD HOSPITAL

## CONSERVATION AREA APPRAISAL AND MANAGEMENT PLAN

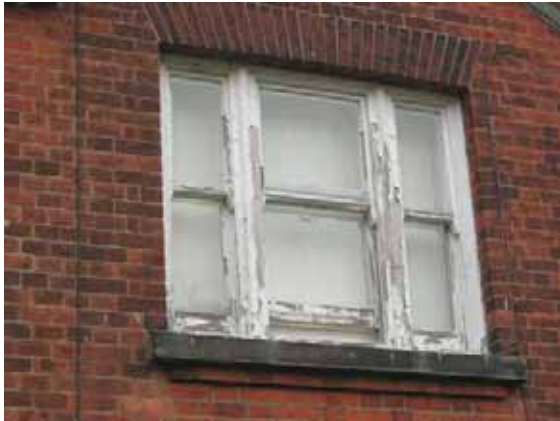
The condition of the external paintwork to windows and doors throughout the site is very poor (Fig.59). Lack of maintenance to external rainwater goods, drains and internal plumbing has resulted in some buildings with damp problems which left unattended will result in the loss of original brickwork. A number of repairs to the brickwork using cement have already taken place causing the loss of the original brick. A general rise in ground levels, and the laying of impermeable surfaces such as asphalt against soft red brick walls (Fig.60), has also led to rising damp problems in many buildings.

*Fig. 59 general condition of windows throughout the site*

**The recommendation is to implement an ongoing maintenance programme within the site to prevent further deterioration to the buildings.**

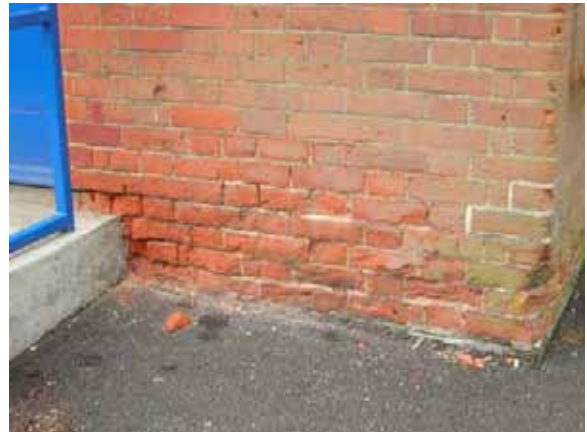
*Fig. 60 loss of brickwork through change of ground level*

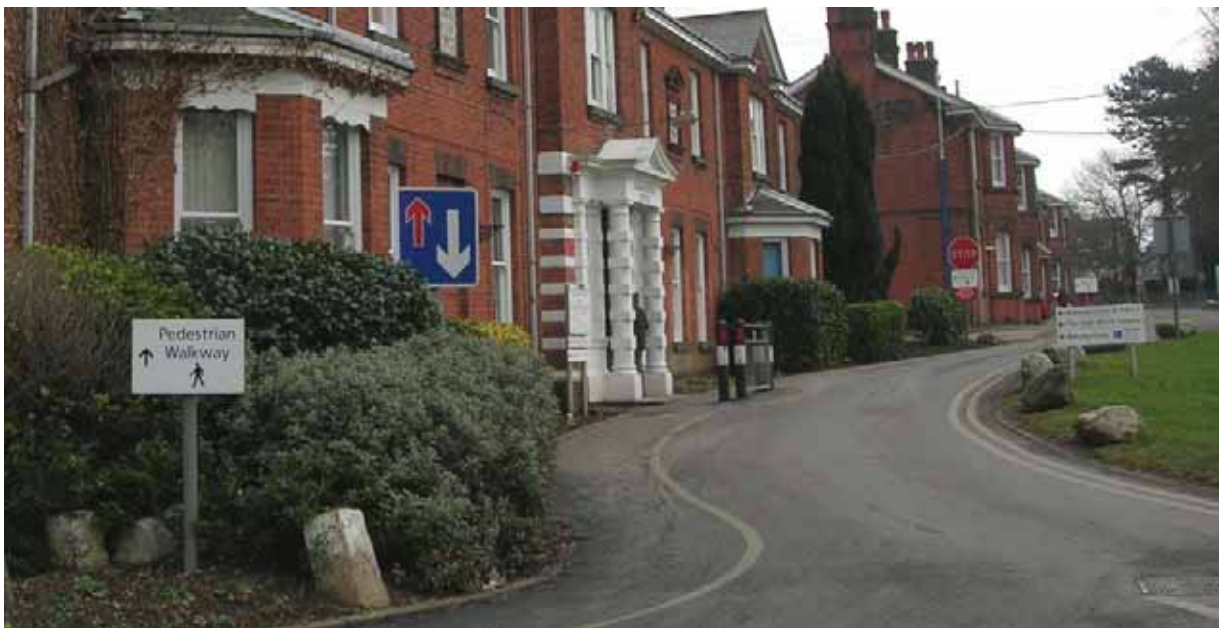
*Fig. 61 signage*

The present heavy signage presence (Fig.61) within the Conservation Area due to the hospital use, has an adverse effect on its appearance.

**The recommendation is that in any future development within the site, signage should be kept to a minimum to preserve the character of the Conservation Area.**

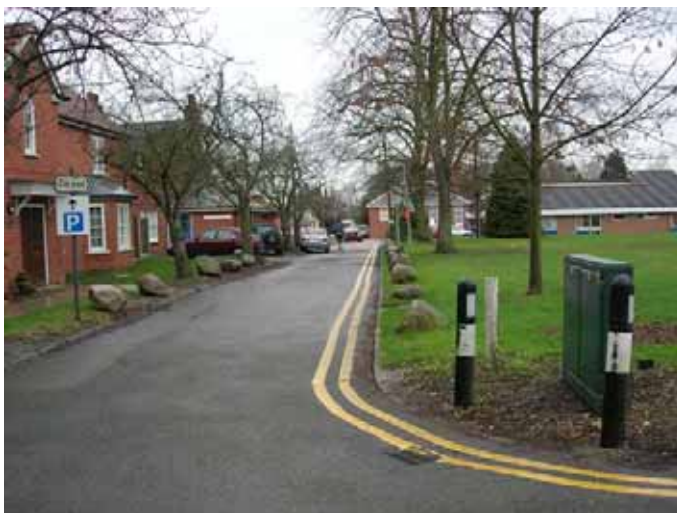
*Fig. 62 South Access Road*

The access roads through the Conservation Area are not wide enough for two way traffic (Fig.62), so this in itself is traffic calming. Also the present uses and amount of signage prove to be a form of traffic calming as people are trying to find their way around the site. There is currently vehicular access through to Little Highwoods.

**It is recommended that road widening should not take place in any future development of the site as it would involve the removal of mature trees, established flower beds and stone boulders that currently line the east and west greens and are very much part of the character and appearance of the Conservation Area.**

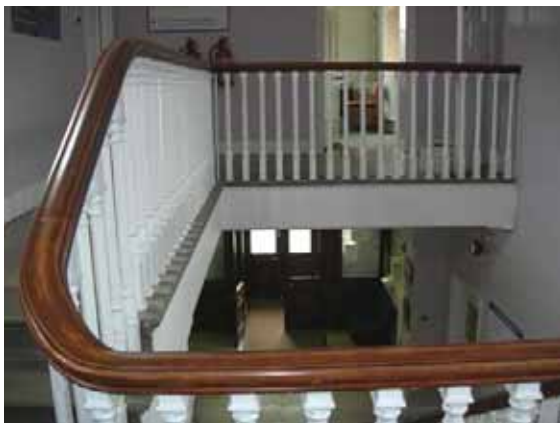
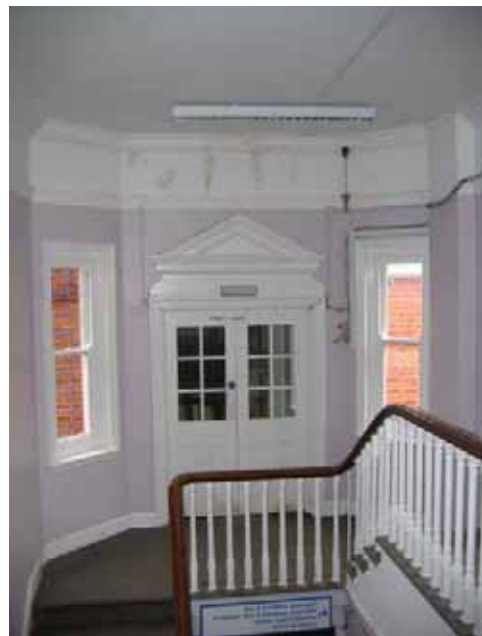
The Administration block, dated 1903, is a building central to the Conservation Area. It is an original Henman designed building and its interior is largely intact (Figs. 63 & 64).

*Fig. 63 Administration Block, original interior*

*Fig. 64 Administration Block, original interior*

It is recommended that the Henman designed Administration Block, should be considered either for full listing or to be included on a 'local list' if one were to be adopted by the Local Authority.

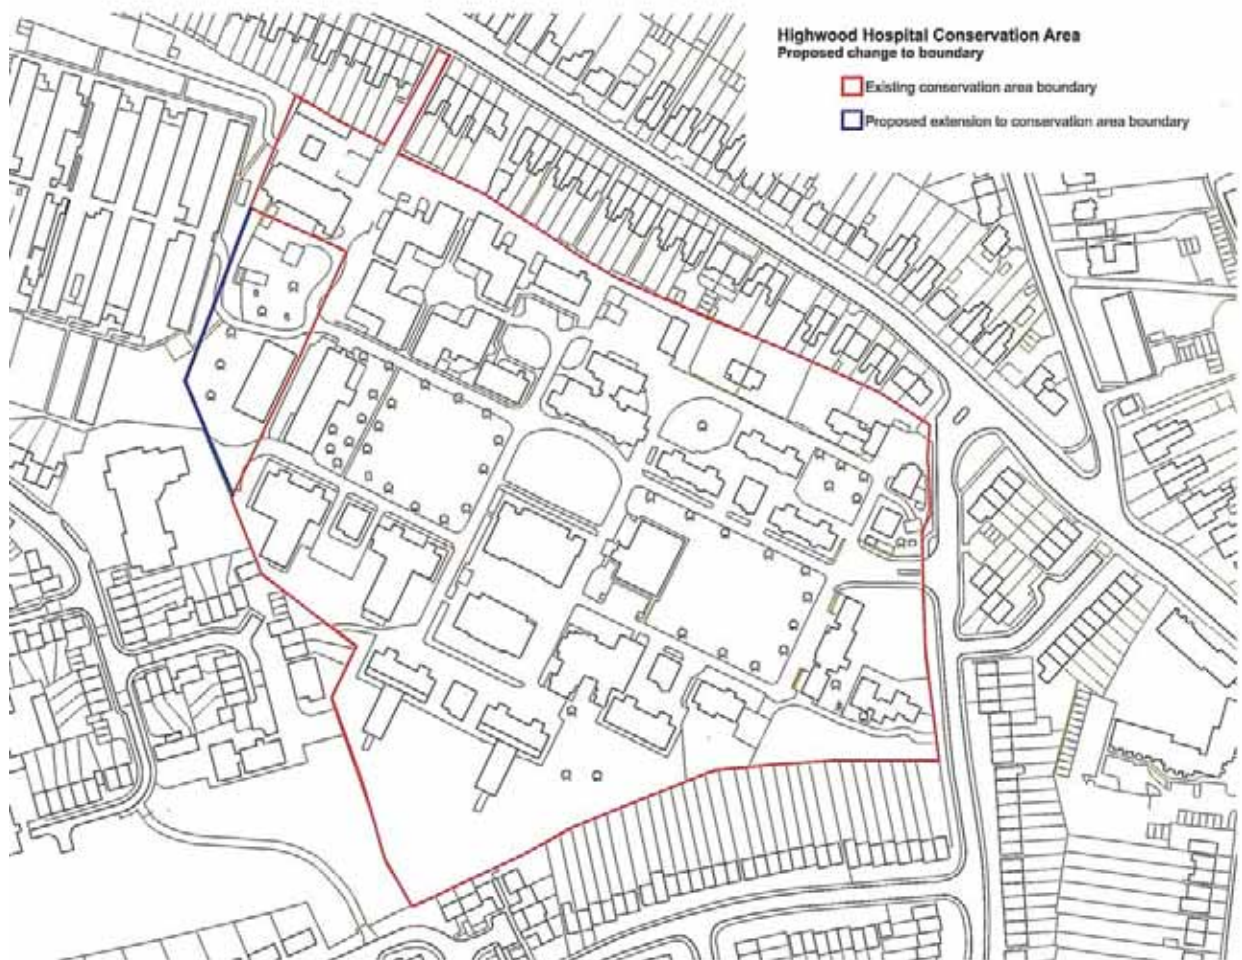
*Fig. 64 Proposed changes to the Conservation Area boundary*

It is proposed to alter the Conservation Area boundary such that to the west it forms a straight line south from the rear of the workshops in the north-west to meet the existing boundary to the west of the Poplars (Fig.65).

This would incorporate the green area behind Brambles surgery which includes a memorial well and water feature. The new boundary would give extra protection to the western edge of the Conservation Area where it meets Little Highwood.
